P081NAS3

TECHNICAL BULLETIN

501-20B: Supplemental Restraint System

SAFETY RECALL: Takata Passenger Airbag

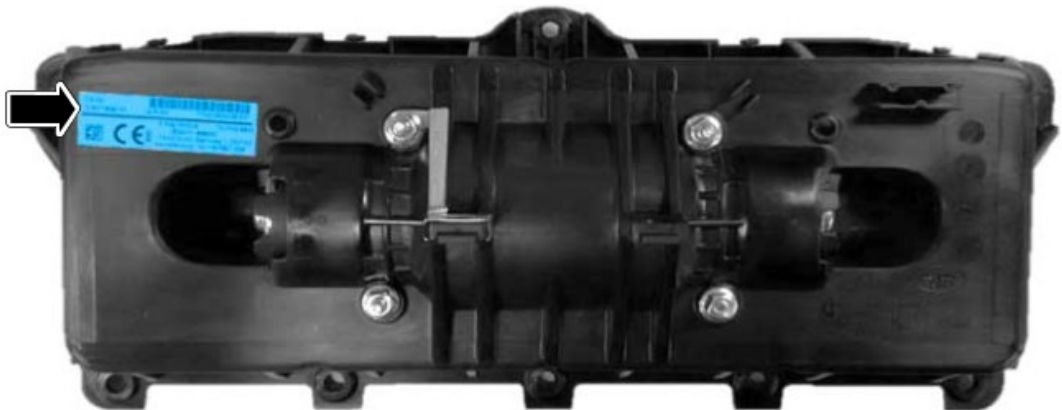
E207032

Locate the label on the NEW passenger airbag module.

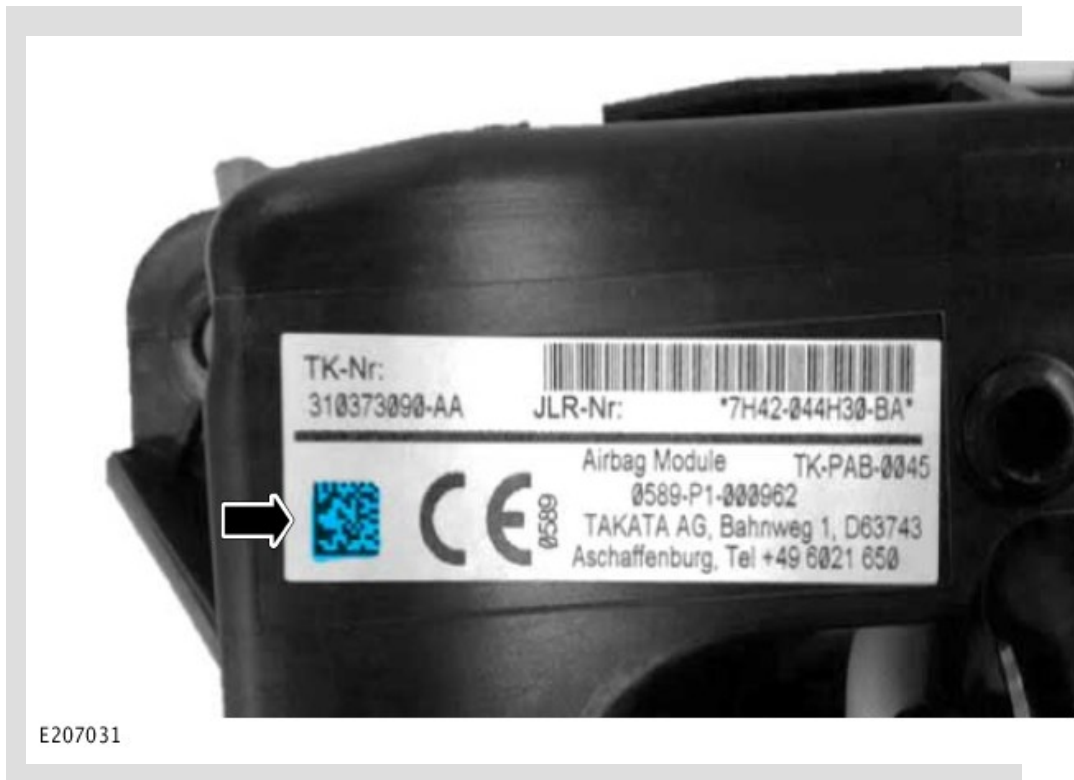
Locate the QR code on the NEW passenger airbag module label.

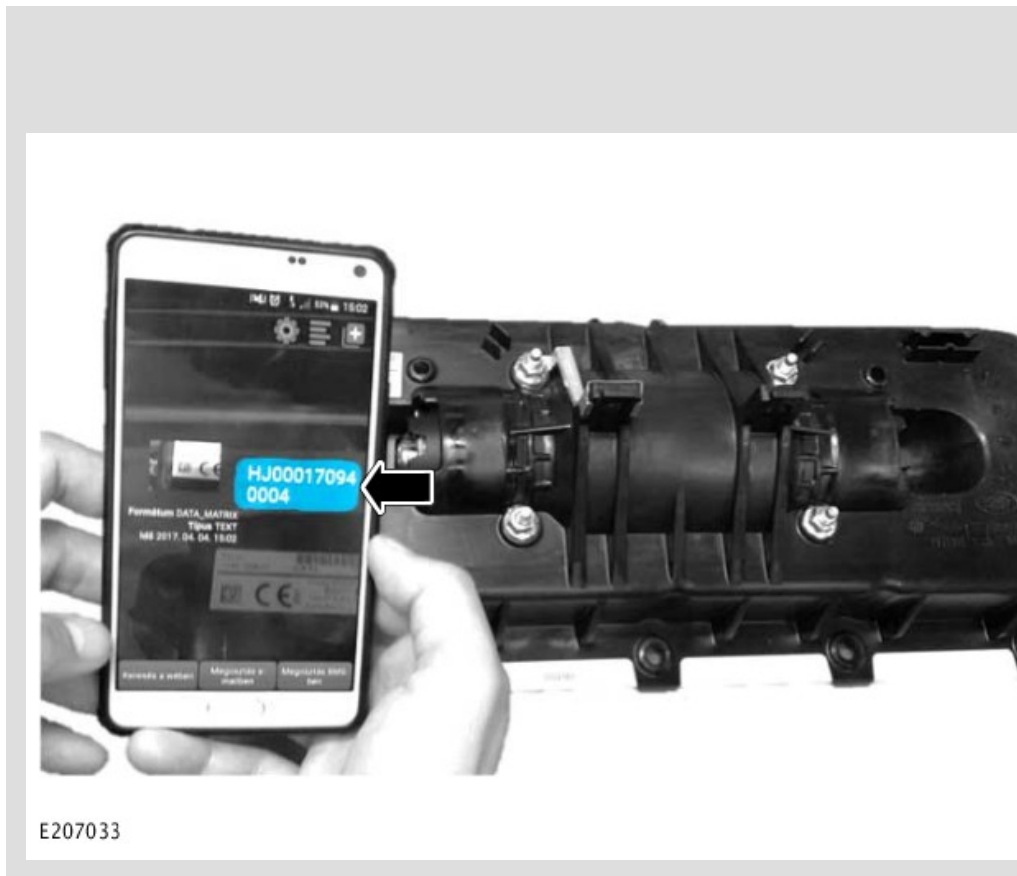
Use a smartphone with a QR code scanner to scan the QR code of the NEW front passenger airbag module.

- 1 Record the NEW passenger airbag module serial number, displayed on the screen, on the claim verbatim.
