P081NAS2

TECHNICAL BULLETIN

501-20B: Supplemental Restraint System

SAFETY RECALL: Takata Passenger Airbag

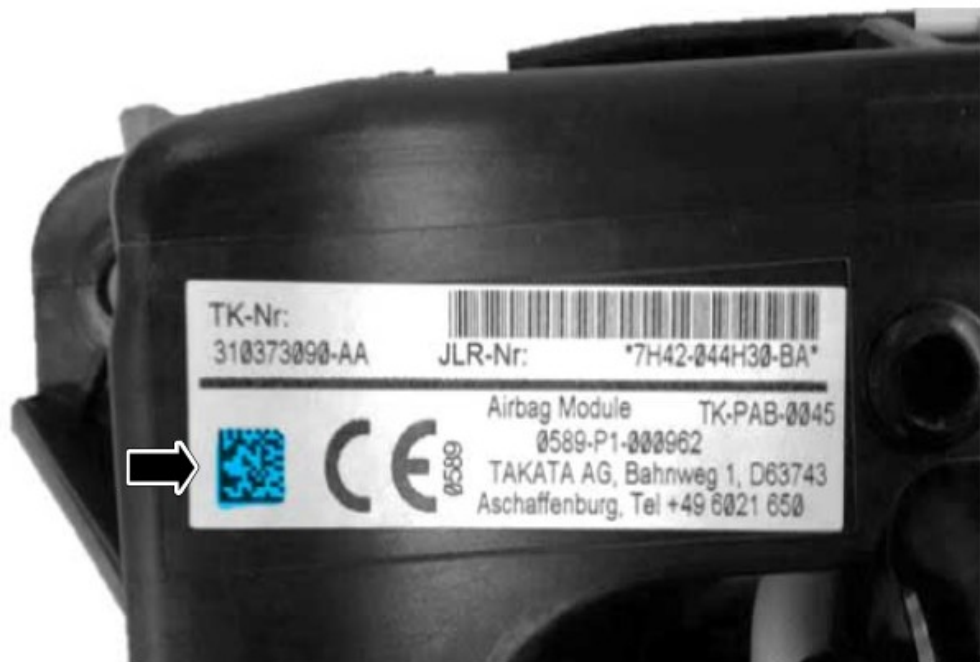
E207031

Locate the QR code on the NEW passenger airbag module label.

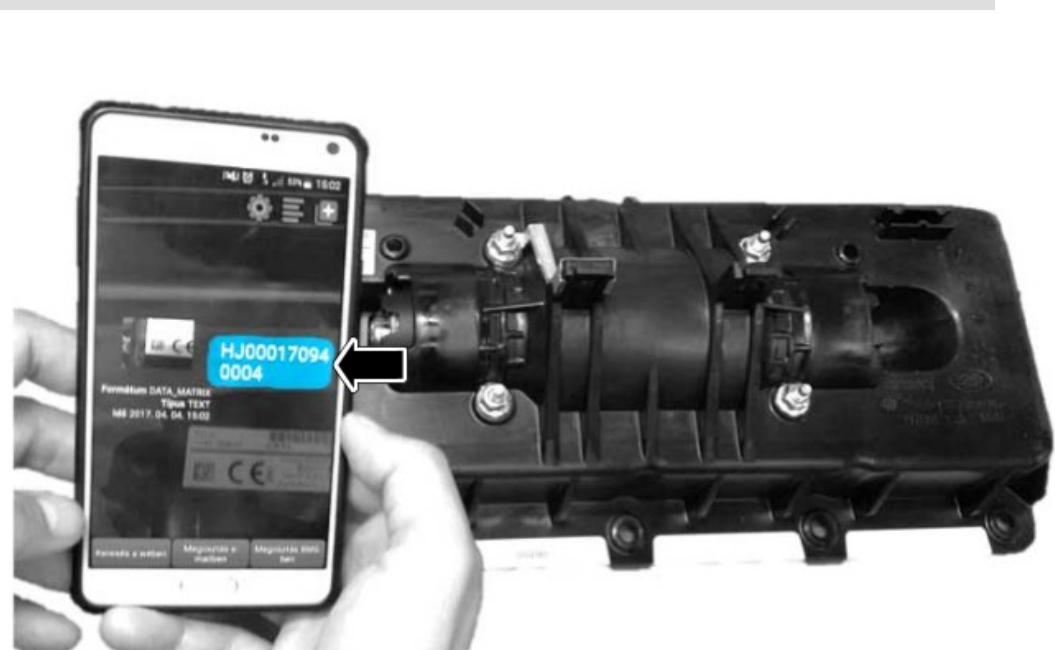
E207033

Use a smartphone with a QR code scanner to scan the QR code of the NEW front passenger airbag module.

- 1 Record the NEW passenger airbag module serial number, displayed on the screen, on the claim verbatim.
