GROUP
Safety Recall
Campaign

MODEL
2006~2014MY
Sedona (VQ)

NUMBER
SC134 Rev 1, 9/2/2016

**SUBJECT: SECONDARY HOOD LATCH REPLACEMENT OR INSPECTION
AND LUBRICANT APPLICATION (SC134)**

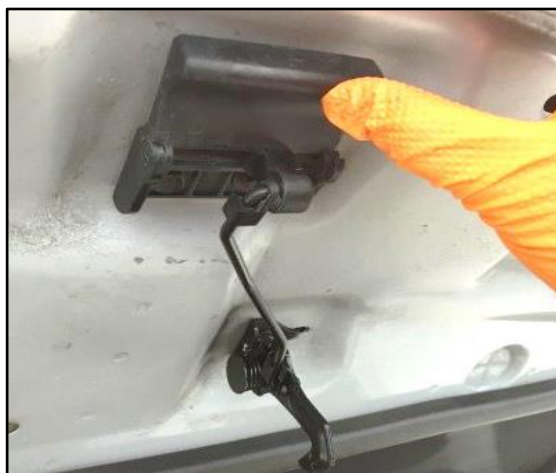
1. Open the hood and inspect the operation of the secondary hood latch.

- If there is no evidence of sticking or binding, apply WD-40 Specialist Lubricant on the rod riveting area.
- If the latch is sticking or binding, replace the latch per steps 1-3 on page 2.
