# RECALL CAMPAIGN BULLETIN

NTB16-065

## VOLUNTARY SAFETY RECALL CAMPAIGN 2016 LEAF AND 2016 SENTRA FRONT PASSENGER AIR BAG MODULE ELECTRICAL CONNECTOR SOCKET INSPECTION

**NHTSA #:** 16V-436

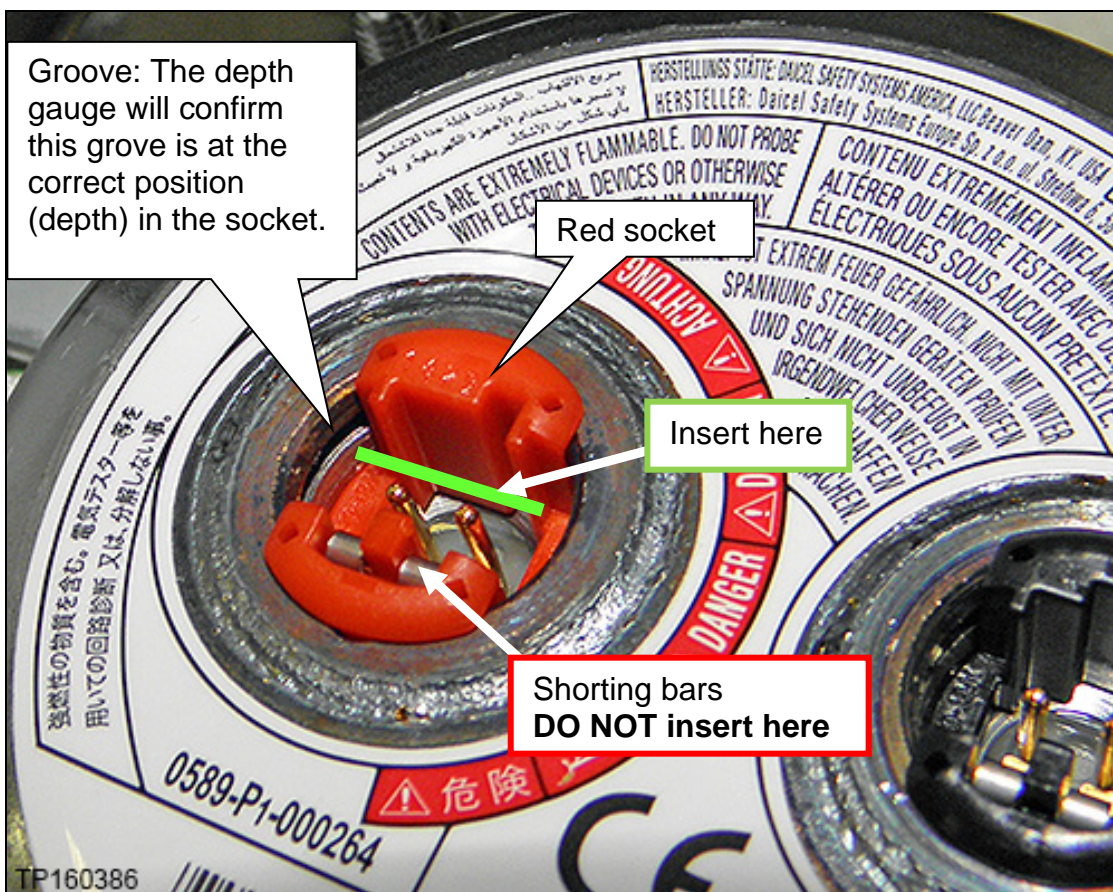
- a. Insert the depth gauge into the red socket shown in Figure 2 between the terminal pins and collar.

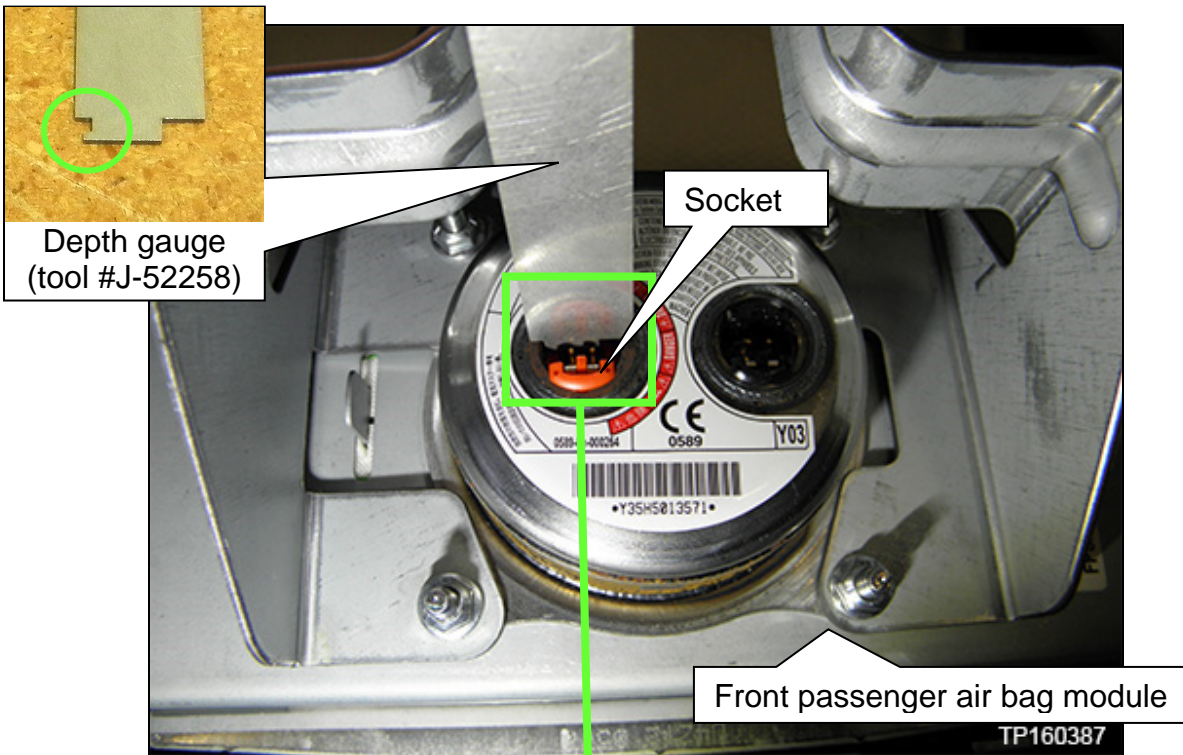
- b. Slide the depth gauge sideways into the socket groove as shown in Figure 3 and 4 below and Figure 5 on the next page.

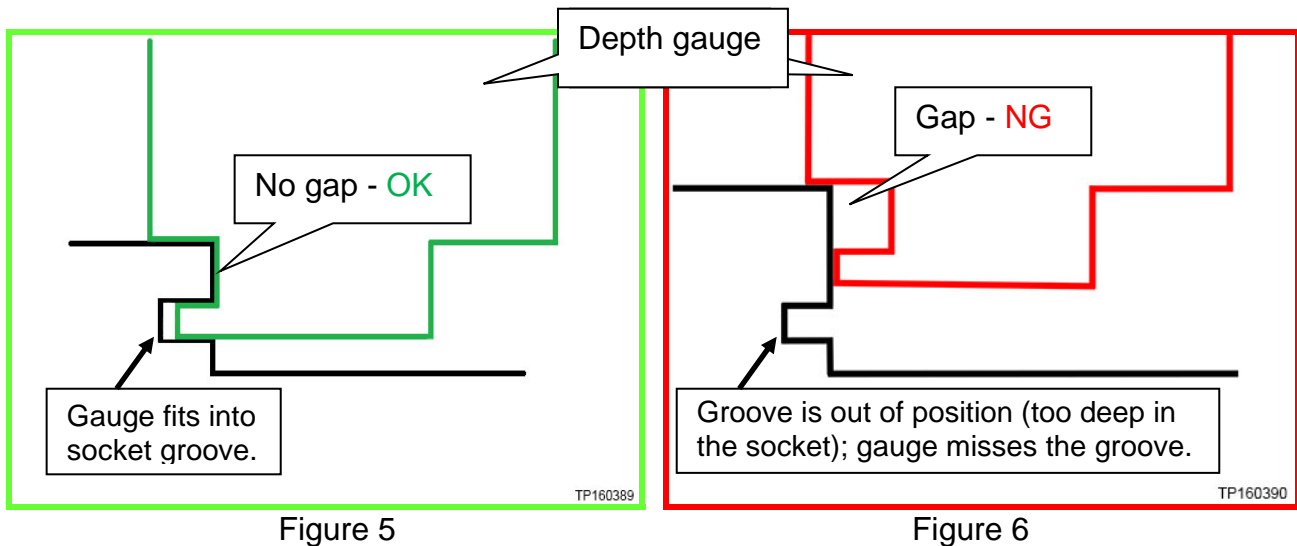
**NOTE:** If the groove is at the correct position (depth), the tool will fit into the groove. If the groove is not in the correct position, the tool will hit the side of the socket causing a gap between the tool and the socket as shown in Figure 6 on the next page.

c. Does the depth gauge fit into the socket groove as shown in Figure 5?

**NOTE:** Figures 5 and 6 show a side view of the socket with the depth gauge measuring the position (depth) of the groove.

**YES:** Proceed to step 11.

**NO:** Refer to Contact Information on page 7 and then, when instructed, proceed to step 11.
