TECHNICAL INSTRUCTIONS

SAFETY RECALL GOU

CURTAIN SHIELD AIRBAG

CERTAIN 2010 –2012 MODEL YEAR PRIUS CERTAIN 2010 AND 2012 MODEL YEAR PRIUS PLUG-IN

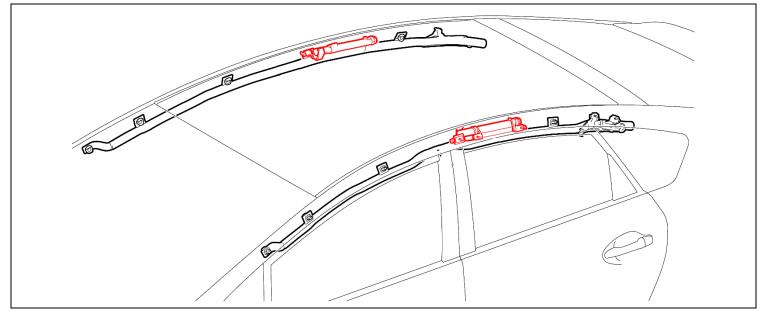
The involved vehicles are equipped with curtain shield air bags (CSA) in the driver and passenger side roof rails that have air bag inflators composed of two chambers welded together. Some inflators could have a small crack in the weld area joining the chambers, which could grow over time, and lead to the separation of the inflator chambers. This has been observed when the vehicle is parked and unoccupied for a period of time. If an inflator separates, the CSA could partially inflate, and, in limited circumstances, one or both sections of the inflator could enter the interior of the vehicle. If an occupant is present in the vehicle, there is an increased risk of injury.

The remedy will consist of installing retention brackets designed to prevent the inflator chambers from entering the vehicle interior if separation occurs.
