# Service Bulletin No. 433B

<i>MODEL</i>	<b>J4500 Series</b>	<i>TYPE</i>	<b>Field Change Program</b>	<i>SECTION/GROUP</i>	<b>3-Body</b>	<i>DATE</i>	
<i>SUBJECT</i>	<b>WINDOW MOUNTING HARDWARE</b>						
<i>CONDITIONS</i>

Ref. MCI NHTSA Recall No.:16V-XXX

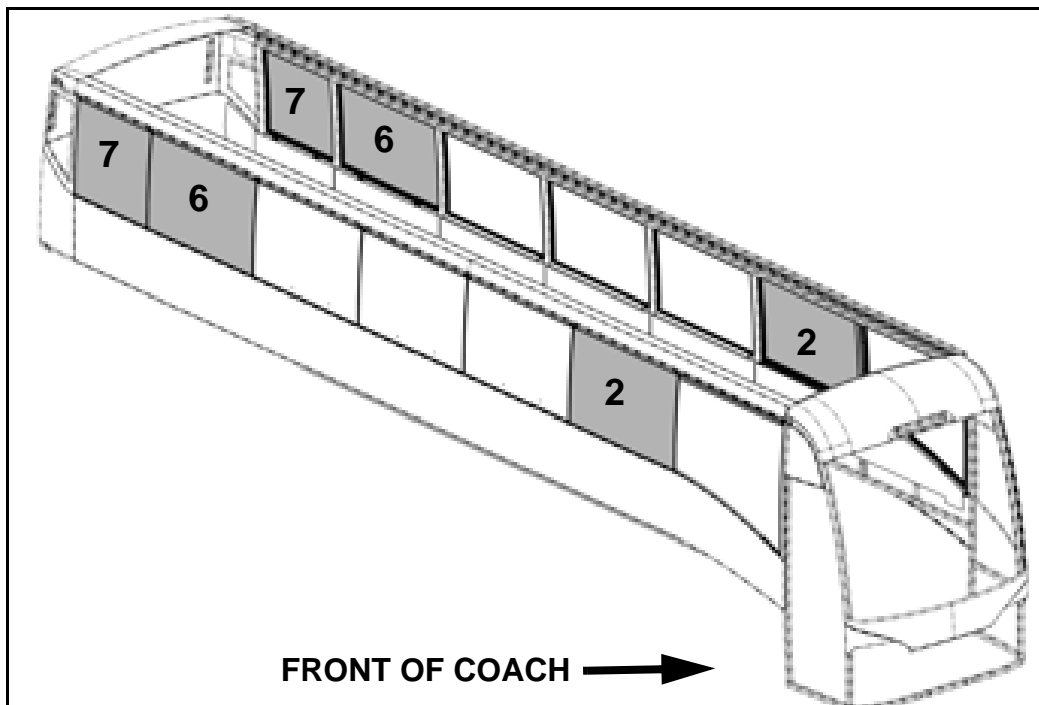
**Figure 1. Non-egress window bracket rework locations only.**

*The outlined procedure steps in this bulletin are applicable only to the #2, #6 and #7 non-egress windows on both the curbside and roadside of the coach ( refer to Figure 1 for designated locations ).*

*If the coach is equipped with a wheelchair lift, the curbside #7 window brackets do not require rework.*

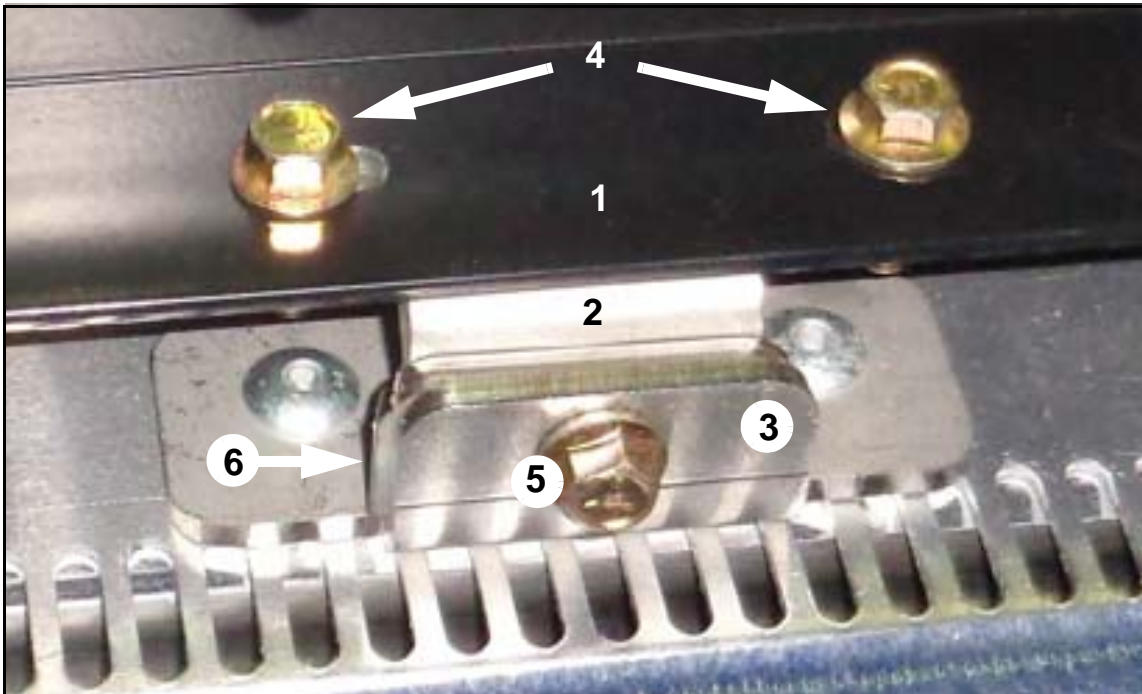
**Figure 4.**

**If a horizontal mounting capscrew ( Item 5 / Figure 4 ) is missing, a new capscrew and eight ( 8 ) shims will need to be ordered for the bracket rework.**

6. Locate one of two sets of mounting hardware ( Items 4 and 5 / Figure 4 ) securing the window to the upper and lower mounting brackets.

- c. **Adjust the alignment of the rework window so that the two ( 2 ) adjacent window edge profiles are flush against the straight edge. Hold in position and add the necessary shims ( 0 to 4 shims ) to fill the gap between the lower mounting bracket and horizontal capscrew ( Items 3 and 5 in Figure 4 ).**

***Remove, add Loctite and re-install one ( 1 ) vertical bolt ( Item 4 / Figure 4 ) at a time to ensure exterior window symmetrical alignment.***

8. Remove one ( 1 ) vertical bolt ( Item 4 / Figure 4 ). Apply blue Loctite 243 to the threads and re-install. Position a wrench on the nut and torque the bolt to 8-10 ft-lbs.
9. Remove the remaining vertical bolt. Apply blue Loctite 243 to the threads and re-install. Position a wrench on the nut and torque the bolt to 8-10 ft-lbs.

10. Remove the horizontal bolt and shims ( if applicable ). Apply blue Loctite 243 to the threads. Orient the shims on the bolt and re-install. Torque the bolt to 8-10 ft-lbs.
11. Repeat Steps 6 to 10 to the other set of mounting hardware on the window.
