# Service Bulletin No. 433B

| MODEL | J4500 Series | TYPE | Field Change Program | SECTION/GROUP | 3-Body | DATE | July 21, 2016 |
| SUBJECT | WINDOW MOUNTING HARDWARE | | | | | | |

Ref. MCI NHTSA Recall No.:16V-510

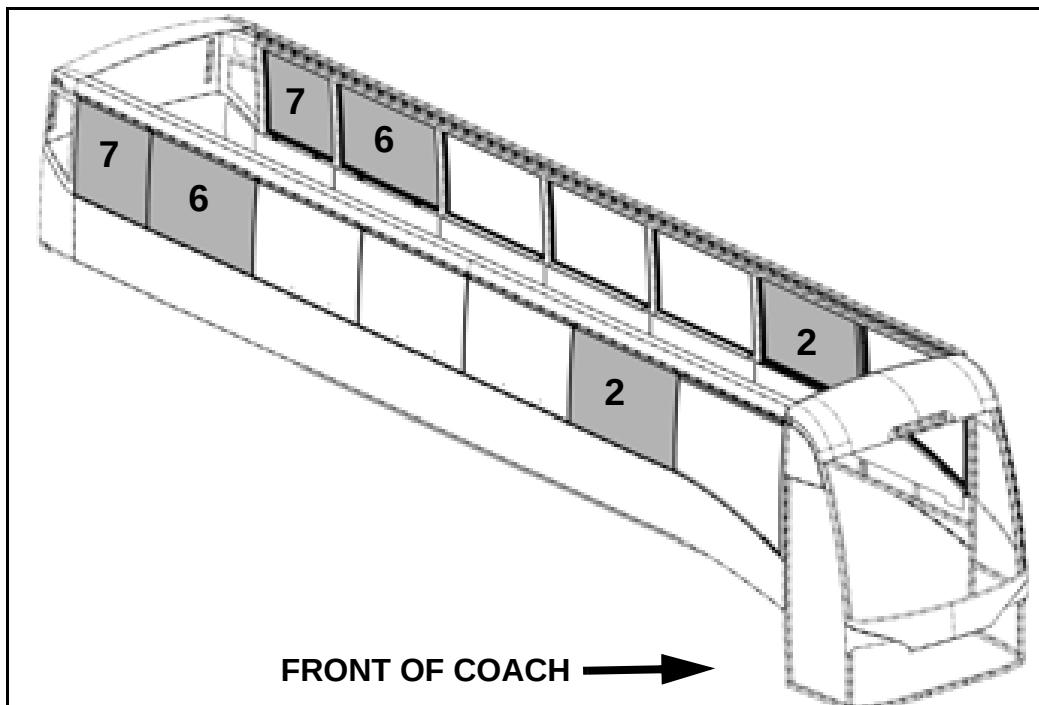
**Figure 1. Non-egress window bracket rework locations only.**

*The outlined procedure steps in this bulletin are applicable only to the #2, #6 and #7 non-egress windows on both the curbside and roadside of the coach ( refer to Figure 1 for designated locations ).*

*If the coach is equipped with a wheelchair lift, the curbside #7 window brackets do not require rework.*

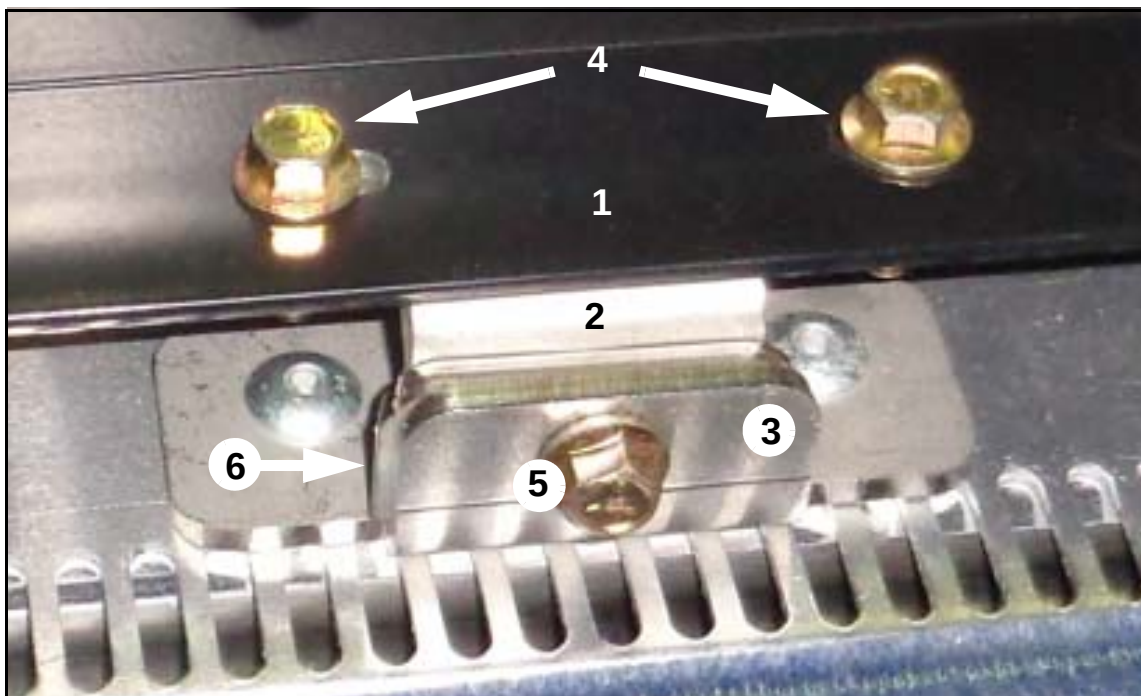
**Figure 4.**

6. Locate one of two sets of mounting hardware ( Items 4 and 5 / Figure 4 ) securing the window to the upper and lower mounting brackets.

***If a horizontal mounting capscrew ( Item 5 / Figure 4 ) is missing, a new capscrew and eight ( 8 ) shims will need to be ordered for the bracket rework.***

- c. Adjust the alignment of the rework window so that the two ( 2 ) adjacent window edge profiles are flush against the straight edge. Hold in position and add the necessary shims ( 0 to 4 shims ) to fill the gap between the lower mounting bracket and horizontal capscrew ( Items 3 and 5 in Figure 4 ).***

***Remove, add Loctite and re-install one ( 1 ) vertical bolt ( Item 4 / Figure 4 ) at a time to ensure exterior window symmetrical alignment.***

8. Remove one ( 1 ) vertical bolt ( Item 4 / Figure 4 ). Apply blue Loctite 243 to the threads and re-install. Position a wrench on the nut and torque the bolt to 8-10 ft-lbs.
9. Remove the remaining vertical bolt. Apply blue Loctite 243 to the threads and re-install. Position a wrench on the nut and torque the bolt to 8-10 ft-lbs.

10. Remove the horizontal bolt and shims ( if applicable ). Apply blue Loctite 243 to the threads. Orient the shims on the bolt and re-install. Torque the bolt to 8-10 ft-lbs.
11. Repeat Steps 6 to 10 to the other set of mounting hardware on the window.
