VOLUNTARY SAFETY RECALL CAMPAIGN 2012 – 2013 M35 HYBRID CONTROL MODULE

CAMPAIGN ID #: R1623

NHTSA #: 16V-527

APPLIED VEHICLES: 2012 – 2013 M35 Hybrid (Y51)

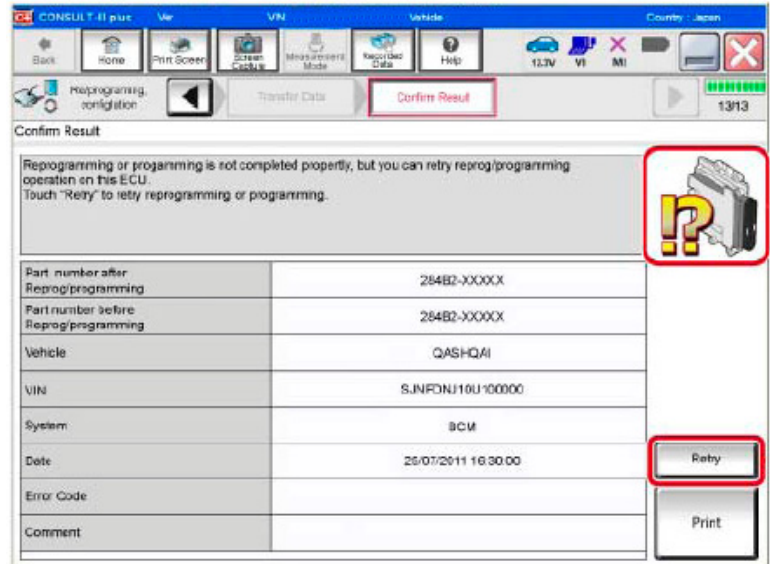
Figure 16

If reprogramming does not complete and the “!” icon displays as shown in Figure 16:

- Check battery voltage (12.0–15.5 V).
- Ignition is ON, not Ready.
- External Bluetooth® devices are OFF.
- All electrical loads are OFF.
- **Select retry and follow the on screen instructions.**
- “Retry” may not go through on first attempt and can be selected more than once.

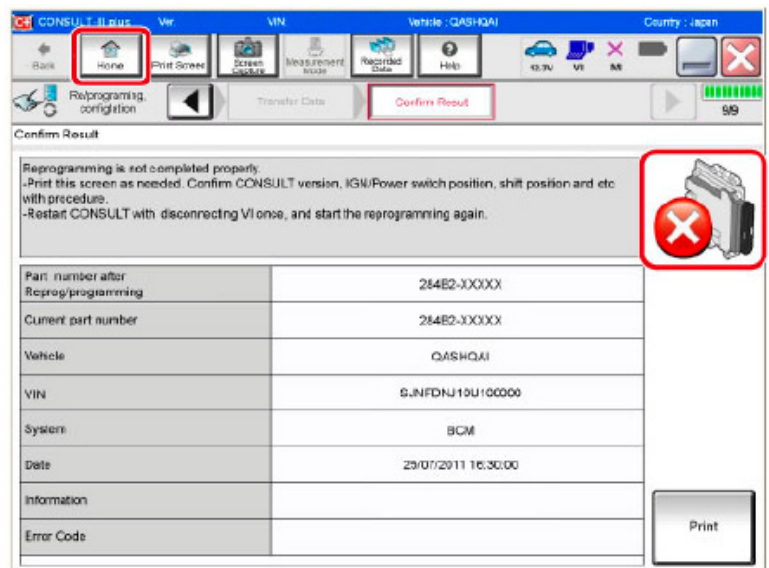
Figure 17

If reprogramming does not complete and the “X” icon displays as shown in Figure 17:

- Check battery voltage (12.0 – 15.5 V).
- CONSULT A/C adapter is plugged in.
- Ignition is ON, not Ready.
- Transmission is in Park.
- All C-III plus / VI cables are securely connected.
- All C-III plus updates are installed.
- **Select Home, and restart the reprogram procedure from the beginning.**
