Revised November 2016

Dealer Service Instructions for:

## **Safety Recall S55 / NHTSA 16V-529 Transaxle Range Sensor Wire Harness**

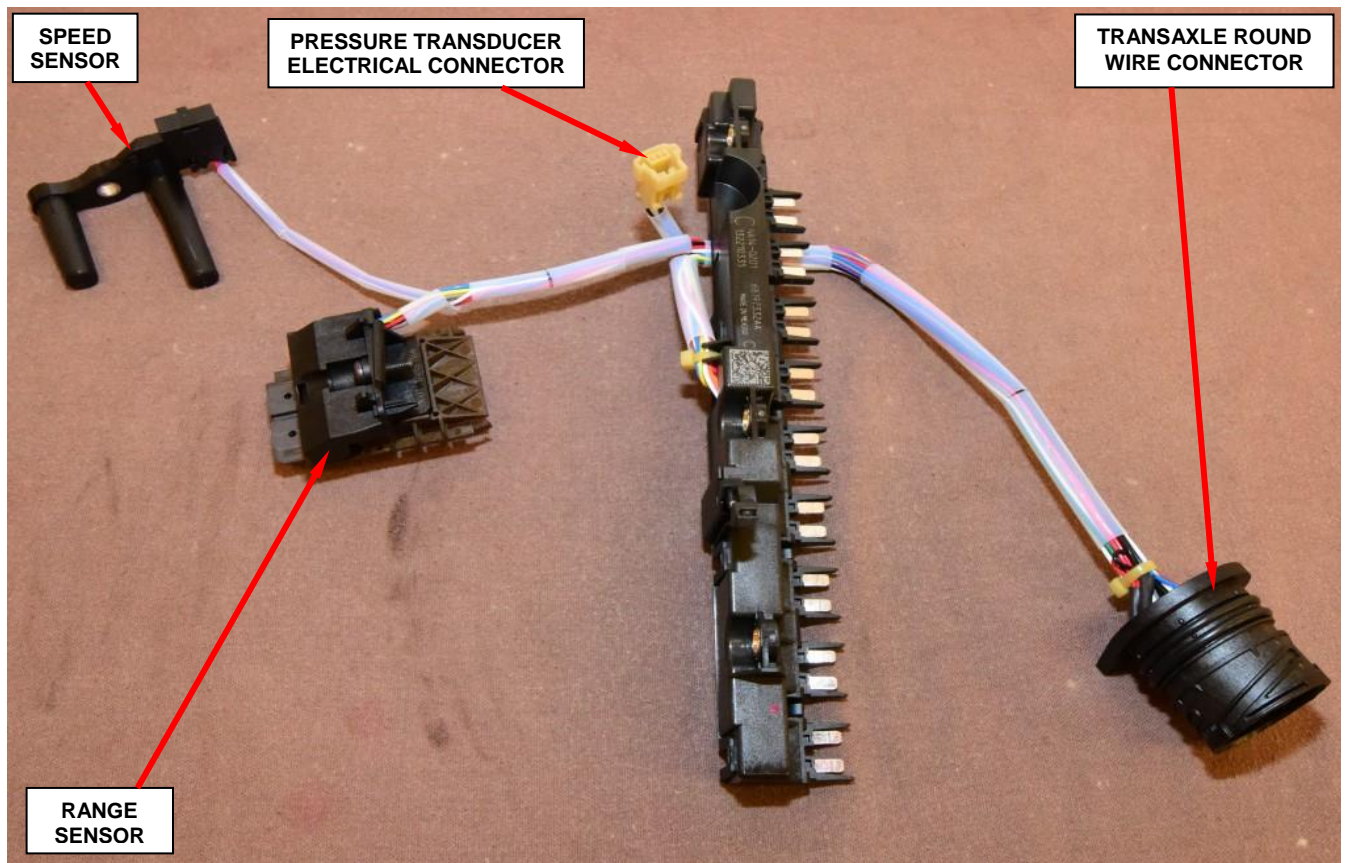
**Figure 9 – Transaxle Range Sensor Wire Harness**

The transaxle range sensor wire harness on about 323,400 of the above vehicles may have been built with insufficient wire terminal crimps. This may cause an intermittent high electrical resistance in the transaxle range sensor wire harness circuit(s). A high resistance circuit(s) in this transaxle range sensor wiring harness will cause the on-board diagnostic system to set a Diagnostic Trouble Code (DTC). When the DTC is set, the system defaults the transaxle to neutral and the customer experiences a loss of motive power. Motive power can usually be regained upon an engine restart. The loss of motive power could cause a crash without warning.

26. Remove and discard the original transaxle range sensor wire harness (Figure 9).
27. Place the new transaxle range sensor wire harness into position (Figure 9).
28. Install the three transaxle range sensor wire harness retaining screws (Figure 8). Tighten the screws to 50 in. lbs. (6 N·m).
29. Connect the electrical connector for the pressure transducer (Figure 9).
30. Replace both rubber O-rings on all the valve body fluid crossover tubes.
