## Field campaign

<b>Topic</b>	
<b>Market area</b>	Bentley: worldwide (2WBE),Hongkong-Macau (5HK)
<b>Brand</b>	Bentley
<b>Transaction No.</b>	2044749/1
<b>Campaign number</b>	RA55
<b>Note</b>	
<b>Type</b>	
<b>US code</b>

### Continental Flying Spur

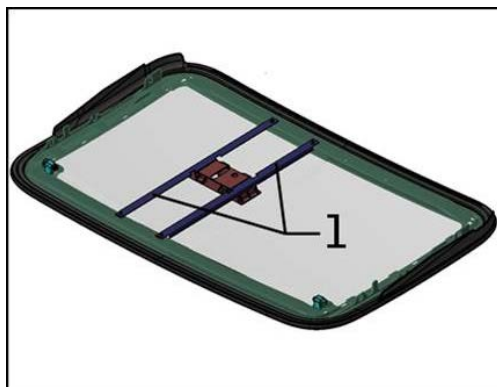
Unscrew the two struts (1) of the DC converter.

Remove the solar glass panel.

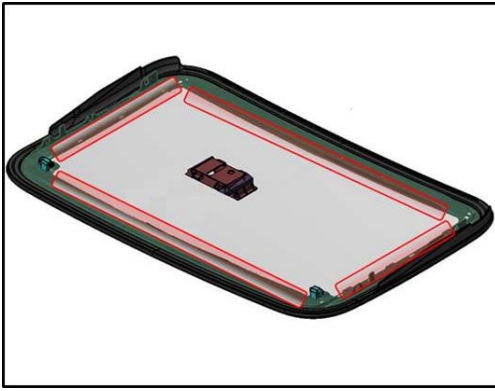
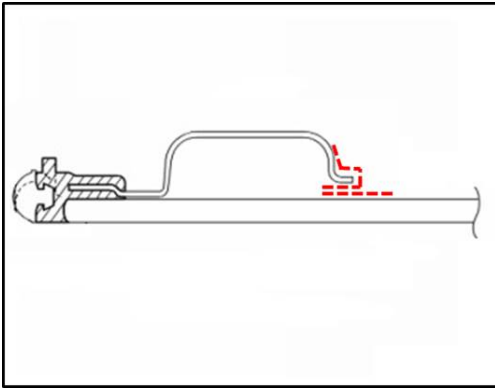
(cutaway picture of left and right moulding)

Thoroughly clean the bonding surfaces (red) with the cleaning solution D 009 401 04.

Apply the glass and paint primer with applicator equally on all the red marked bonding surfaces.

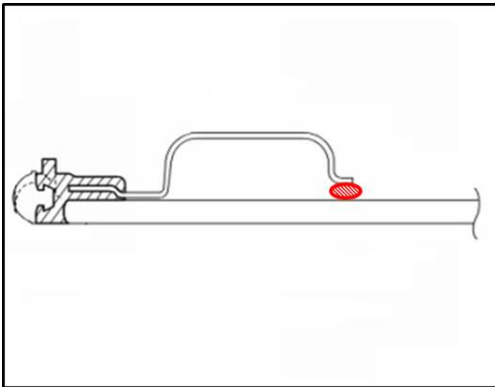
(cutaway picture: first adhesive bead of left and right moulding)

Apply the 1K window bonder with the unshortened application nozzle and fill the gap between glass and frame with a thin adhesive bead.

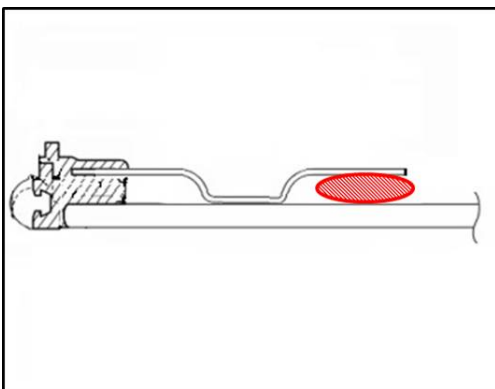
(cutaway picture: first adhesive bead of front and rear moulding)

Shorten the application nozzle by 45 mm.

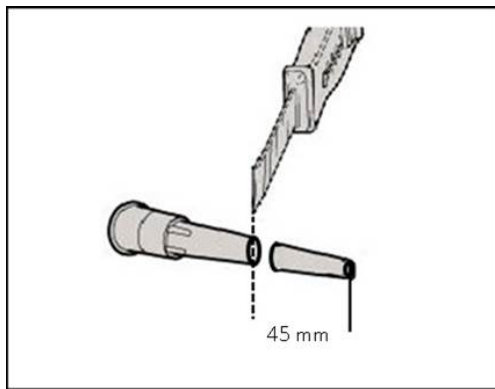
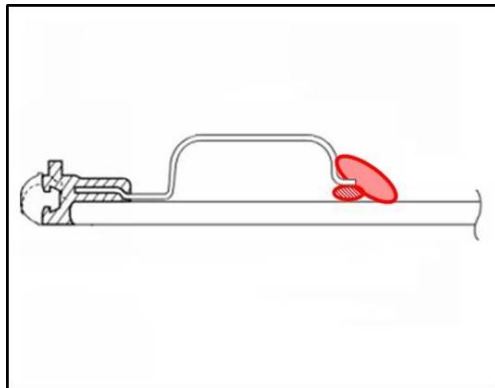
(cutaway picture: second adhesive bead of left and right moulding)

Apply the 1K window bonder with the shortened application nozzle and bond the glass with the frame using a wide adhesive bead.

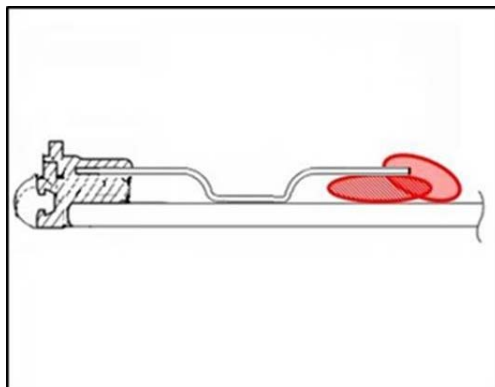
(cutaway picture: second adhesive bead of front and rear moulding)

*Observe the minimum airing period for 1 K window bonder.*

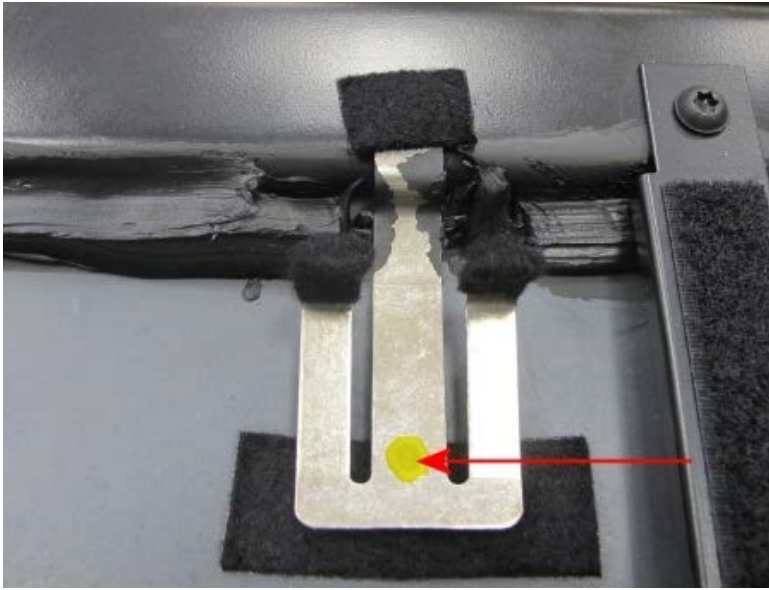
Figure 1

Unclip and slide the sunroof blind back, check for yellow campaign identification mark to sunroof blind clip (see Figure 1)

If the vehicle is not already listed as repaired in the "Repair History" (in ElsaPro), check for the presence of a yellow paint spot on the sun roof blind clip (see Figure 1)
