# SAFETY RECALL BULLETIN

SUBJECT: <h2 style="text-align: center; margin: 0;">TRANSMISSION FLUID HOSE CLAMP NOT RELEASED – SAFETY RECALL CAMPAIGN</h2>		No: <b>SR-16-005</b> DATE: <b>July, 2016</b> MODEL: <b>2015 Outlander Sport/ RVR w/ 2.0L Engine and CVT</b>	
CIRCULATE TO:	<input checked="" type="checkbox"/> GENERAL MANAGER	<input checked="" type="checkbox"/> PARTS MANAGER	<input checked="" type="checkbox"/> TECHNICIAN
<input checked="" type="checkbox"/> SERVICE ADVISOR	<input checked="" type="checkbox"/> SERVICE MANAGER	<input checked="" type="checkbox"/> WARRANTY PROCESSOR	<input checked="" type="checkbox"/> SALES MANAGER

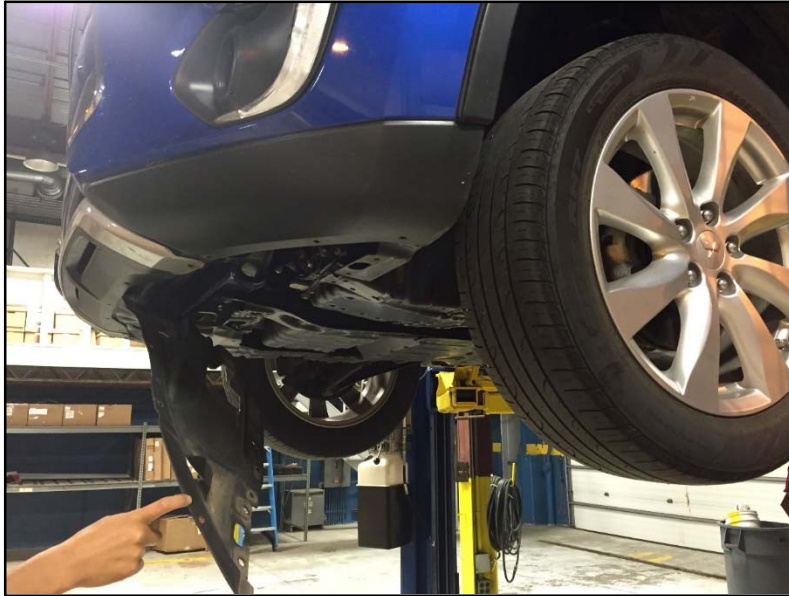
1. Raise the vehicle and partially remove the engine under cover to allow inspection of the hose clamps at the left front corner of the vehicle.

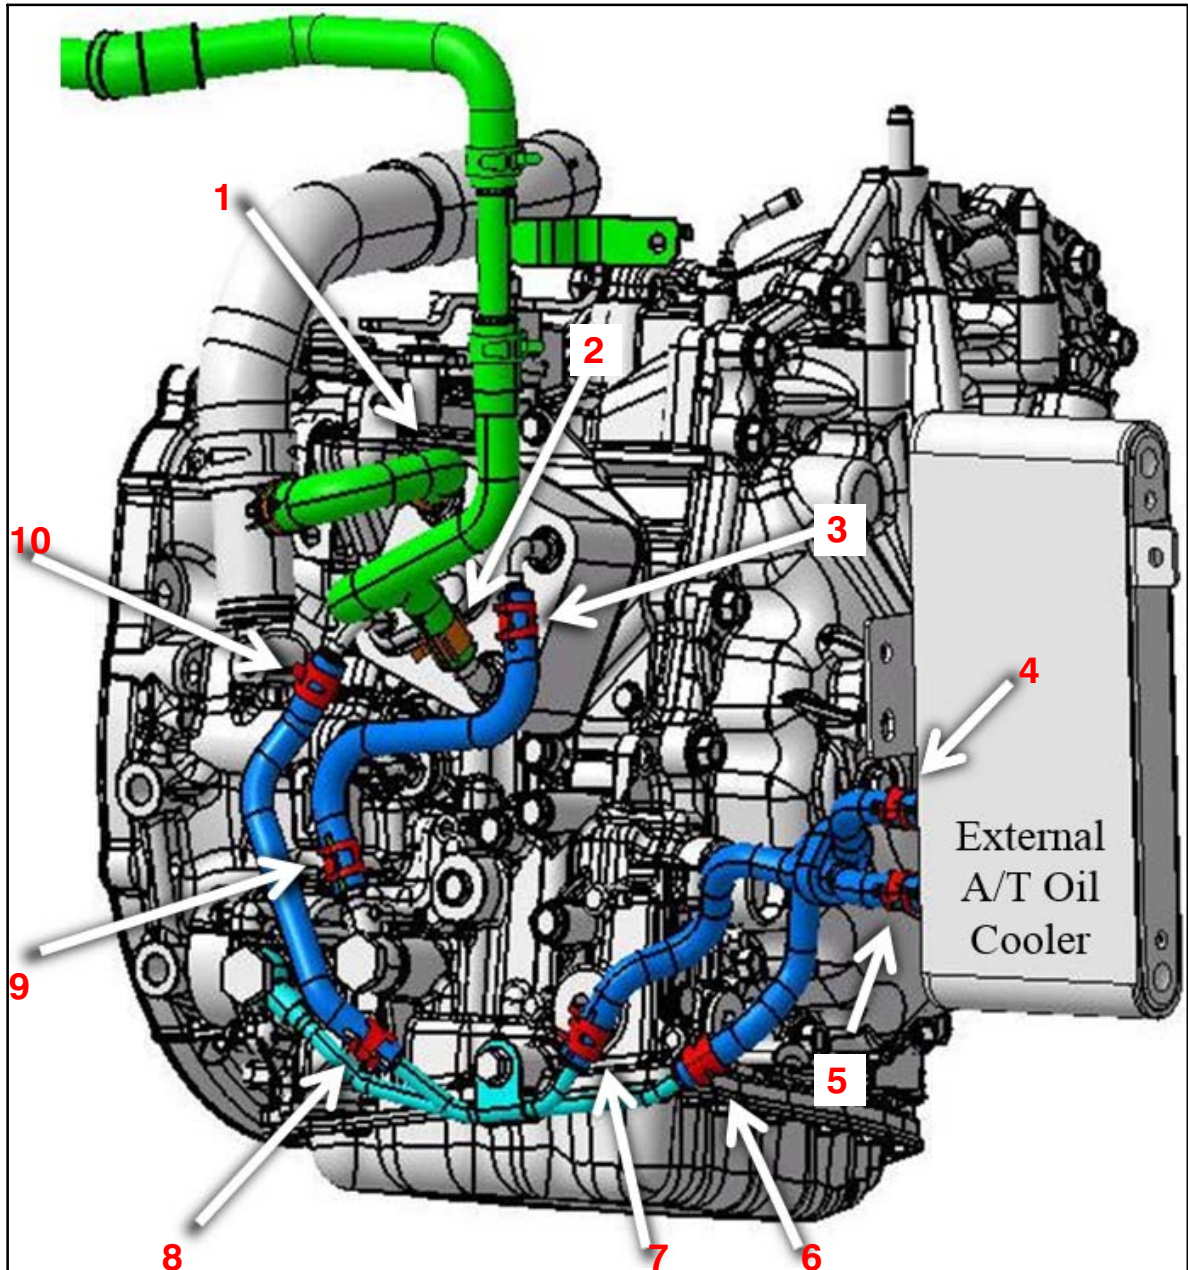
CVT with External Oil Cooler

2. Inspect the hose clamps at the locations illustrated.
  - a. For CVT with an External Oil Cooler, inspect (10) hose clamps.
  - b. For CVT without an External Oil Cooler, inspect (6) hose clamps.

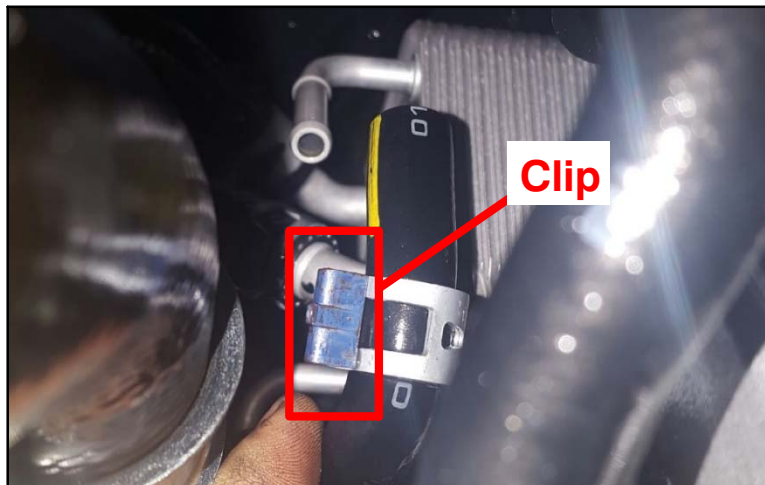
- Verify that each hose clamp is correctly positioned on the hose and does not have a clip installed.

- If a clip is found to be installed (i.e., clamp not released), take clear photograph(s) of the clamp and clip, and submit to the MMNA Photo Required Center (PRC). Inspect for any signs of transmission fluid or engine coolant leak. Remove the clip and retain it for potential MMNA inspection. Ensure that the hose and clamp are installed correctly on the fitting, and transmission and coolant fluids are at their recommended levels.
- Reinstall engine under cover.
