SAFETY RECALL BULLETIN

SUBJECT: CVT HESITATION – SAFETY RECALL CAMPAIGN			No: SR-16-006
			DATE: August, 2016
			MODEL: SEE BELOW
CIRCULATE TO:	<input checked="" type="checkbox"/> GENERAL MANAGER	<input checked="" type="checkbox"/> PARTS MANAGER	<input checked="" type="checkbox"/> TECHNICIAN
<input checked="" type="checkbox"/> SERVICE ADVISOR	<input checked="" type="checkbox"/> SERVICE MANAGER	<input checked="" type="checkbox"/> WARRANTY PROCESSOR	<input checked="" type="checkbox"/> SALES MANAGER

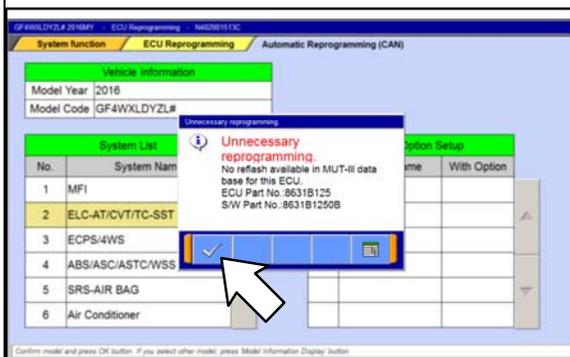
IF ECU IS ALREADY AT LATEST VERSION

If the message seen at left is displayed, the ECU software is already at the most current level. Do not continue with the reprogramming procedure. **This Recall is complete; note on the RO that the flash was not necessary and still submit a recall claim.**

Click the check mark to clear the window, then click the Home icon at the lower left corner of the screen to return to the System Select main page.

Turn the ignition switch to the OFF position and disconnect the MUT-III. Turn off and disconnect the battery charger. Conduct normal diagnosis per the service manual.
