## Recall Notice

**Recall #:** 100715

Inform Aluma dealers and owners that 5410T tilt trailer may have missing weld that may contribute to a failure of the trailer's tongue weldment.

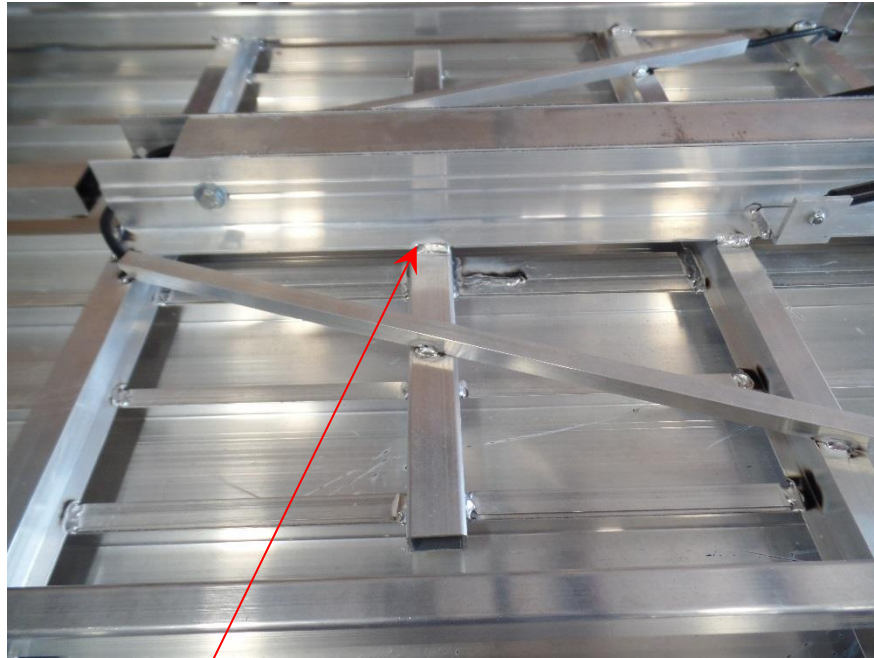
Figure 1

Inspect weld and base material

- 2.0 Inspect all welds and base material on tongue retainer and trailer frame to ensure no signs of damage has occurred. See Figure 1, 2 and 3. Prepare surface areas that are to be welded. Person performing retrofit should be qualified and proficient aluminum welder. **Caution:** Use appropriate PPEs when preparing surface and welding.

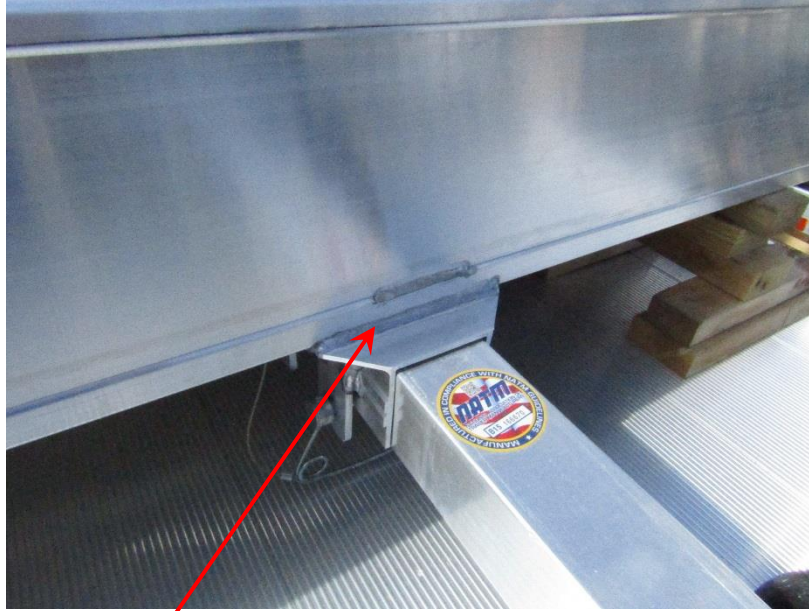
Figure 3

Inspect weld and base material
