# Recall Notice

**Recall #: R000003**

**Date: 8-08-2016**

Inform Aluma dealers and owners that 8605T, 8610T and 8612T trailers may have misaligned welds that may contribute to a failure of the trailer's axle mount weldment.

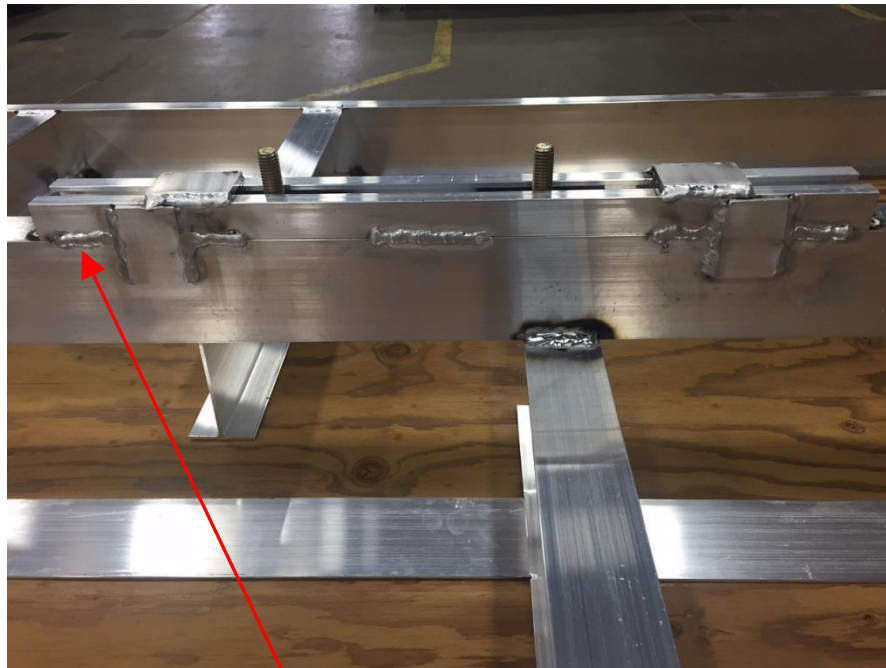
- 2.0 Remove and secure tires and hardware to be reinstalled later in step 8.
- 3.0 Inspect inside weld joint of axle mounts and U-channels for misalignment of weld or any cracks in welds. See Figure 1. If any defects are present proceed to inspecting axle mount outside welds and verify that there are no signs of base material damage. Repair all suspect welds using step 6. See Figures 3 and 4.

Option 1: flat strap configuration.  
Inspect location of weld in joint.

- 4.0 Add flat strap to inside of axle mount as shown in Figure 1 and 2. Depending on condition of welds found in steps 5 or 6.
  - 4.1 Option 1: Flat strap must be located 2 inches from end of axle mount if flat strap can be placed flat onto axle mount and U-channel and then weld.
