Technical Service Bulletin

16-01-037

**2015
GENESIS SEDAN (DH)****SUBJECT:****GENESIS SEDAN (DH) SUPER VISION CLUSTER LOGIC UPDATE
(RECALL 147)****★ IMPORTANT******* Dealer Stock and Retail Vehicles *****

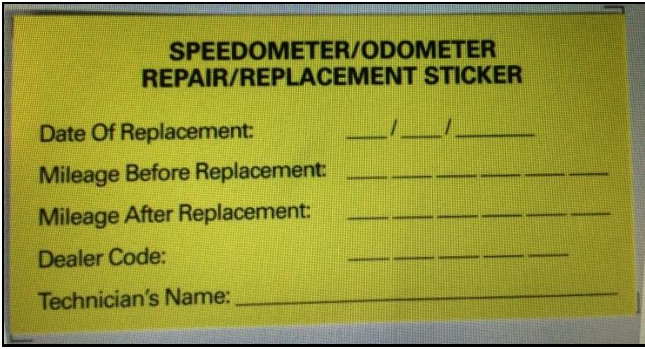
00924-0000C (Speedometer Sticker)	If the mileage display on the cluster is inconsistent/lower than what is on the service record, then record the correct mileage on this sticker and place it in the vehicle door jam.	1

- If the mileage display on the cluster is inconsistent/lower than what is on the service record, then record the correct mileage on the speedometer sticker (00924-0000C) and place it in the vehicle door jam.
