REPAIR PROCEDURE

NUMBERS: WTE-66

DATE: 07/29/16

SUBJECT: Repair Procedure for Subaru Recall Campaign Stop Sale WTE-66 Front Brake Caliper, Wheel Hub and Stabilizer Clamp Attaching Bolt Torque.

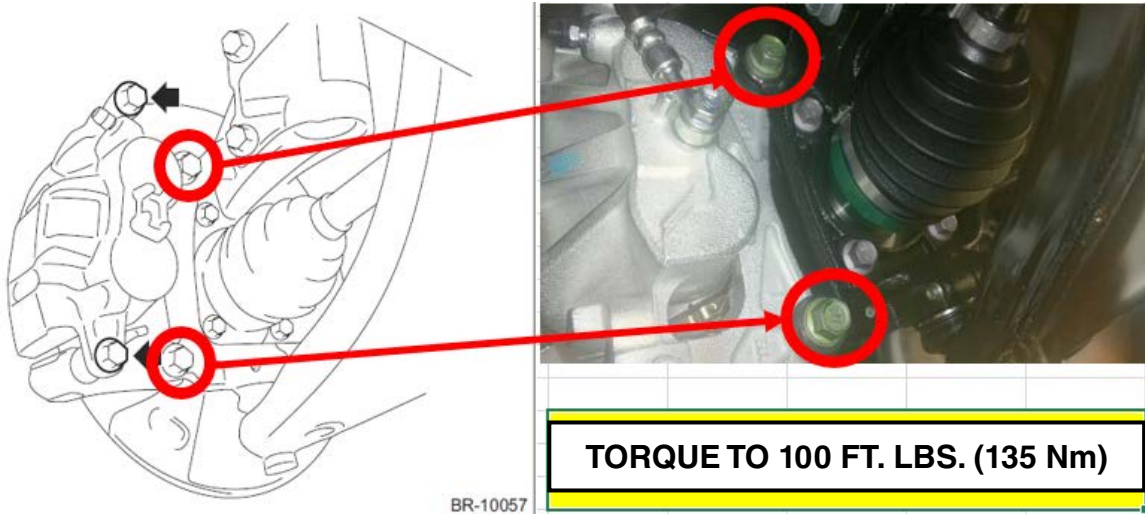
STEP 2: Using a 17mm socket, verify the torque of the 2- 17mm hex bolts securing the front disc brake caliper support to the axle housing. **Torque each bolt to 100 ft. lbs. (135 Nm).**

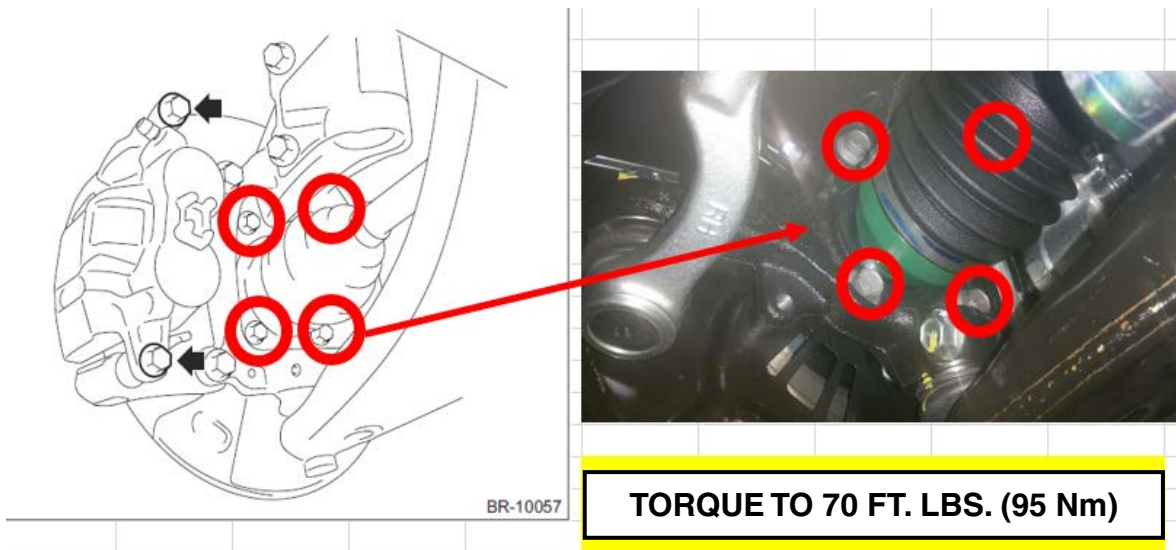
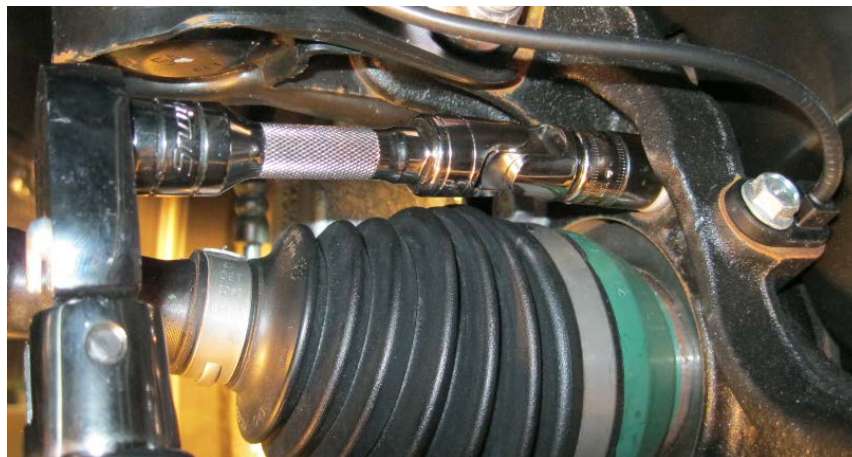
STEP 3: Using a 14mm socket, 3/8” swivel adapter and a 3” extension, verify the torque of the 8- (4 each side) 14mm hex head bolts securing the front hub unit to the axle housing. **Torque each bolt to 70 ft. lbs. (95 Nm).**

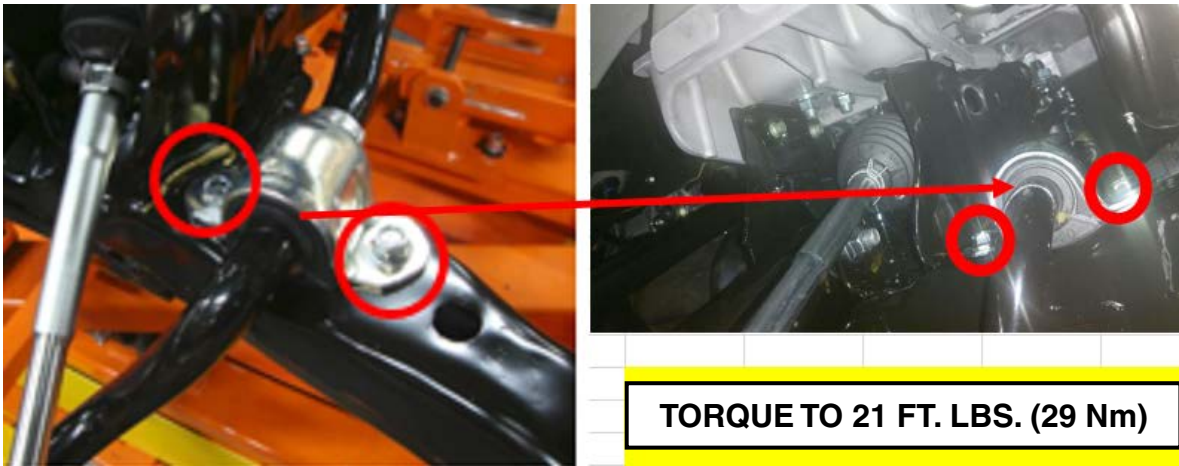
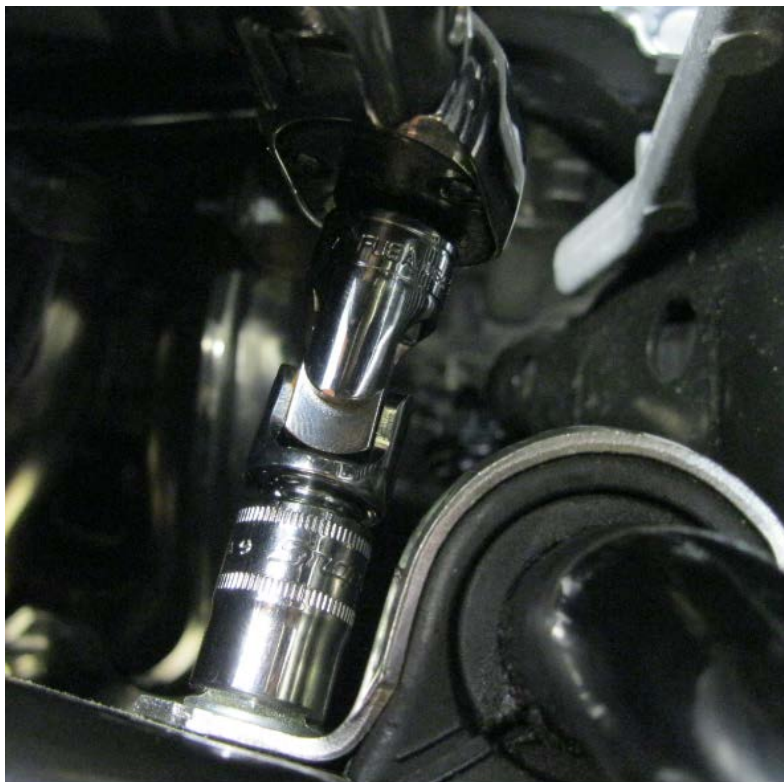
STEP 4: Using a 12mm socket and 3/8" swivel adapter, verify the torque of the 2- **RIGHT SIDE ONLY** 12mm hex head bolts securing the stabilizer bar bushing retaining bracket to the engine cradle. **Torque each bolt to 21 ft. lbs. (29 Nm).** (Steer the front wheels full right to gain enough access.)
