August 2016

Safety Recall S59 / NHTSA 16V-589

Chassis Fasteners

2016 (UF) Chrysler 200

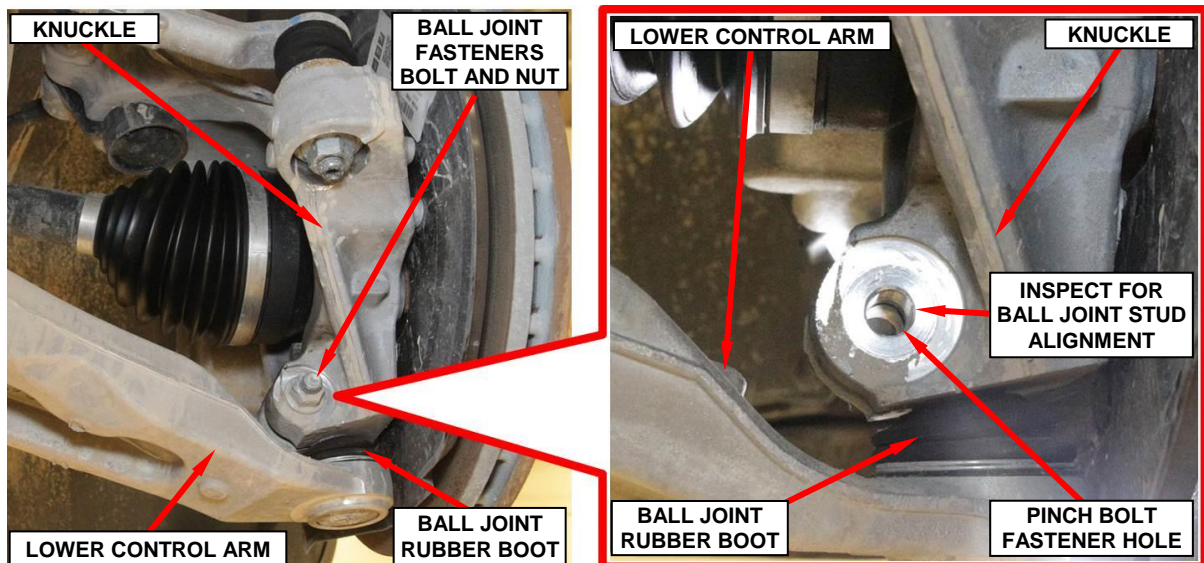
Figure 13 – Lower Control Arm Ball Joint

WARNING: Visually inspect that the lower control arm ball joint stud is fully inserted into knuckle before the pinch bolt is inserted into knuckle. Only the ball joint rubber boot should be visible below the knuckle; the ball joint stud should not be visible. Failure to fully and properly insert the ball joint stud into the knuckle could lead to wheel separation and loss of vehicle mobility and could result in personal injury and/or death (Figure 13).

17. Front lower control arm ball joint to knuckle fasteners on the left and right side of the vehicle. Remove and discard the bolt and nut. Install a NEW bolt and nut. Hold the bolt while tightening the nut to 44 ft. lbs. + 48 degrees (60 N·m + 48 degrees) (Figure 13).
