SAFETY RECALL BULLETIN

NHTSA RECALL 16V599, Transport Canada 2016-401

AUTOCAR INDUSTRIES, LLC SAFETY RECALL ACTT-1601

Autocar has determined that a safety defect exists in the steering column of certain 2016-2017 model year Xspotters.

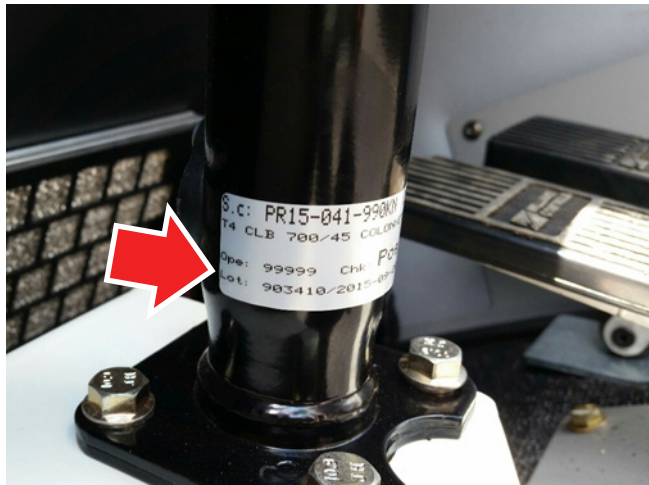
Figure 1, Steering Column Label

At the base of the steering column, check the lot code number on the label (See Figure 1 and Figure 2).

If the lot code number is 869501, replace the steering column per the procedure below.

If the label has been removed or is not legible, replace the steering column per the procedure below.

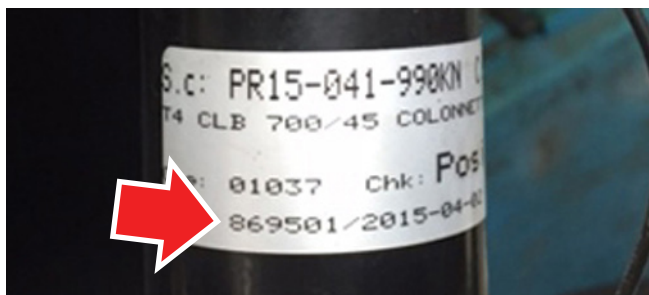
Figure 2, Lot Code Number

If the lot code number is not 869501, the steering column does not need to be replaced.
