Technical Service Bulletin

GROUP	NUMBER
	RECALL	17-01-020
	DATE	MODEL(S)
	FEBRUARY 2017	SONATA (LF) SONATA HYBRID (LFHEV)

DRIVER AIRBAG (DAB) REPLACEMENT (RECALL CAMPAIGN 148)

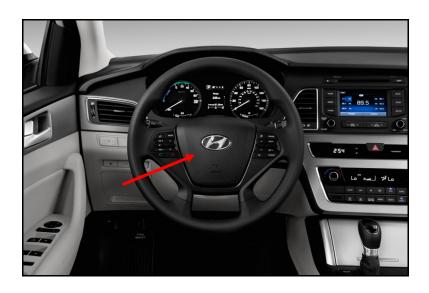
Description: Certain 2015 - 2017 Sonata (LF) and 2016 Sonata Hybrid (LFHEV) vehicles have a driver-side frontal airbag that may not adequately protect the driver's neck from injury in the event of a crash. These vehicles may not comply with the requirements of Federal Motor Vehicle Safety Standard (FMVSS) number 208, "Occupant Crash Protection." This bulletin describes the procedure to replace the Driver Airbag (DAB) to correct this condition.
