HYUNDAI NEW THINKING. NEW POSSIBILITIES. Technical Service Bulletin	GROUP RECALL	NUMBER 16-01-040-1
	DATE OCTOBER 2016	MODEL(S) SONATA (LF)
SUBJECT: DRIVER AIRBAG (DAB) REPLACEMENT (RECALL CAMPAIGN 148)

This TSB supersedes TSB 16-01-040 to revise the DAB manufacturing date in the Parts Information Table.

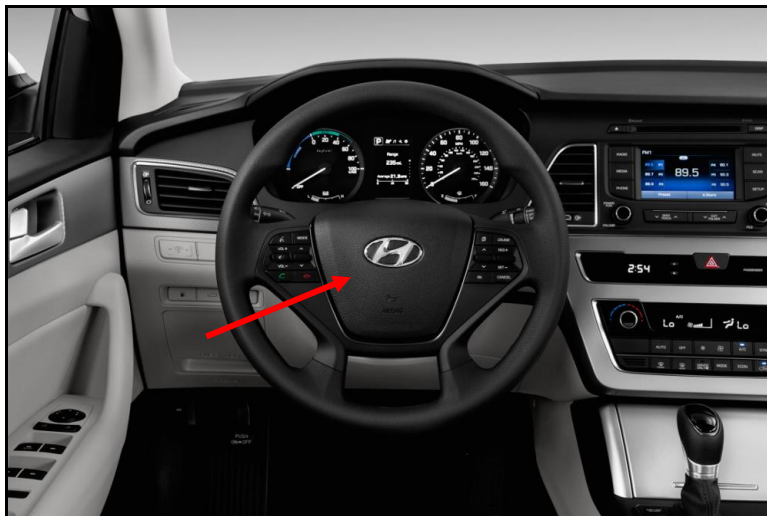
Description: Certain 2016 Sonata vehicles have a driver-side frontal air bag that may not adequately protect the driver's neck from injury in the event of a crash. These vehicles may not comply with the requirements of Federal Motor Vehicle Safety Standard (FMVSS) number 208, "Occupant Crash Protection." This bulletin describes the procedure to replace the Driver Airbag (DAB) to correct this condition.

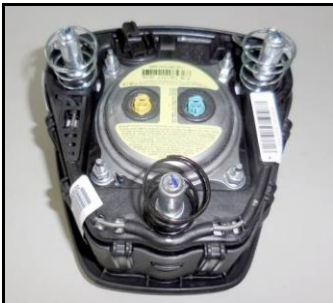
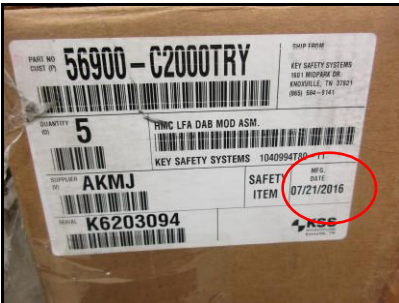
56900-C2000TRY	1	<u>DO NOT</u> use parts with package label MFG dates <u>3/18/2016</u> or <u>3/21/2016</u>
	Module Assy-Strg Wheel Airbag
