HYUNDAI

Technical Service Bulletin

16-01-041

SUBJECT: 2007-2008 AZERA (TG) DRIVER POWER SEAT SWITCH REPLACEMENT
(RECALL CAMPAIGN 150)

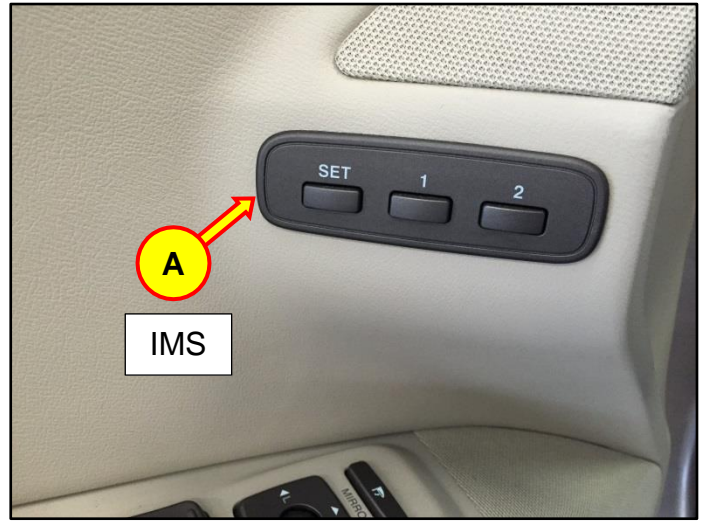
- To identify the correct part replacement, examine the driver interior door panel to see if the vehicle is equipped with IMS (Integrated Memory System) (A) or not.

IMS (INTEGRATED MEMORY SYSTEM)
: P/N 88193-3L100QQH

NON-IMS: P/N 88193-3L211QQH
