RECALL CAMPAIGN BULLETIN

NTB16-088b

January 12, 2017

VOLUNTARY SAFETY RECALL CAMPAIGN 2015 – 2017 MURANO AND 2016 – 2017 MAXIMA ABS ACTUATOR

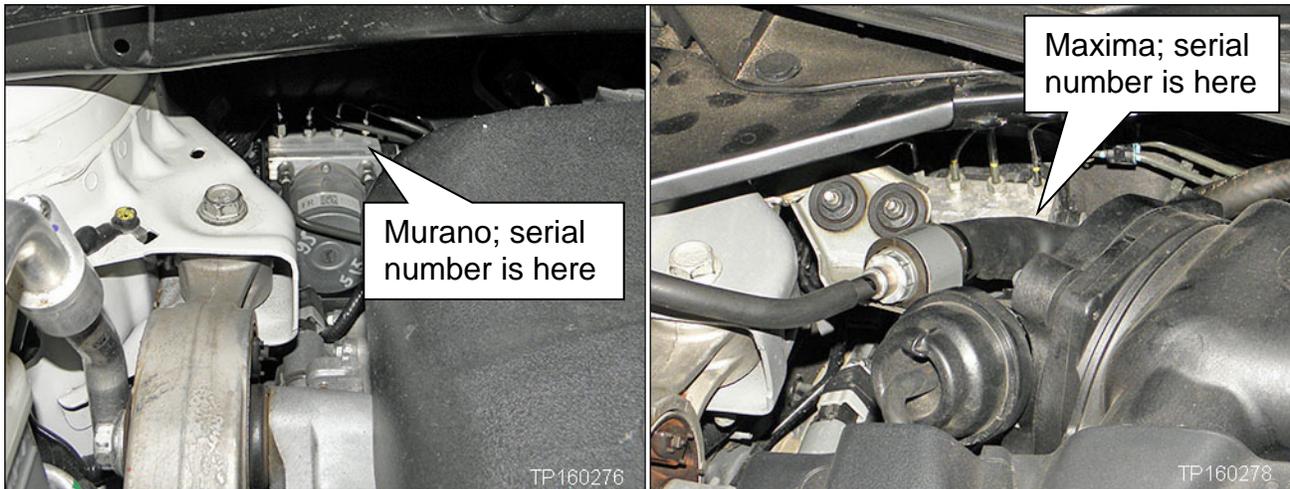
Figure 1A

1. Open the engine hood and locate the ABS Actuator and Electric Unit (ABS control unit).
 - ABS control unit is on the passenger side of the engine compartment next to the engine wall.

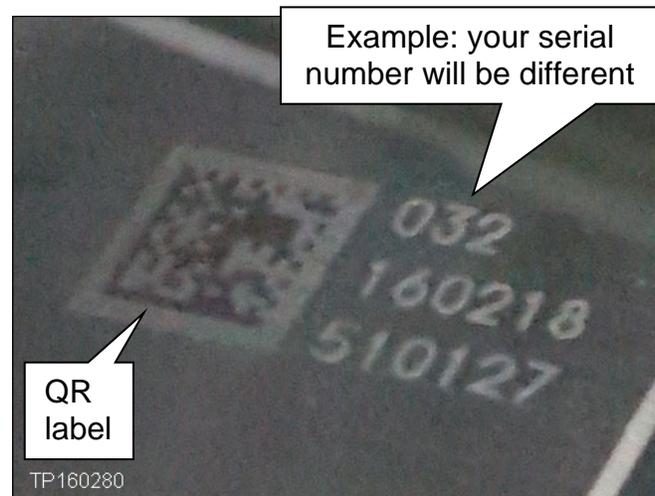
2. Locate the serial number on the top of the ABS control unit next to the QR label (see Figures 1A and 2A).

- If there is no serial number (the area shown in Figure 2A is blank), **skip to step 9** for ABS control unit replacement.

3. Write the 15 digit serial number on the repair order.
 - In the **example** in Figure 2A, the serial number is **032160218510127** (this is an example, your serial number will be different).

9. If the ABS Actuator and Electric Unit (ABS control unit) requires replacement:

- If parts are not available, provide the customer with a rental.
- Refer to the appropriate Electronic Service Manual (ESM), section BRC-Brake Control System, for replacement information.
- Follow all instructions in the ESM for ABS Control Unit replacement.
- **IMPORTANT:** Make sure ADJUSTMENT OF STEERING ANGLE SENSOR NEUTRAL POSITION and CALIBRATION OF DECEL G SENSOR are done as part of the ABS control Unit replacement procedure (both are listed in the BRC section index).
- Refer to the next page for ABS Control Unit Configuration.

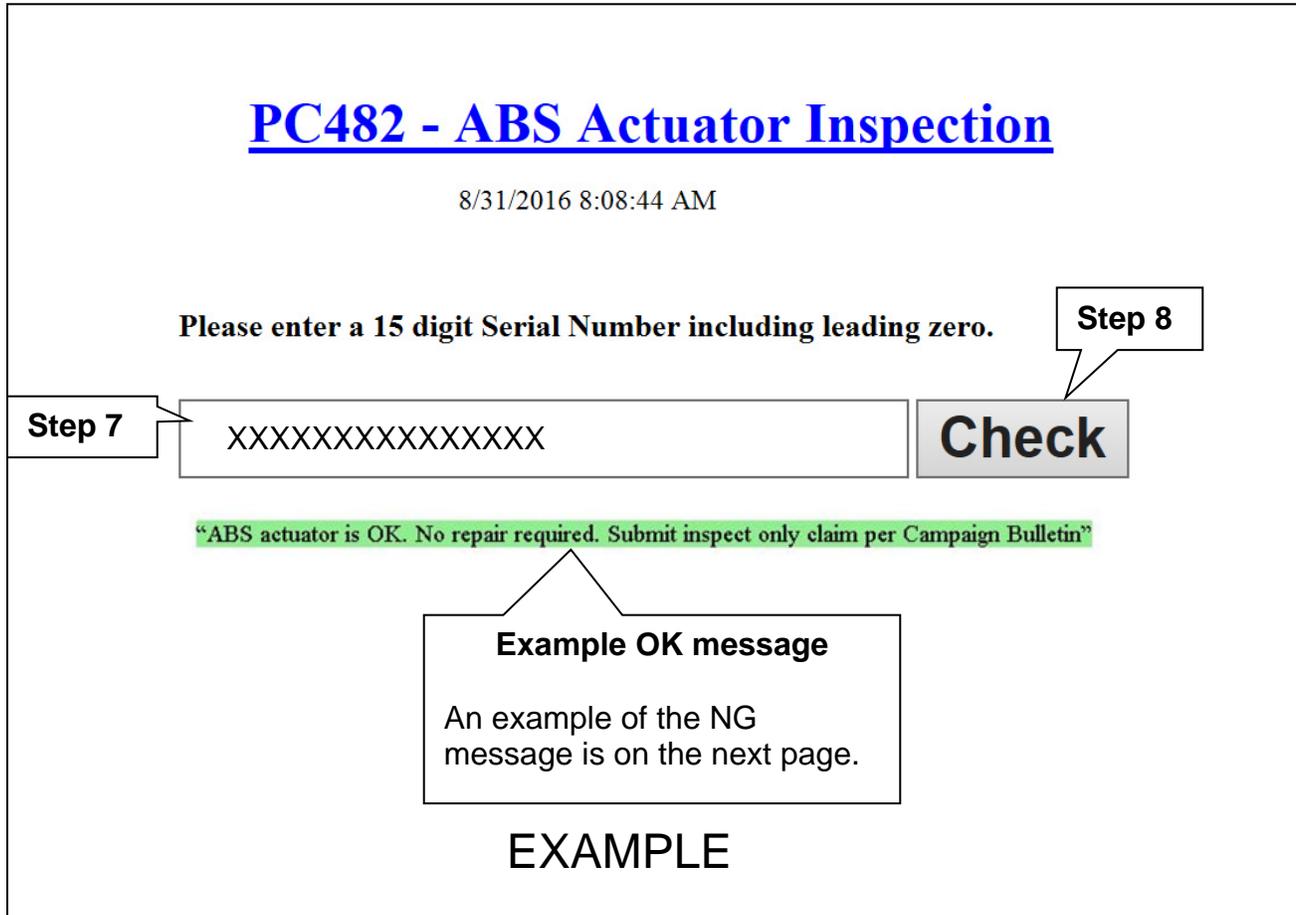
- If your ABS control unit (ABS Actuator) is OK, the **OK** message shown in Figure 5A will display.
- The screen in Figure 5A showing the 15 digit serial number and the **OK** message, **MUST** be printed and attached to the repair order for warranty documentation.

IMPORTANT: If the ABS control unit (ABS Actuator) is OK per the check above, but the **ABS warning light is ON:**

- The vehicle should **not** be driven.
- Diagnose and repair under normal warranty, this campaign does not apply.
- If there is a delay between inspection and repair; park the vehicle outside away from other vehicles or structures, disconnect the vehicle 12 volt battery and leave it disconnected while the vehicle is parked waiting for service.

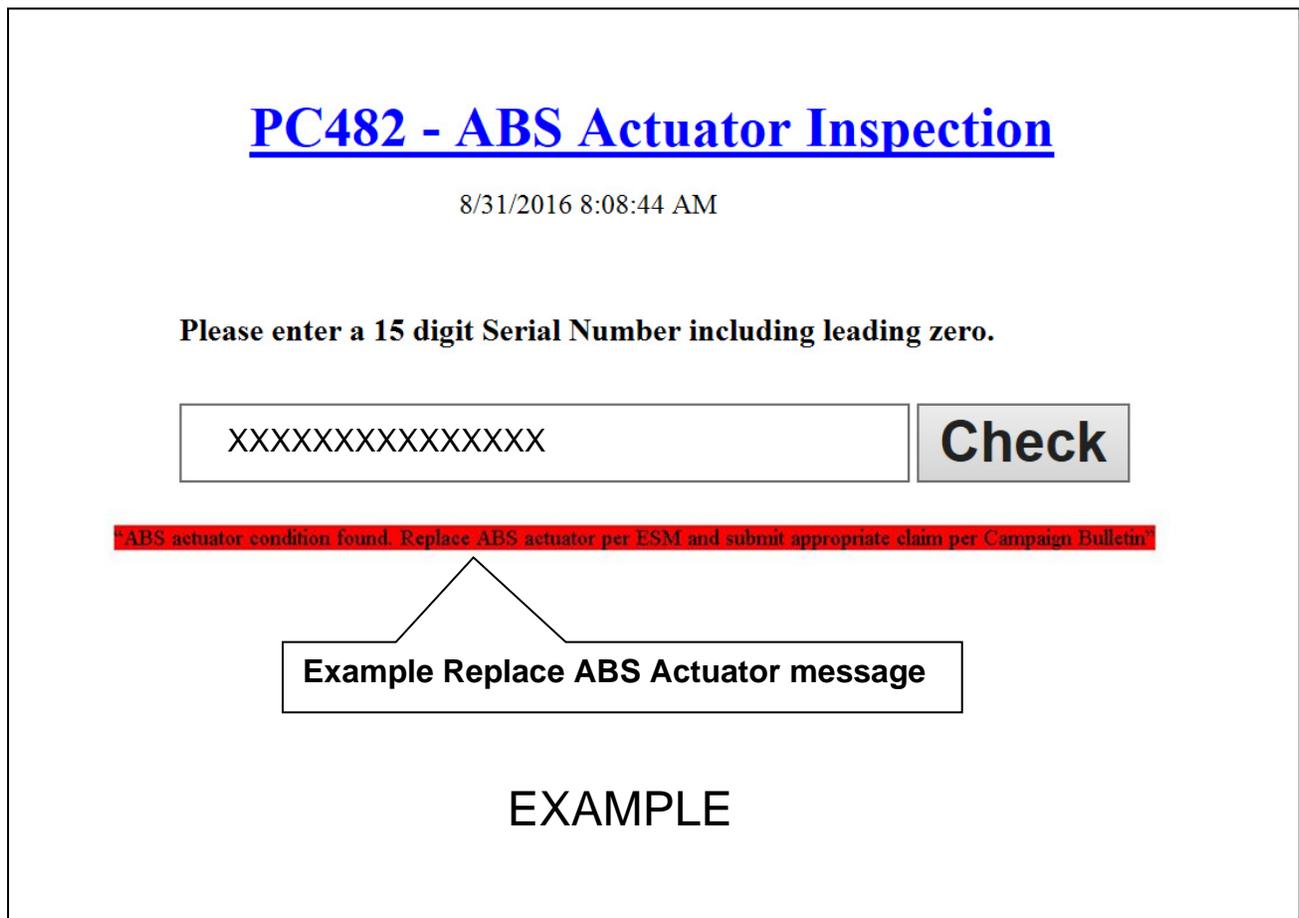
- If your ABS control unit (ABS Actuator) is NG, the **Replace ABS Actuator** message shown in Figure 6A will display.
- The screen in Figure 6A showing the 15 digit serial number and the **Replace ABS Actuator** message, **MUST** be printed and attached to the repair order for warranty documentation.

IMPORTANT: If the ABS control unit (ABS Actuator) is NG:

- The vehicle should **not** be driven.
- If parts are not available, provide the customer with a rental.
- If there is a delay between inspection and replacement of the ABS control unit; park the vehicle outside away from other vehicles or structures, disconnect the vehicle 12 volt battery and leave it disconnected while the vehicle is parked waiting for service.
