# RECALL CAMPAIGN BULLETIN

Classification: BR16-003d	Reference: NTB16-088d	Date: November 19, 2019
------------------------------	--------------------------	----------------------------

## VOLUNTARY SAFETY RECALL CAMPAIGN 2016 MURANO HYBRID; ABS ACTUATOR

**CAMPAIGN ID #:** PC649  
**NHTSA #:** 16V-636  
**APPLIED VEHICLES:** 2016 Murano Hybrid (Z52)

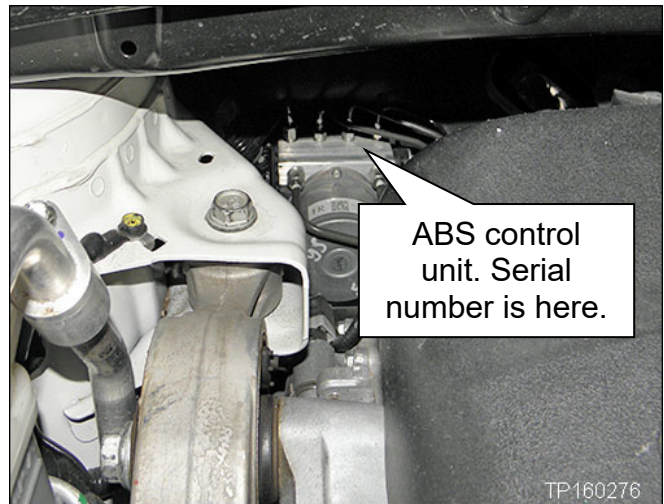
Figure 1A

1. Open the engine hood and locate the ABS Actuator and Electric Unit (ABS control unit).
  - The ABS control unit is on the passenger side of the engine compartment next to the engine wall.

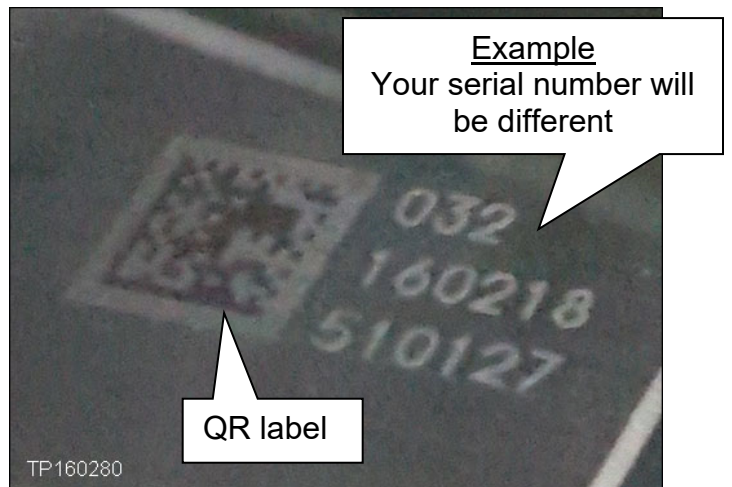
2. Locate the serial number on the top of the ABS control unit next to the QR label (see Figures 1A and 2A).

- If there is no serial number (the area shown in Figure 2A is blank), **skip to step 9** for ABS control unit replacement.

3. Write the 15-digit serial number on the repair order.
  - In the **example** in Figure 2A, the serial number is **032160218510127** (this is an example - your serial number will be different).

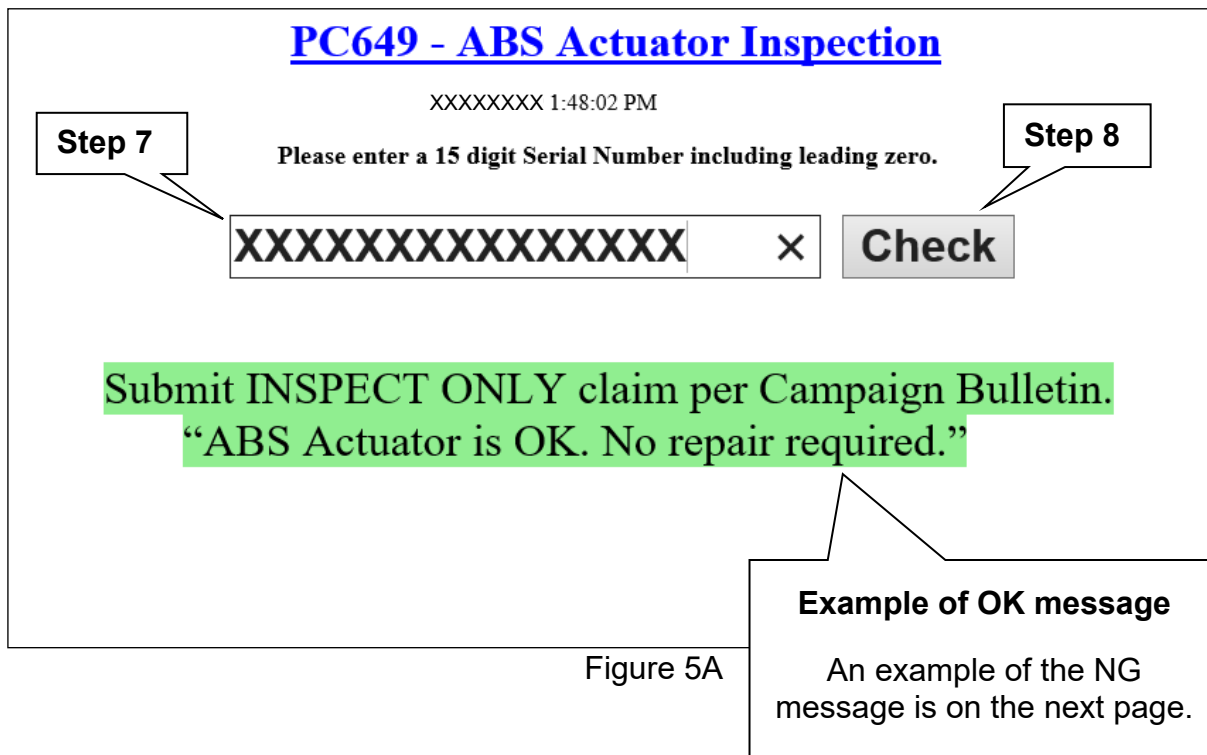
- If your ABS control unit (ABS Actuator) is OK, the **OK** message shown in Figure 5A will display.
- **The screen in Figure 5A, showing the 15-digit serial number and the OK message, MUST be printed and attached to the repair order for warranty documentation.**

If the ABS control unit (ABS Actuator) is OK per the check above, but the **ABS warning light is ON**:

- **The vehicle should not be driven.**
- Diagnose and repair under normal warranty; this campaign does not apply.
- If there is a delay between vehicle inspection and repair, park the vehicle outside and away from other vehicles and structures, disconnect the vehicle 12 volt battery and leave it disconnected while the vehicle is parked waiting for service. There is the potential of a thermal incident that could cause vehicle and property damage, severe injury from burns, or death.

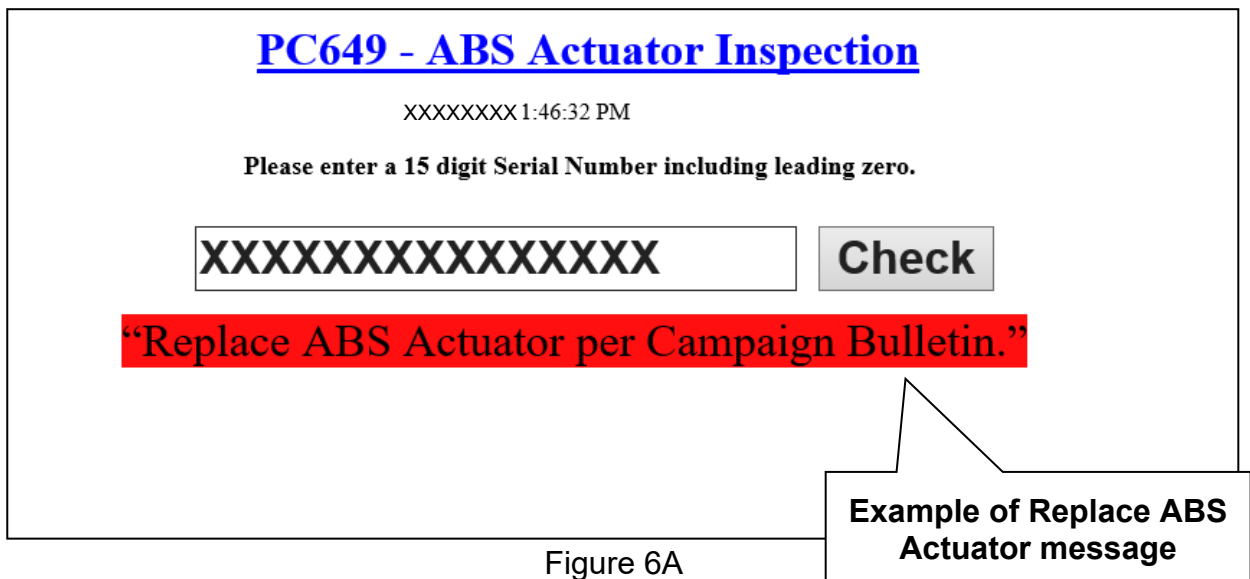
- If your ABS control unit (ABS Actuator) is NG, the **Replace ABS Actuator** message shown in Figure 6A will display.
- The screen in Figure 6A, showing the 15-digit serial number and the **Replace ABS Actuator** message, **MUST** be printed and attached to the repair order for warranty documentation.

If the ABS control unit (ABS Actuator) is NG:

- The vehicle should **not** be driven.
- If parts are not available, provide the customer with a rental.
- If there is a delay between vehicle inspection and repair, park the vehicle outside and away from other vehicles and structures, disconnect the vehicle 12 volt battery and leave it disconnected while the vehicle is parked waiting for service. There is the potential of a thermal incident that could cause vehicle and property damage, severe injury from burns, or death.

9. If the ABS Actuator and Electric Unit (ABS control unit) requires replacement:

- If parts are not available, provide the customer with a rental.
- Refer to the appropriate Electronic Service Manual (ESM), section BRC/BRAKES-Brake Control System, for replacement information.
- Follow all instructions in the ESM for ABS Control Unit replacement.
- **IMPORTANT:** Make sure ADJUSTMENT OF STEERING ANGLE SENSOR NEUTRAL POSITION and CALIBRATION OF DECEL G SENSOR are done as part of the ABS Control Unit replacement procedure (both are listed in the Installation section of the procedure).
- Refer to the next page for ABS Control Unit Configuration.
