Safety Recall

Code: 20Y6

Subject	Suction Pump
Release Date	December 21, 2016
Revision Summary	Certain work instruction steps have been modified to help technicians avoid consequential damage during this repair.
Affected Vehicles	U.S.A. & CANADA: 2015-2016 MY Volkswagen Golf, GTI & Golf SportWagen <i>Check Campaigns/Actions screen in Elsa on the day of repair to verify that a VIN qualifies for repair under this action. Elsa is the <u>only</u> valid campaign inquiry & verification source.</i> <ul style="list-style-type: none">✓ Campaign status must show "open."✓ If Elsa shows other open action(s), inform your customer so that the work can also be completed at the same time the vehicle is in the workshop for this campaign.
Problem Description	The suction pump inside the fuel tank designed to purge fuel from the evaporative emissions (EVAP) system may have been damaged during assembly. This could cause fuel to flow directly into the EVAP system which could, over time, accumulate and cause a leak through the charcoal canister filter element. Leaking fuel, in the presence of an ignition source, may result in a fire.

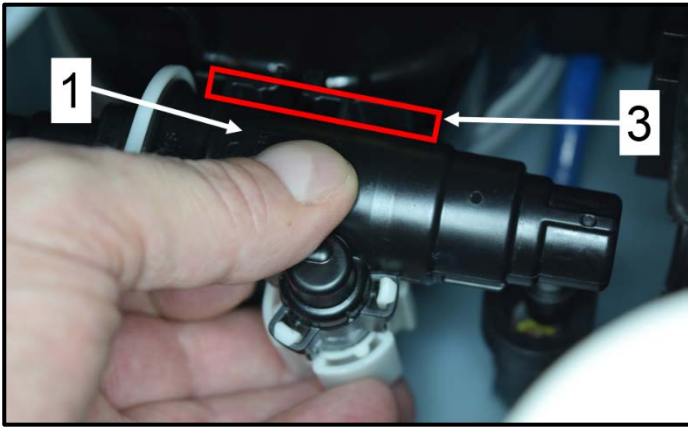
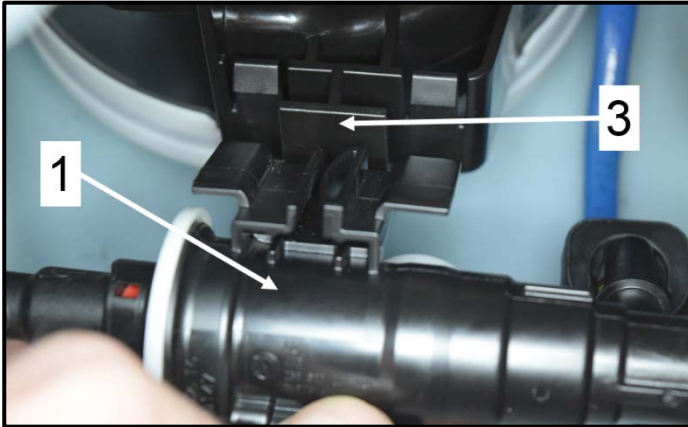
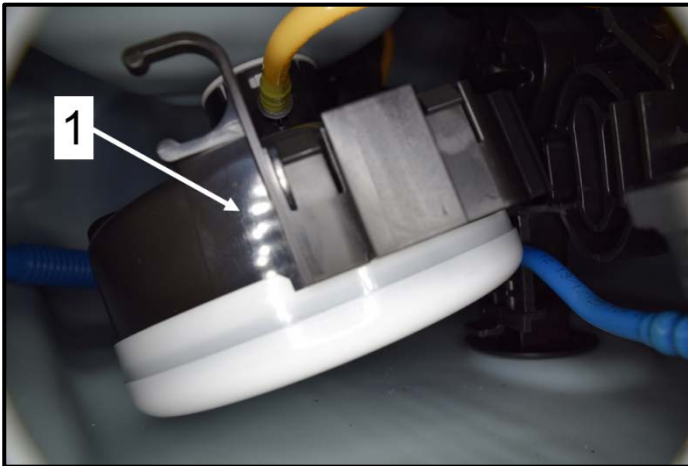
- Take care that the Liquid-Vapor Separator Assembly <1> does not come off of its attachment bracket when removing the Suction Jet Pump.

- Remove the suction pump <1> off the retainer bracket <3>:
 - Slightly rotate suction pump <1> away from the bracket <3>
 - Remove the pump <1> from the fuel tank by gently rocking it back and forth between the fingers and thumb.
 - Use caution not to damage the attached front suction line.
