RECALL CAMPAIGN 16V-653: REPLACE THE REAR SUB-FRAME BOLTS

This Service Information bulletin supersedes SI B33 05 16 **dated September 2016**.

F80 (M3 Sedan)	F82 (M4 Coupe)	F83 (M4 Convertible)	F87 (M2 Coupe)
----------------	----------------	----------------------	----------------

Model Year 2015-2017
BMW M2 Coupe, M3 Sedan, M4 Coupe, M4 GTS, M4 Convertible
Rear Sub-frame Bolts
Safety Recall 16V-653
Last Updated: 9/29/2016

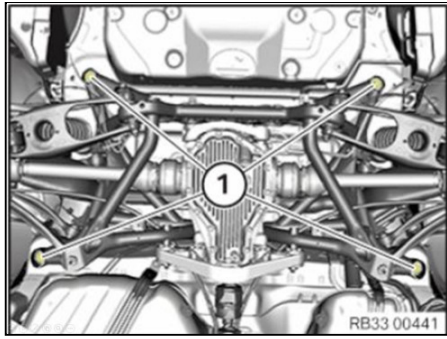
<ol style="list-style-type: none"> 1. Set a torque wrench to 90 Nm and check the initial torque of each original sub-frame bolt (1). Is the initial torque of 90 Nm reached for each bolt (torque wrench/bolt did not move at 90 Nm)?
--	--

YES - Individually replace and tighten the four sub-frame bolts to 108 Nm. Perform a wheel alignment. Repairs are complete.

NO - Continue to next step.

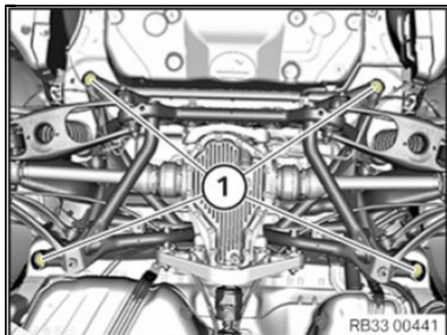
2. Check integrity of the sub-frame threads.

- a. Individually loosen a bolt (1) from the rear sub-frame and unscrew it completely.
- b. By hand, screw in a **new** sub-frame bolt as far as it should go and screw it back out.
- c. Do this for all (4) bolts.

Were all the bolts able to be screwed in and out completely (by hand only)?

YES- the threads are OK. Repairs on the threads are **not** needed. Go to step 6

NO - (the bolt cannot be easily screwed in and out again) - the thread in the body is damaged and will need to be repaired. Go to next step.
