Service Bulletin

SAFETY and EMISSIONS RECALL

2014-2015 Grom125 FUEL PUMP REPLACEMENT

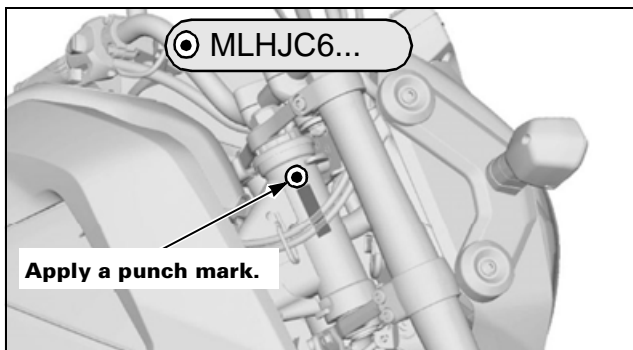
After you have completed the REPAIR PROCEDURE, apply a punch mark **before** the first character of the VIN located on the frame as shown.

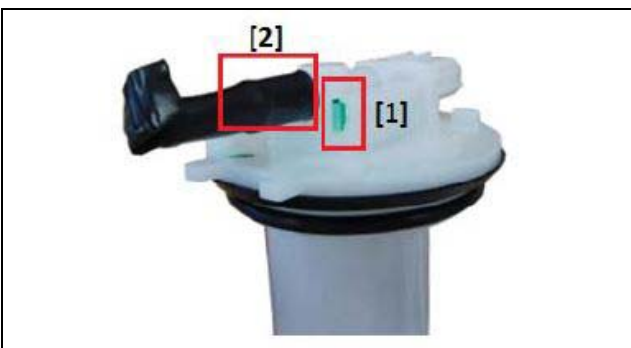
Be careful not to mix up the defective or original recall parts with remedy parts. The remedy part is identified by a green paint mark [1] on top of the fuel pump unit and a black cap cover [2] as shown. Use care during unpacking and installation as the paint mark is easily wiped off.
