SAFETY RECALL BULLETIN

HID HEADLAMP HORIZONTAL ADJUSTMENT LOCKING CLIPS NOT SECURED – SAFETY RECALL CAMPAIGN

No: **SR-16-008**

MODEL: 2017 Mirage

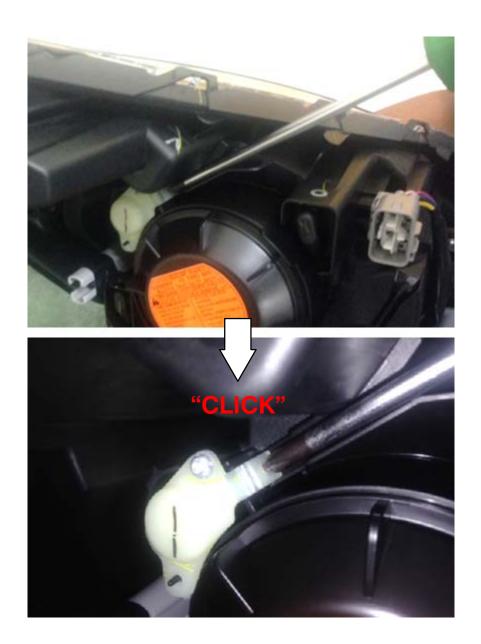
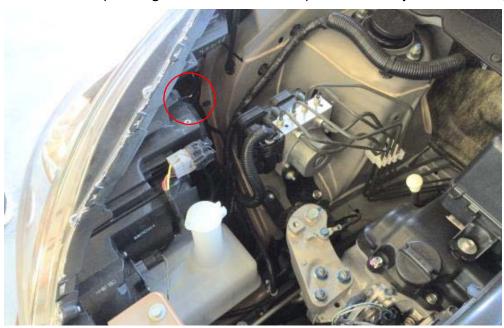
- a. If HID headlamp horizontal adjustment locking clip is secured, proceed to step 5.
- b. If NG condition is found (HID headlamp horizontal adjustment locking clip not secured), take a photo of NG condition for posting to Photos Required Condition (PRC) system, then fold the tab over against the lamp housing using a Phillips screwdriver until you hear a "click" as it locks into place.

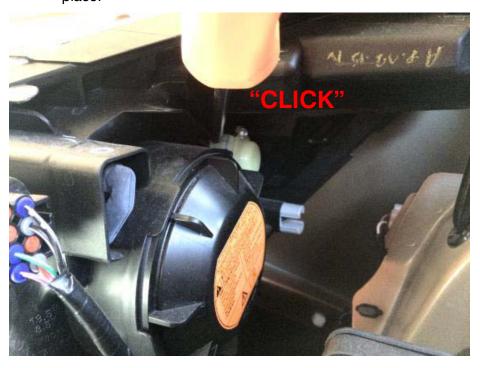
5. Locate the passenger's side HID headlamp horizontal adjustment locking clip.

- a. If HID headlamp horizontal adjustment locking clip is secured, proceed to step 6.
- b. If NG condition is found (HID headlamp horizontal adjustment locking clip not secured), take a photo of NG condition for posting to Photos Required Condition (PRC) system, then fold the tab over against the lamp housing using a Phillips screwdriver until you hear a "click" as it locks into place.
