PRODUCT CAMPAIGN BULLETIN

APPLICABILITY: 2010-14MY Subaru Legacy & Outback
SUBJECT: Windshield Wiper Motor

NUMBER: WTK-71
DATE: 09/28/16
NHTSA ID: 16V-694

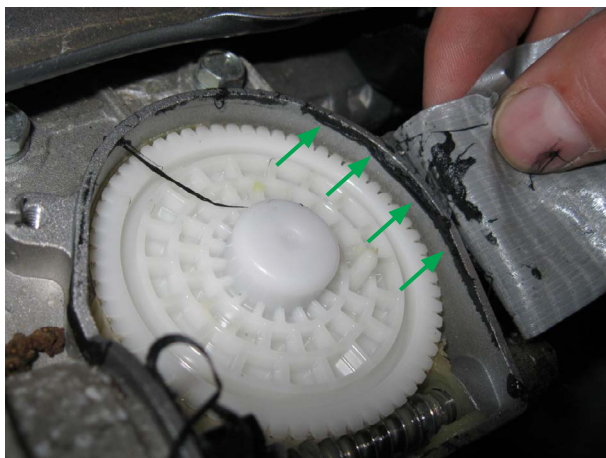
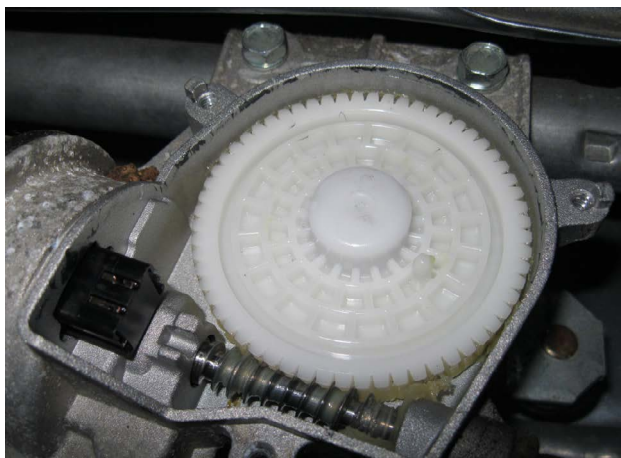
10) After the cover has been removed, remove any residual butyl rubber from the sealing surface of the frame using the adhesive side of a piece of duct tape as shown in the photos below. More than one piece of tape may be required. Butyl rubber below the face of the sealing surface (green arrows) does not have to be removed. Pay special attention to insure no pieces of the butyl rubber fall into the housing or between the gears. If so, make sure it is removed before reassembly. The photo on the right shows the sealing surface clean and ready for new cover installation.

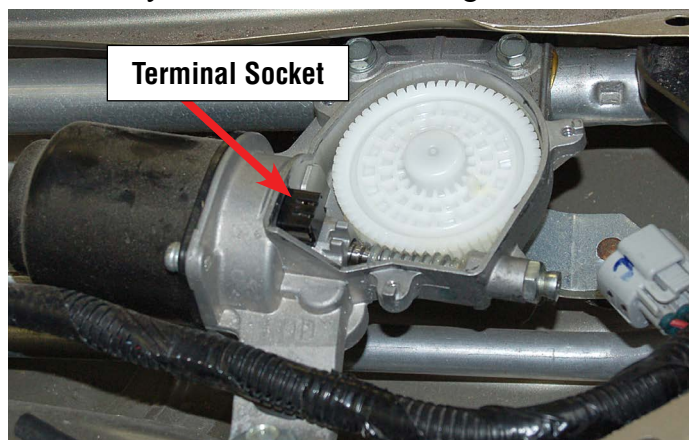
IMPORTANT: Make sure there is no butyl rubber in the terminal socket. If present, the wiper motor will not operate.

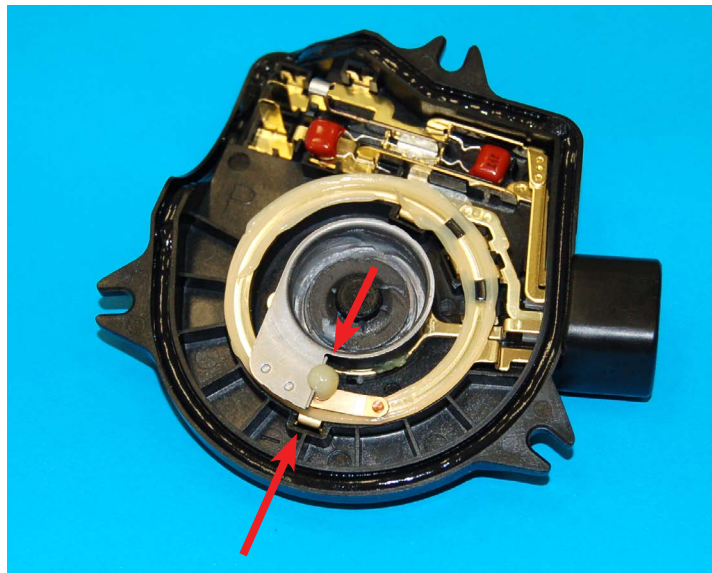
NOTE: The new wiper motor cover is prepackaged with butyl rubber and grease. Be extremely careful when removing it from the package and when handling. Do not touch the grease or butyl rubber. The new cover also has a yellow paint mark for identification as shown in the installation photos below.
