MODEL  
**2016MY  
Optima (JFa)**

NUMBER  
**SC139**

DATE  
**November 2016**

**SUBJECT: RIGHT FRONT AXLE DRIVESHAFT REPLACEMENT (SC139)**

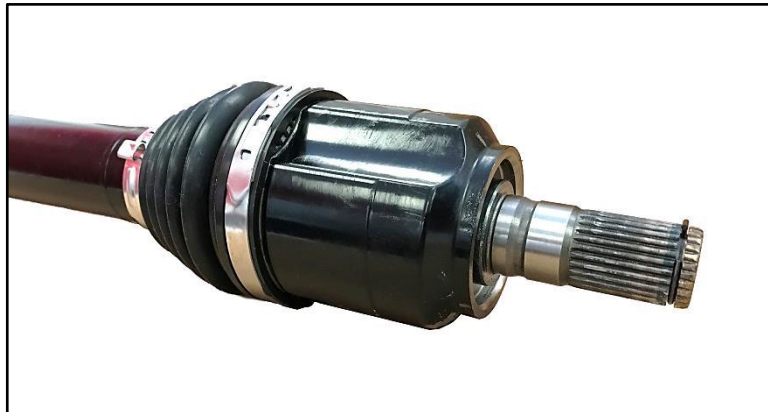
This bulletin provides the procedure to replace the right front axle driveshaft on certain 2016MY Optima (JFa) vehicles, produced from November 13, 2015 to April 23, 2016, which may exhibit a crack in the area of the stub at the wheel end of the driveshaft. When moving from a stopped location, the crack can lead to a separation of the shaft, causing a loud noise. The vehicle would then lose motive power. In addition, if the driver fails to engage the parking brake when the vehicle is parked on an incline, it may roll. In either case, a crash could result. Follow the procedure outlined in this bulletin to replace the right front axle driveshaft. Before conducting the procedure, verify the vehicle is included in the list of affected VINs.
