SAFETY RECALL BULLETIN

NHTSA RECALL 16V720, Transport Canada 2016-497

AUTOCAR, LLC SAFETY RECALL ACX-1604 REV. 001

CORRECTION OF TORQUE VALUES ON CASTLE NUTS OF STEERING ASSEMBLY

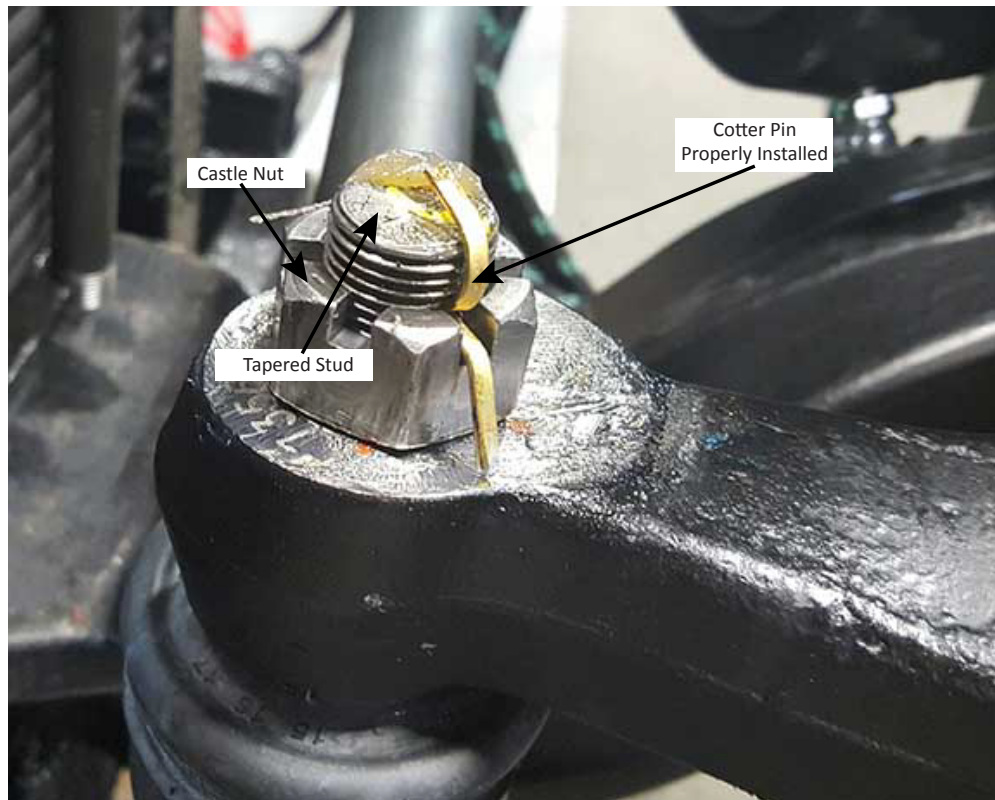
Figure 6

3. Un-screw the castle nut by rotating it counter-clockwise until the castle nut turns freely. Using hand force only, check for any movement of the tapered stud within the steering arm/pitman arm. Inspect each tapered stud (See Figure 6). If there are any signs wear or fretting on the contact surface between the castle nut and the steering arm/pitman arm, or if there are any signs of loose fit or movement or rotation within the steering arm or pitman arm, or if the nut will not tighten to the specified torque (See Torque Chart on page 8), call Autocar technical support at 888-218-3611.

5. Install a new cotter pin through the hole and bend one leg toward the back of the castle nut and the other up around the end of the threaded fastener (See Figure 6).
6. Repeat step 2 through step 5 until all the castle nuts in the steering assembly have been re-torqued and all of the castle nuts have new cotter pins installed.
