## Technical Service Bulletin

GROUP <b>RECALL</b>	NUMBER <b>16-01-042</b>
DATE <b>OCTOBER 2016</b>	MODEL(S) <b>GENESIS COUPE (BK)</b>

**SUBJECT:** PASSENGER OCCUPANT DETECTING SENSOR (PODS) UNIT  
CONNECTOR REWORK (RECALL 151)

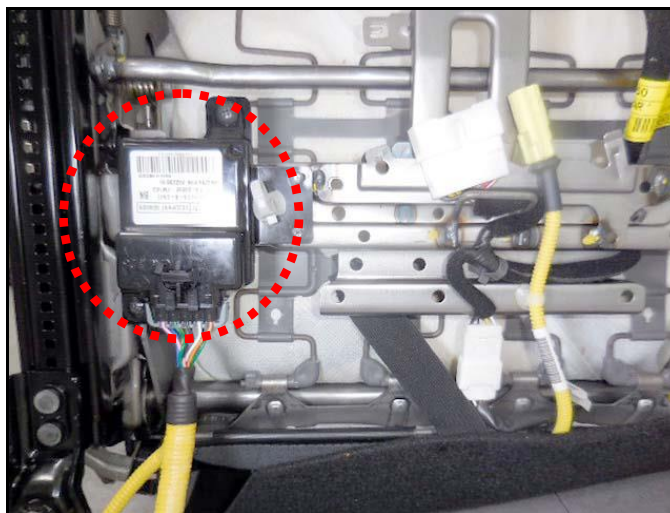
- 6. Locate the PODS unit under the seat.

Confirm the harness is fully seated in the PODS unit.

If the harness is disconnected from the PODS, then reconnect and confirm it is fully seated.
