# SAFETY RECALL BULLETIN

## NHTSA RECALL 16V723, Transport Canada 2016-504

AUTOCAR INDUSTRIES, LLC SAFETY RECALL MDTT-1602 REV. 001

Autocar has determined that a safety defect exists in the steering linkage assembly of certain 2015-2017 model-year Xspotters and Xperts.

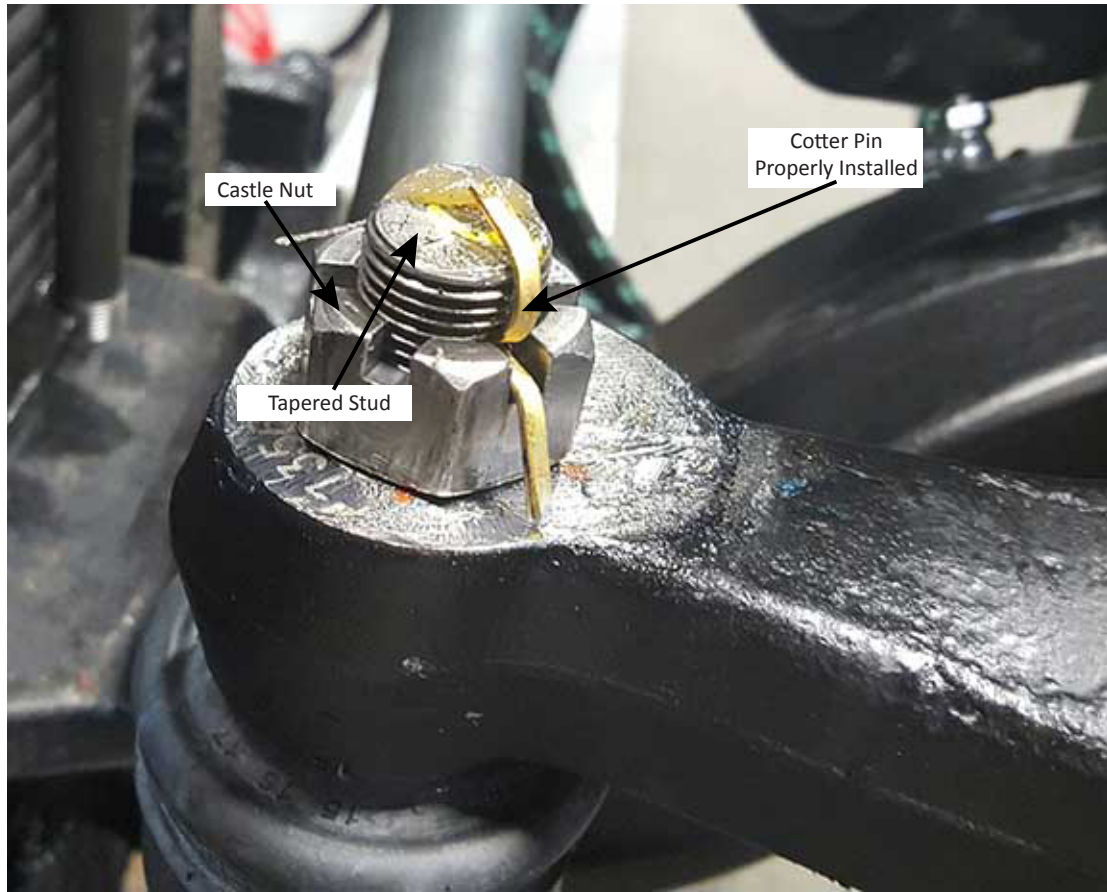
**Figure 4**

3. Un-screw the castle nut by rotating it counter-clockwise until the castle nut turns freely. Using hand force only, check for any movement of the tapered stud within the steering arm/pitman arm. Inspect each tapered stud (See Figure 4). If there are any signs wear or fretting on the contact surface between the castle nut and the steering arm/pitman arm, or if there are any signs of loose fit or movement or rotation within the steering arm or pitman arm, or if the nut will not tighten to the specified torque (See Torque Chart below), call Autocar technical support at 888-218-3611.

5. Install a new cotter pin through the hole and bend one leg toward the back of the castle nut and the other up around the end of the threaded fastener (See Figure 4).
