## PRODUCT CAMPAIGN BULLETIN

**APPLICABILITY:** 2007-2009 MY Legacy (Turbo)  
 2007-2009 Outback (Turbo)  
 2008-2014 Impreza (WRX/STI)  
 2009-2013MY Forester (Turbo)

**NUMBER:** WTM-73R  
**DATE:** 10/31/16  
**NHTSA ID:** 16V738  
**REVISED:** 07/11/17

**SUBJECT:** Secondary Air Injection Pump Relay Replacement

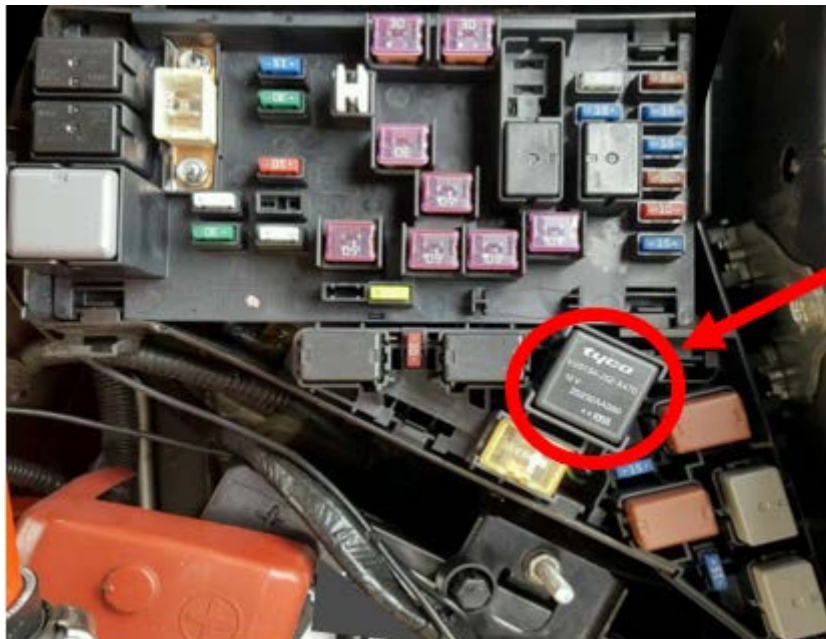
Contacts points inside the relay which controls the secondary air injection pump may be welded due to insufficient understanding of one of the relay specifications (characteristics) and the relay may allow the pump to operate continuously. ***Under this condition, the vehicle “check engine” light will illuminate.*** The continuous operation may cause the secondary air injection pump to overheat. In some instances, if overheating were to occur, the secondary air injection pump could begin to smoke, increasing the risk of fire.

- Record the customer’s radio station presets (and Navigation Favorites where applicable).
- **Remove the negative cable from the battery.**
- Remove the lid from the underhood (Main) fuse box (M/B), locate and replace the Secondary Air Pump Relay. **IMPORTANT:** To prevent damaging the contacts in the fuse box, avoid “rocking” the relay while removing it. Always pull straight up.
