RECALL CAMPAIGN 16V-746: REPLACE LOW-PRESSURE ELECTRIC IN-TANK FUEL PUMP

F07 (5 Series Gran Turismo)	F10 (5 Series Sedan)	F12 (6 Series Convertible)	F13 (6 Series Coupe)
E70 (X5)	E71 (X6)	E72 (X6 Hybrid)

The vehicle can exhibit a fuel leak from the area surrounding the low-pressure electric in-tank fuel pump electrical connector.

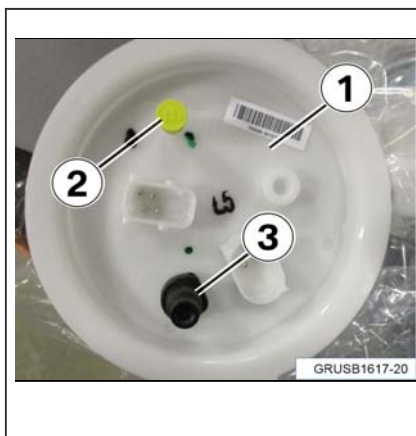
2. Inspect the new fuel pump assembly white plastic lid (1).

The yellow transportation cap for the fuel supply line (2) must be removed and discarded before installation. The black plastic cap (3) must not be removed. If removed, a fuel leak may develop if an open port is present. If the new fuel pump is received without this the black plastic cap (3) and an open port is present then another fuel pump must be ordered.
Do not use a fuel pump that is missing the black plastic cap (3) and it has an open port which may cause a fuel leak.

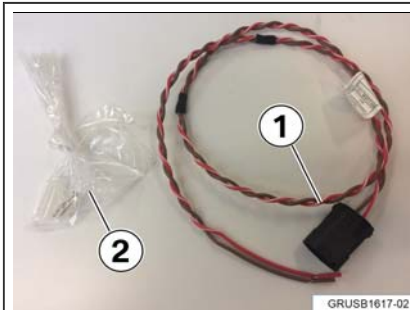
Repair kit overview:
 Repair harness (1)
 Butt connector and shrink tubing (2)
