SIB 16 04 16

## RECALL CAMPAIGN 16V-746: REPLACE LOW-PRESSURE ELECTRIC IN-TANK FUEL PUMP

This Service Information bulletin replaces SI B16 04 16 dated August 2017

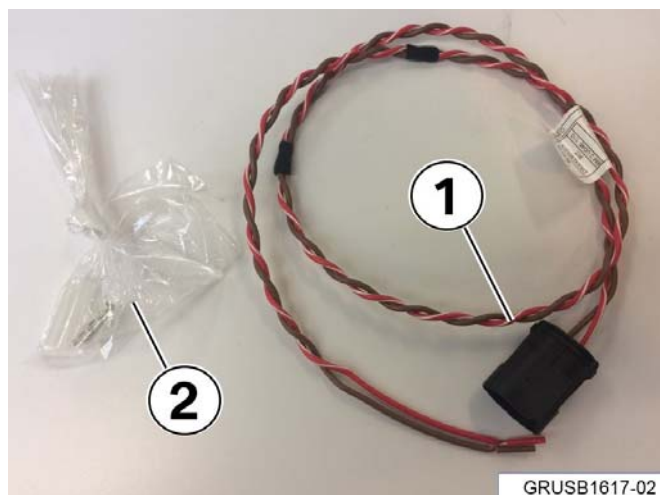
Repair kit overview:

Repair harness (1)

Butt connector and shrink tubing (2)

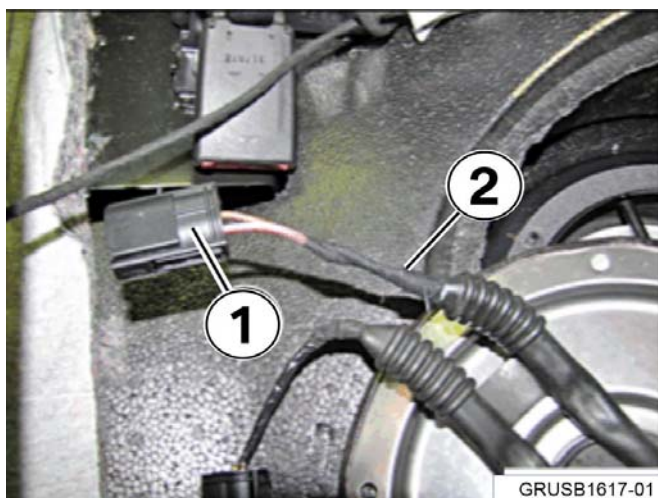
Locate the fuel pump electrical connector (1).

Unwrap the tape (2) from rubber grommet.

Repair harness procedure:

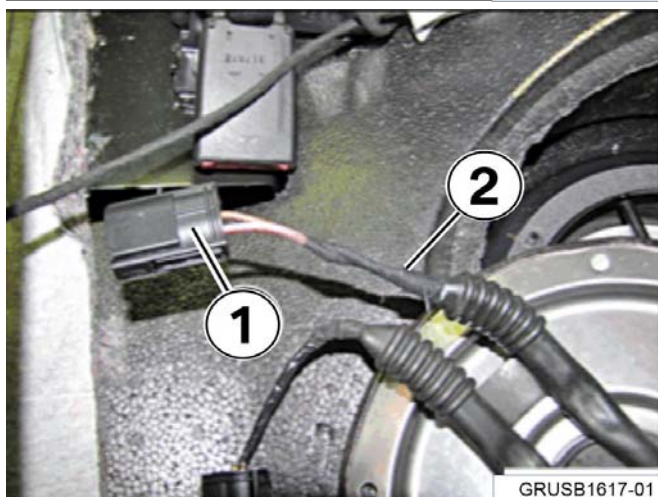
Verify that the length of harness protruding from the grommet is correct (1).

Tape the harness (2) at the grommet to seal it from water ingress.
