SIB 16 04 16

## RECALL CAMPAIGN 16V-746: REPLACE LOW-PRESSURE ELECTRIC IN-TANK FUEL PUMP

The vehicle can exhibit a fuel leak from the area surrounding the low-pressure electric in-tank fuel pump electrical connector.

An improper crimp on the low pressure electric in-tank pump electrical connector pins can result in increased resistance. The heat generated from the resistance can melt or deform the fuel pump flange plastic housing and electrical connector pin sealing surfaces.

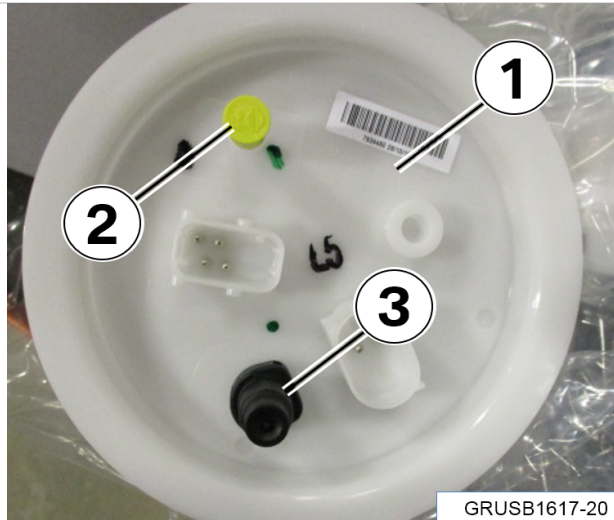
Concerns part number 16 11 7 934 459 and 16 11 7 934 460 only. All other part numbers do not need an inspection.

2. Inspect the new fuel pump assembly's white plastic lid (1).

The yellow transportation cap for the fuel supply line (2) must be removed and discarded before installation.

The black plastic cap (3) must not be removed. If removed, a fuel leak may develop if an open port is present.

If the new fuel pump is received without this the black plastic cap (3) and an open port is present, then another fuel pump must be ordered.

**Do not use a fuel pump that is missing the black plastic cap (3) and it has an open port which may cause a fuel leak.**
