TIS Service Bulletin Page 1 of 7

RECALL CAMPAIGN 16V-746: REPLACE LOW-PRESSURE **ELECTRIC IN-TANK FUEL PUMP**

In-Tank Fuel Pump Safety Recall 16V-746

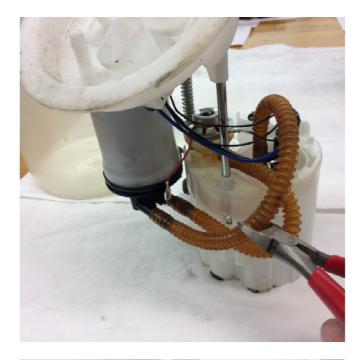
1. After removing the pump from the vehicle, place the fuel pump over a suitable container and use a suitable cutting tool (material cutter) to cut the hoses.

Turn the pump in a few different directions to allow the hoses to drain. This may take a few seconds or up to 1 minute.

Suitable cutting tool shown in the illustration.

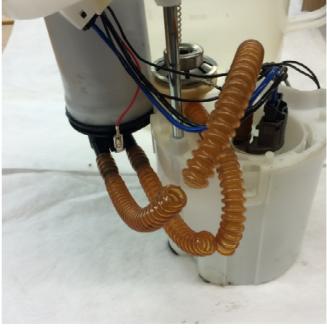
The hoses are cut in this illustration.

2. After the residual fuel has been drained, the part must be held until requested by the WPRC.
