**SIB 16 04 16**

2021-05-08

## RECALL CAMPAIGN 16V-746- REPLACE LOW-PRESSURE ELECTRIC IN-TANK FUEL PUMP

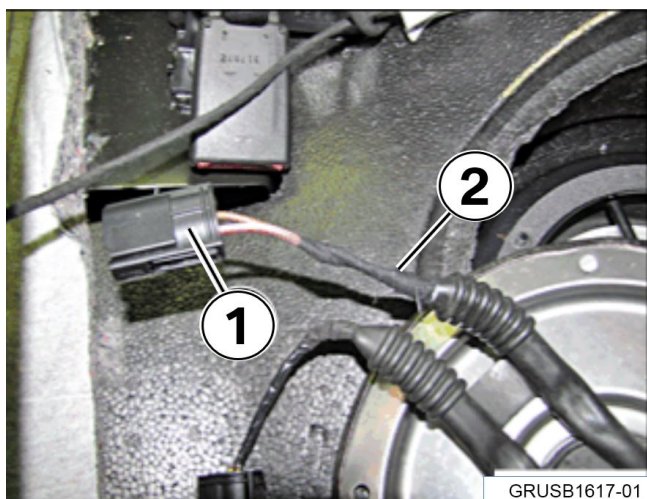
Repair kit overview:

Repair harness (1)

Butt connector and shrink tubing (2)
