SIB 16 04 16

## RECALL CAMPAIGN 16V-746: REPLACE LOW-PRESSURE ELECTRIC IN-TANK FUEL PUMP

This Service Information Bulletin (Revision 7) replaces SI B16 04 16 **dated August 2019**.

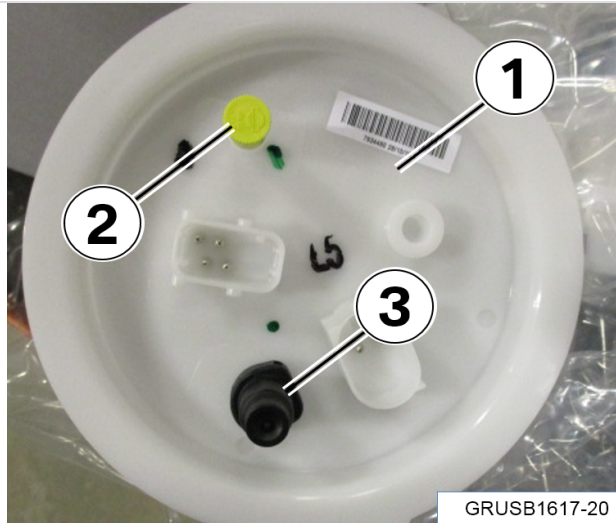
2. Inspect the new fuel pump assembly's white plastic lid (1).

The yellow transportation cap for the fuel supply line (2) must be removed and discarded before installation.

The black plastic cap (3) must not be removed. If removed, a fuel leak may develop if an open port is present.

If the new fuel pump is received without this the black plastic cap (3) and an open port is present, then another fuel pump must be ordered.

**Do not use a fuel pump that is missing the black plastic cap (3) and it has an open port which may cause a fuel leak.**

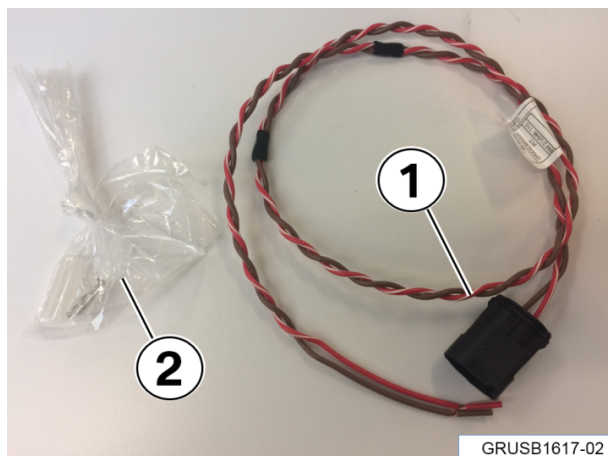
GRUSB1617-02

Repair kit overview:

Repair harness (1)

Butt connector and shrink tubing (2)

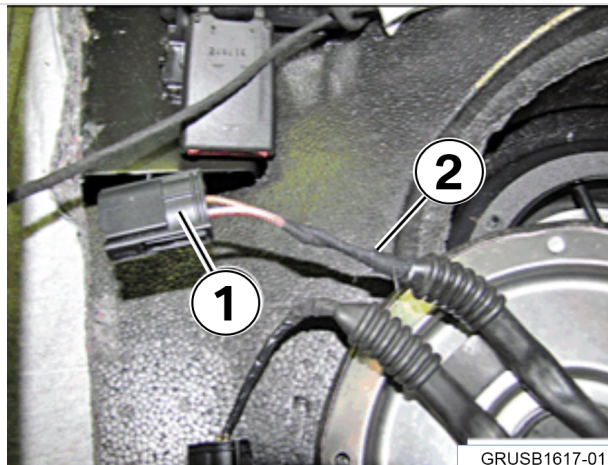
GRUSB1617-01

Locate the fuel pump electrical connector (1).

Unwrap the tape (2) from rubber grommet.

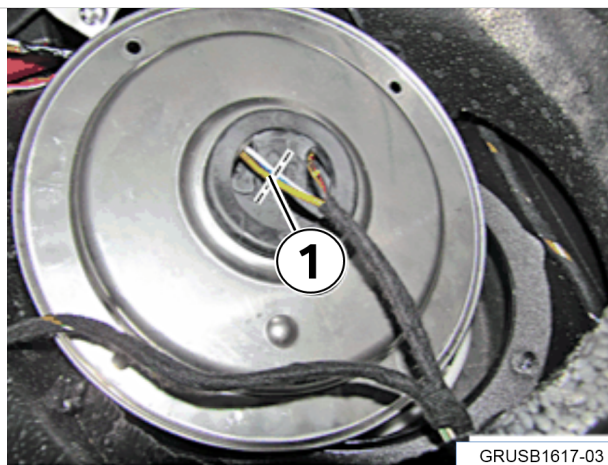
GRUSB1617-03

Turn over the steel lid.

Cut the electrical harness (1) and remove it from the grommet. Measure the removed section of the harness.

Cut the new repair harness to the same length as the removed section of electrical harness.

Install the repair harness through the grommet and install the shrink tubing and butt connectors at this location (1).

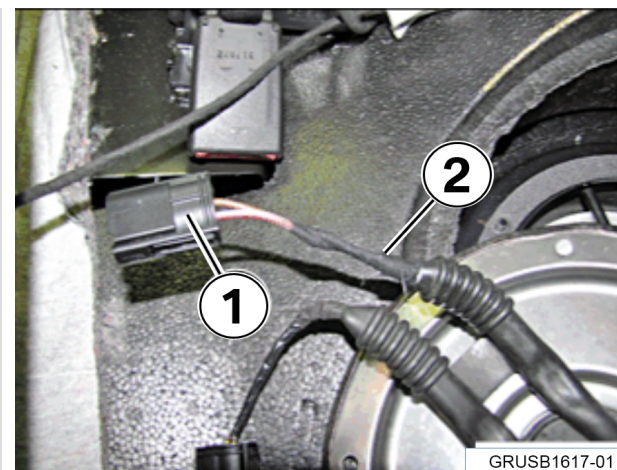
GRUSB1617-01

Verify that the length of harness protruding from the grommet is correct (1).

Tape the harness (2) at the grommet to seal it from water ingress.

Reassemble the vehicle as per the applicable repair instruction.
