SIB 16 04 16

2019-08-19

## RECALL CAMPAIGN 16V-746: REPLACE LOW-PRESSURE ELECTRIC IN-TANK FUEL PUMP

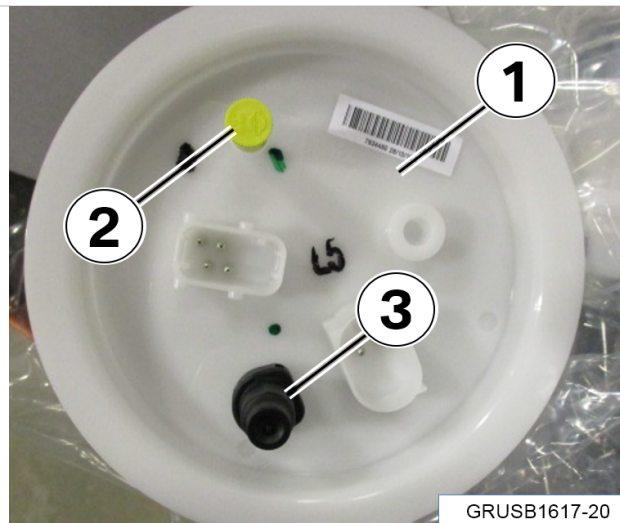
2. Inspect the new fuel pump assembly's white plastic lid (1).

The yellow transportation cap for the fuel supply line (2) must be removed and discarded before installation.

The black plastic cap (3) must not be removed. If removed, a fuel leak may develop if an open port is present.

If the new fuel pump is received without this the black plastic cap (3) and an open port is present, then another fuel pump must be ordered.

**Do not use a fuel pump that is missing the black plastic cap (3) and it has an open port which may cause a fuel leak.**

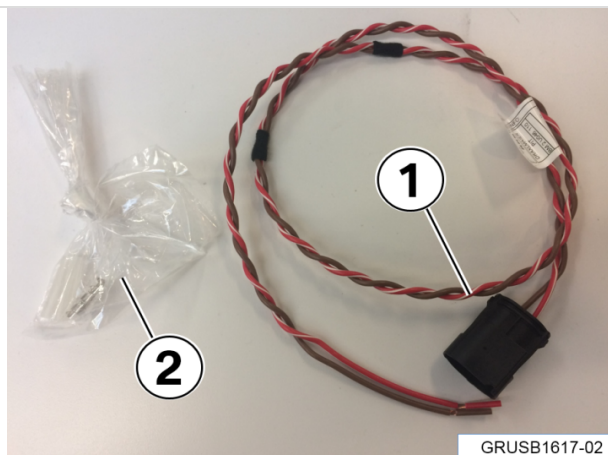
Repair kit overview:

Repair harness (1)

Butt connector and shrink tubing (2)

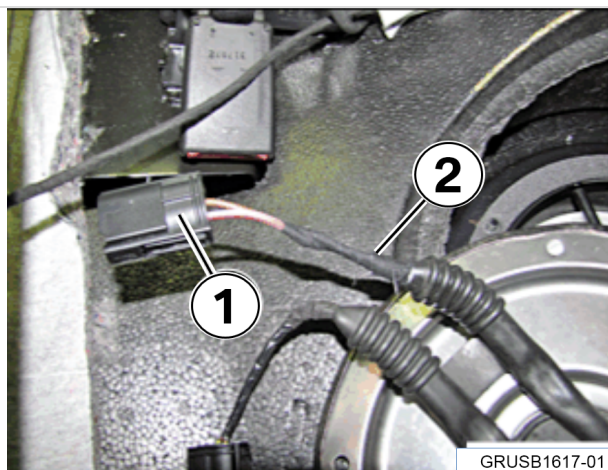
Locate the fuel pump electrical connector (1).

Unwrap the tape (2) from rubber grommet.

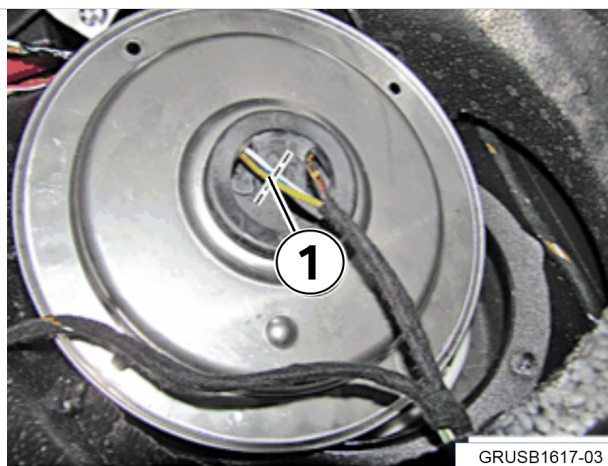
Turn over the steel lid.

Cut the electrical harness (1) and remove it from the grommet. Measure the removed section of the harness.

Cut the new repair harness to the same length as the removed section of electrical harness.

Install the repair harness through the grommet and install the shrink tubing and butt connectors at this location (1).

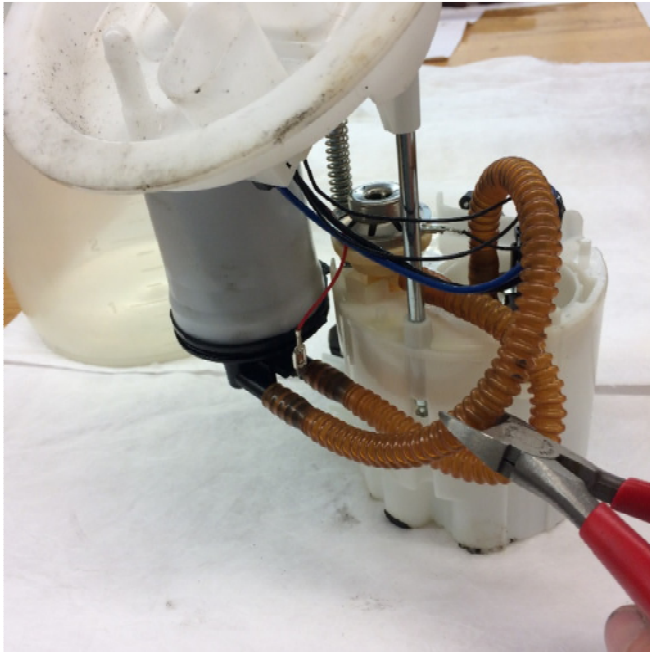
1. After removing the pump from the vehicle, place the fuel pump over a suitable container and use a suitable cutting tool (material cutter) to cut the hoses.

Suitable cutting tool shown in the illustration.

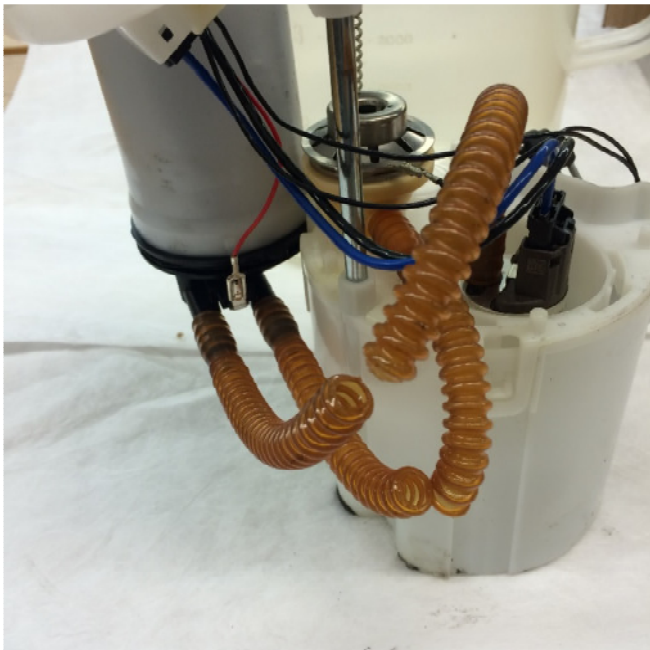
The hoses are cut in this illustration.
