SIB 16 04 16

2021-02-25

## RECALL CAMPAIGN 16V-746: REPLACE LOW-PRESSURE ELECTRIC IN-TANK FUEL PUMP

This Service Information Bulletin (Revision 9) replaces SI B16 04 16 **dated October 2020**.

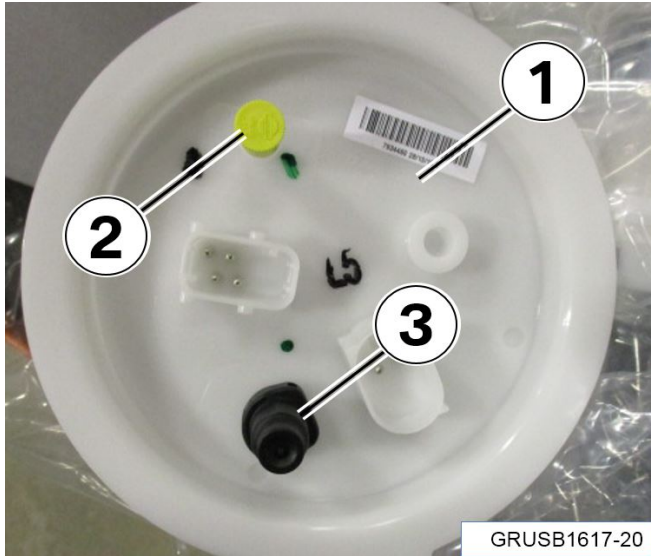
2. Inspect the new fuel pump assembly's white plastic lid (1).

The yellow transportation cap for the fuel supply line (2) must be removed and discarded before installation.

The black plastic cap (3) must not be removed. If removed, a fuel leak may develop if an open port is present.

If the new fuel pump is received without this the black plastic cap (3) and an open port is present, then another fuel pump must be ordered.

**Do not use a fuel pump that is missing the black plastic cap (3) and it has an open port which may cause a fuel leak.**

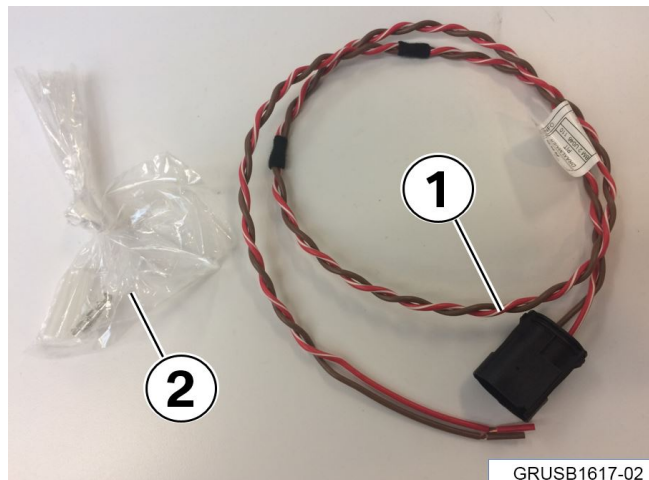
Repair kit overview:

Repair harness (1)

Butt connector and shrink tubing (2)

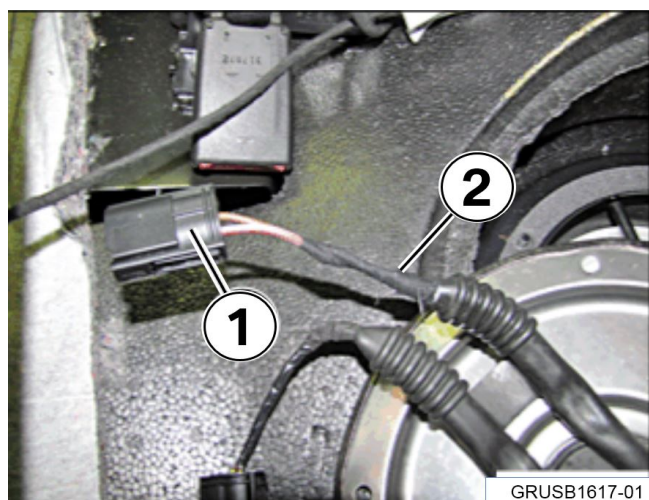
Locate the fuel pump electrical connector (1).

Unwrap the tape (2) from rubber grommet.

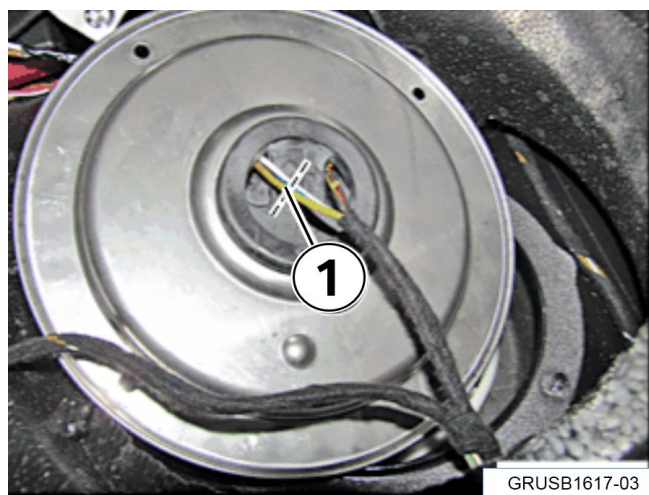
Turn over the steel lid.

Cut the electrical harness (1) and remove it from the grommet. Measure the removed section of the harness.

Cut the new repair harness to the same length as the removed section of electrical harness.

Install the repair harness through the grommet and install the shrink tubing and butt connectors at this location (1).

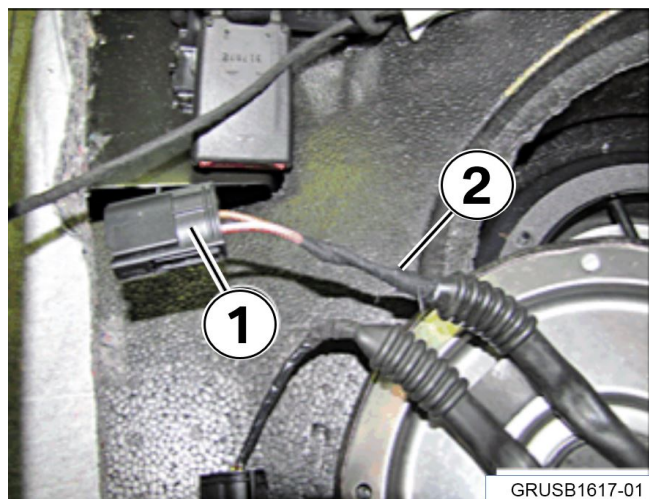
Verify that the length of harness protruding from the grommet is correct (1).

Tape the harness (2) at the grommet to seal it from water ingress.

Reassemble the vehicle as per the applicable repair instruction.
