# TECHNICAL SERVICE BULLETIN

Bulletin Number: T-16-02

VERSION: R02 (October 27, 2016)

**SUBJECT:****2016-2017 SLINGSHOT – Stat-O-Seal Replacement****PURPOSE:**

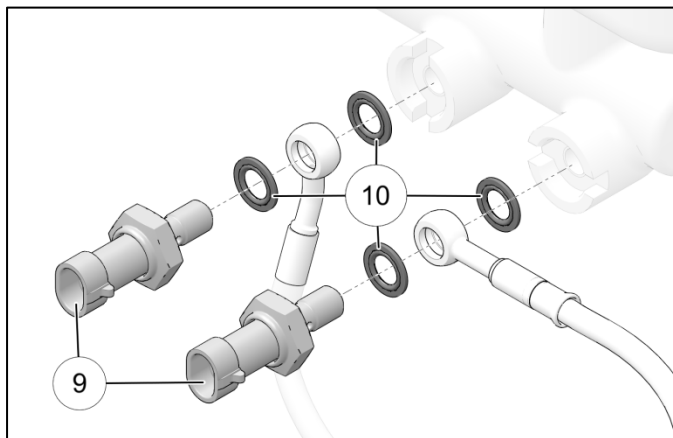
10. Remove the Brake Pressure Switches ⑨ and discard Stat-O-Seals ⑩.

1. Apply a thin layer of lubricant 8560254 (provided in kit) to new Stat-O-Seals ①.

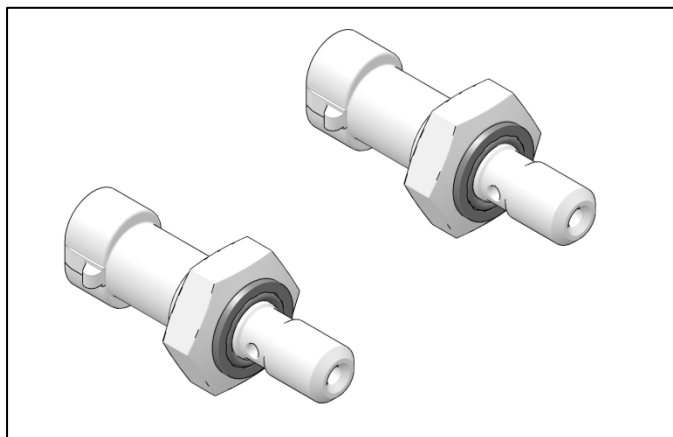
A secondary dealer representative must verify that both Stat-O-Seals have been fully seated against the switch base surface. Improperly seating Stat-O-Seals can cause damage to the seal and cause a brake system leak.

2. Install one Stat-O-Seal onto each Brake Pressure Switch until fully seated against switch base surface.

#### IMPORTANT – AUDIT STEP

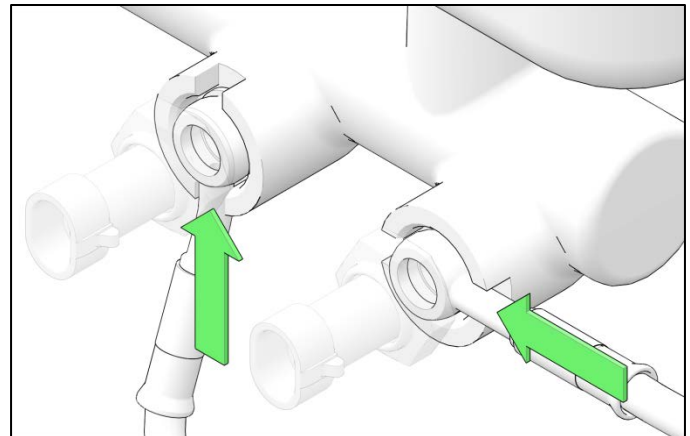
The Brake Pressure Switch is torque critical.  
**DO NOT OVERTORQUE**

4. Stabilize master cylinder and torque Brake Pressure Switches to specification.

Brake Pressure Switch:  
**12 ft-lb (16 Nm)**
