TECHNICAL SERVICE BULLETIN

Bulletin Number: T-16-02

VERSION: R03 (February 23, 2017)

2016-2017 SLINGSHOT – Stat-O-Seal Replacement

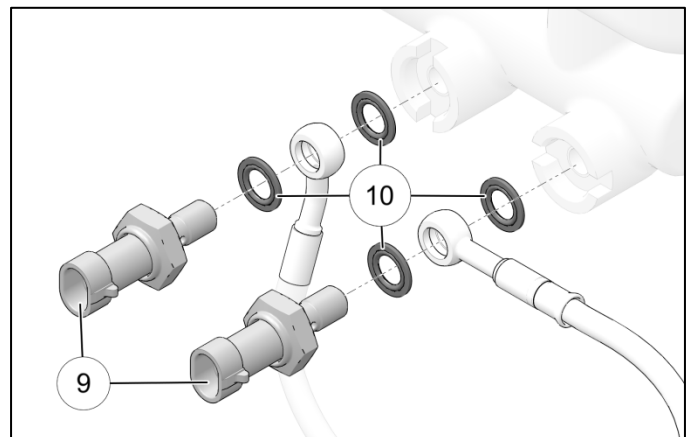
10. Remove the Brake Pressure Switches (9) and discard Stat-O-Seals (10).

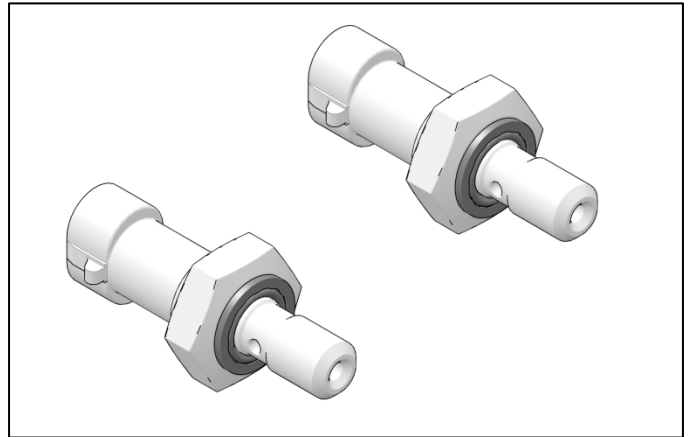
2. Install one Stat-O-Seal onto each Brake Pressure Switch until fully seated against switch base surface.

A secondary dealer representative must verify that both Stat-O-Seals have been fully seated against the switch base surface. Improperly seating Stat-O-Seals can cause damage to the seal and cause a brake system leak.

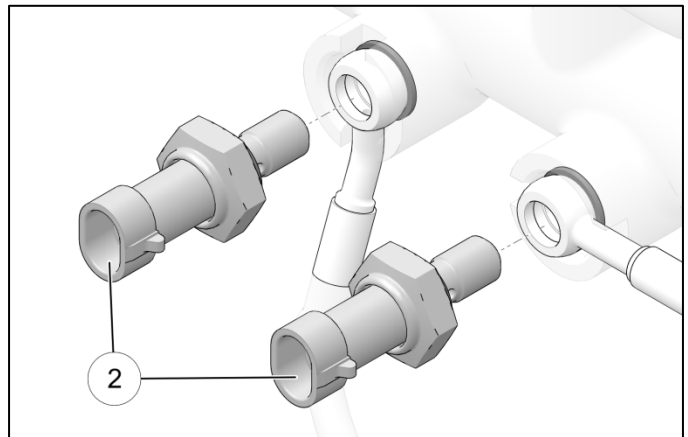
3. Install the remaining two Stat-O-Seals in between the brake line ends and the Master Cylinder. Install the Brake Pressure Switches ②.

Before tightening, make sure brake lines are properly aligned in notches of master cylinder as shown.

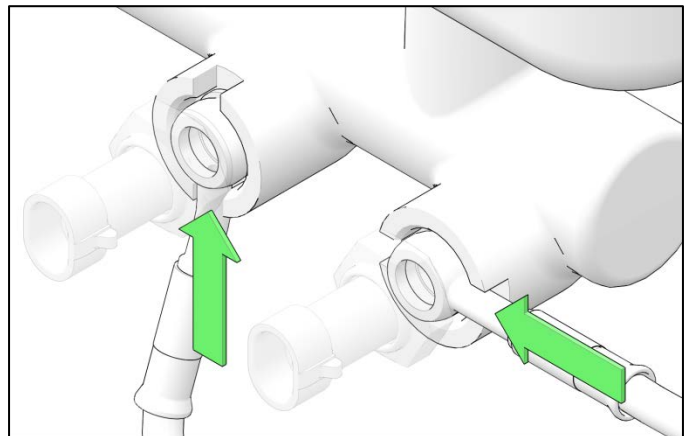
4. Stabilize master cylinder and torque Brake Pressure Switches to specification.

The Brake Pressure Switch is torque critical.
DO NOT OVERTORQUE

Brake Pressure Switch:
12 ft-lb (16 Nm)

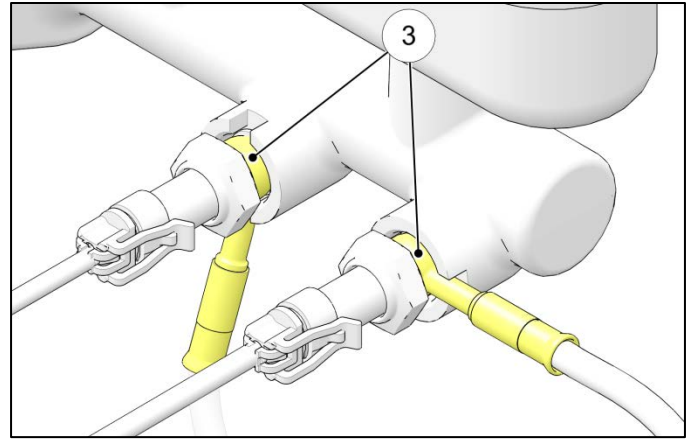
14. Check the brake system for any sign of leaks. Clean the brake line connections between the brake pressure switches and master cylinder ③ thoroughly using brake cleaner and compressed air. Apply pressure to brake pedal for three minutes. Thoroughly wipe break line fittings and pressure switch connections with shop towel (2830403) to inspect for any signs of fluid leak.
