Recall Service Bulletin

APPLIES TO: This Recall service bulletin applies to motorhome chassis, model year 2017, K2 and K3 models built between March 24, 2016 and August 31, 2016.

NHTSA/TC Id: 16V-776

CONDITION: Certain wires in the throttle circuit were not twisted which could result in a throttle setting above or below the commanded throttle setting/input.

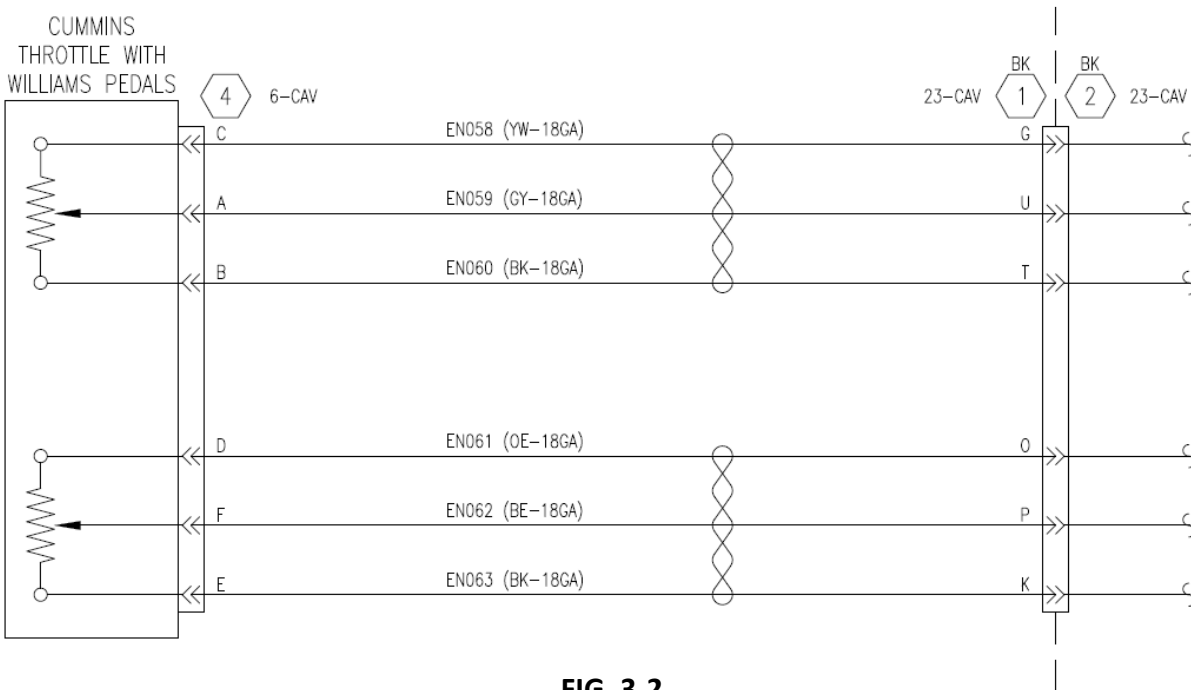
1. Identify and disconnect throttle pedal connector, Item **④** in FIG. 3-2, from throttle assembly. Pull back loom 12 inches over wiring terminated into throttle pedal connector. Verify wiring consists of 6 discreet wires (untwisted) then go to step 2. If wiring consists of 2 twisted triplets (refer to FIG. 3-2), replace loom over wiring and reconnect throttle pedal connector, Item **④**. No further action is required.

2. Pull back existing throttle pedal connector and stow/tape it back onto existing harness.
3. Connect new throttle pedal connector, Item **④**, of new 3995-GG5-001 overlay harness into throttle assembly. Refer to FIG. 3-2.

5. Locate and disconnect main chassis harness interconnect, Item **①**, from forward electrical compartment disconnect. Refer to FIG. 3-2
6. Using Deutsch contact removal tool, remove circuits from disconnected Item **①**, cavities O, P, K, G, U, and T. Refer to FIG. 3-1.

- Cut off contacts from removed circuits, individually heat shrink, and pull/tape back onto existing harness.
- Insert new circuits from new overlay harness into existing main chassis harness interconnect connector Item 1. Refer to FIG. 3-1. Each wire is tagged with a label depicting which cavity it belongs in. Refer to FIG. 3-2. Note that the wiring/pin out does not change.

, to firewall disconnect. Refer to FIG. 3-2.
10. Assure new overlay harness is secured to existing harness as required throughout its entire run. Tape back any extra length as required.
11. Using Cummins® INSITE™, verify that no fault codes are generated at key-up. Also verify that appropriate values are seen in regards to throttle pedal position.

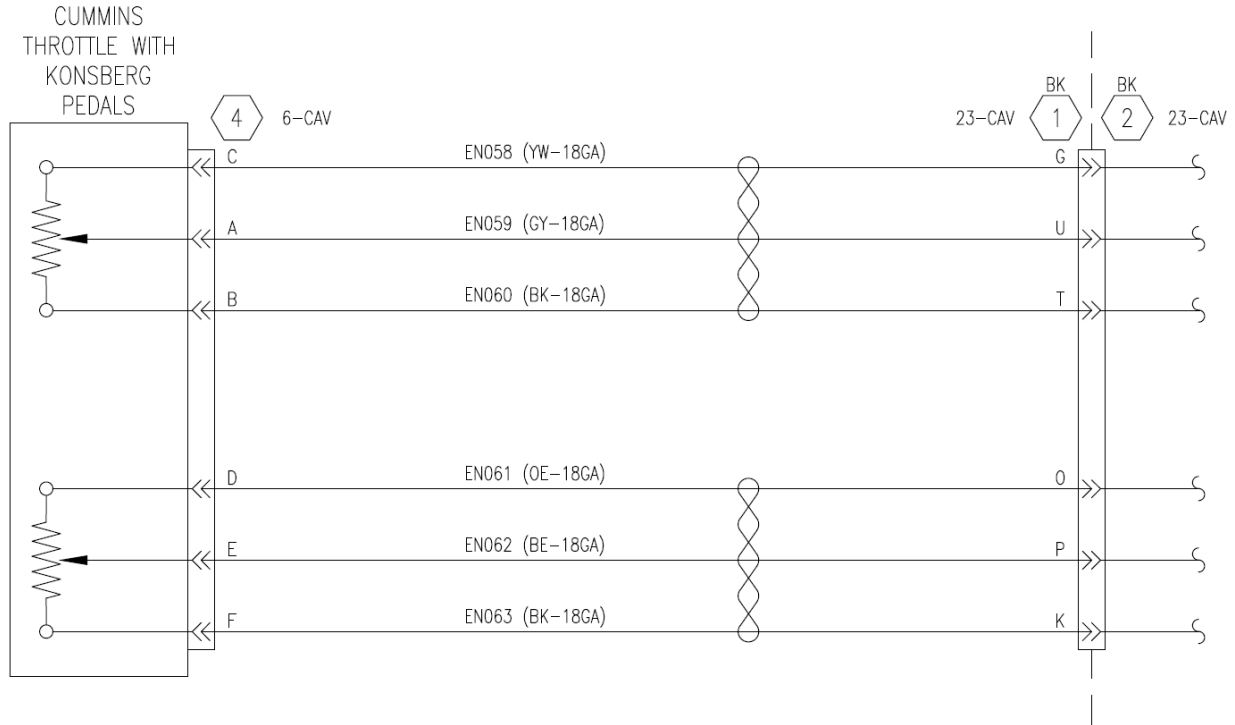
FIG. 6-1

1. Identify and disconnect throttle pedal connector, Item **④** in FIG 6-1, from throttle assembly. Pull back loom 12 inches over wiring terminated into throttle pedal connector. Verify wiring consists of 6 discreet wires (untwisted) then go to step 2. If wiring consists of 2 twisted triplets (refer to FIG. 6-1), replace loom over wiring and reconnect throttle pedal connector, Item **④**. No further action is required.

2. Pull back existing throttle pedal connector and stow/tape it back onto existing harness.
3. Connect new throttle pedal connector, Item **④** , of new 3995-GG5-002 overlay harness into throttle assembly. Refer to FIG. 6-1.

4. Route and secure as necessary new 3995-GG5-002 overlay harness along existing harness to firewall disconnect located forward of driver's position.
5. Locate and disconnect main chassis harness interconnect, Item **①** , from firewall disconnect. Refer to FIG. 6-1.

- Re-connect main chassis harness interconnect connector, Item **1** , to firewall disconnect. Refer to FIG. 6-1.
- Assure new overlay harness is secured to existing harness as required throughout its entire run. Tape back any extra length as required.
- Using Cummins® INSITE™, verify that no fault codes are generated at key-up. Also verify that appropriate values are seen in regards to throttle pedal position.

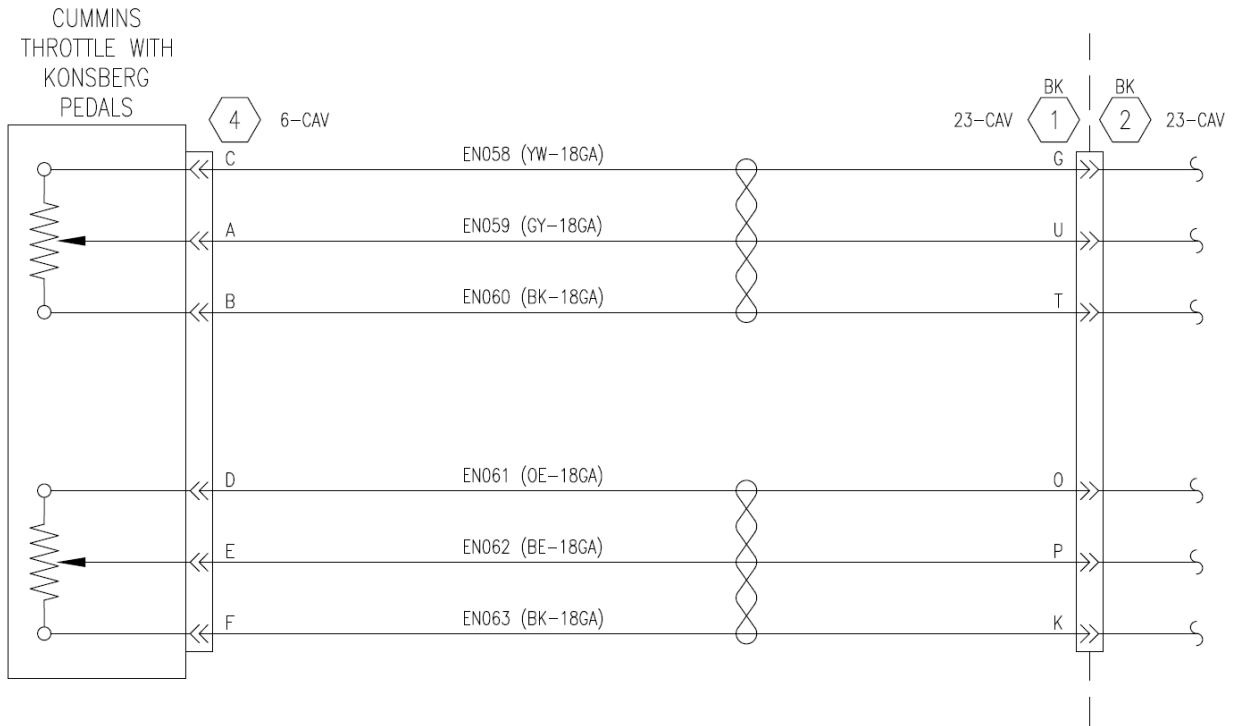
FIG. 8-1

1. Identify and disconnect throttle pedal connector, Item ④ in FIG. 8-1, from throttle assembly. Pull back loom 12 inches over wiring terminated into throttle pedal connector. Verify wiring consists of 6 discreet wires (untwisted) then go to step 2. If wiring consists of 2 twisted triplets (refer to FIG. 8-1), replace loom over wiring and reconnect throttle pedal connector, Item ④. No further action is required.

2. Pull back existing throttle pedal connector and stow/tape it back onto existing harness.
3. Connect new throttle pedal connector, Item ④, of new 3995-GG5-002 overlay harness into throttle assembly. Refer to FIG. 8-1.

9. Re-connect main chassis harness interconnect connector, Item **1** , to forward electrical compartment disconnect. Refer to FIG. 8-1.
10. Assure new overlay harness is secured to existing harness as required throughout its entire run. Tape back any extra length as required.
11. Using Cummins® INSITE™, verify that no fault codes are generated at key-up. Also verify that appropriate values are seen in regards to throttle pedal position.
