SAFETY RECALL BULLETIN

SUBJECT: WINDSHIELD WIPER LINK – SAFETY RECALL CAMPAIGN		No: SR-16-009
		DATE: July 2017
		MODEL: 2007–2013 Outlander
CIRCULATE TO:	<input checked="" type="checkbox"/> GENERAL MANAGER	<input checked="" type="checkbox"/> PARTS MANAGER
<input checked="" type="checkbox"/> SERVICE ADVISOR	<input checked="" type="checkbox"/> SERVICE MANAGER	<input checked="" type="checkbox"/> SALES MANAGER
		<input checked="" type="checkbox"/> TECHNICIAN
		<input checked="" type="checkbox"/> WARRANTY PROCESSOR

WIPER LINK ROD ASSEMBLY REPLACEMENT PROCEDURE

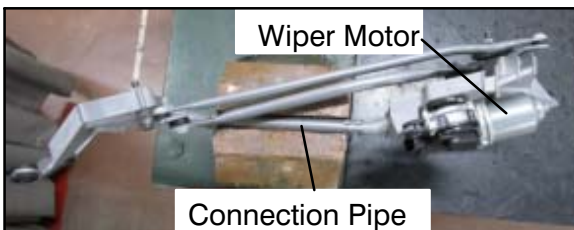
⚠ CAUTION Clamp the wiper link assembly at the connection pipe only.

1. Rotate the wiper link assembly 90 degrees upward so that the wiper motor is directly visible from the top.

CAUTION: Clamp ONLY the connection pipe section.

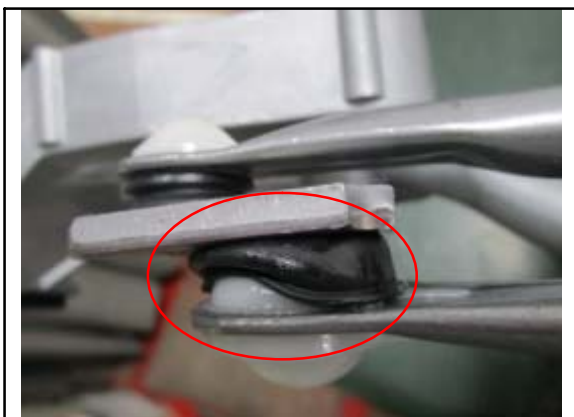
⚠ CAUTION Do not remove the wiper motor side joint.

2. Pull back the rubber seal to prevent damage when performing the following steps.

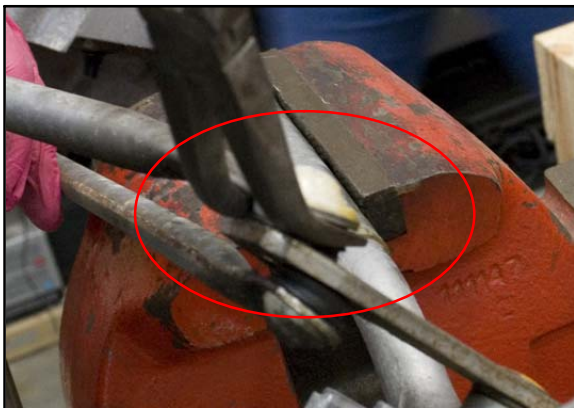
3. Use bent needle nose pliers to separate the wiper link rod from the wiper link assembly.

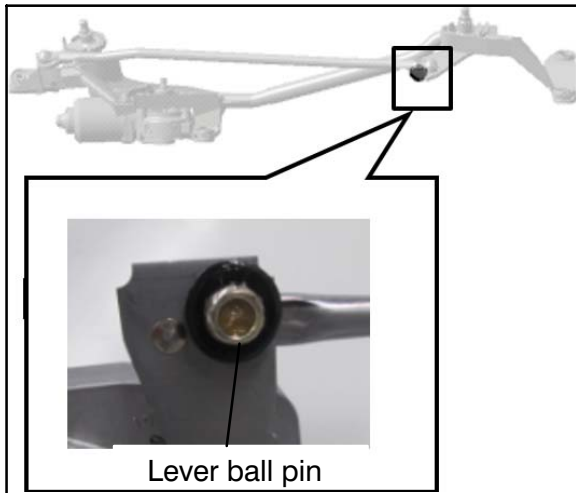
4. Use a rag to clean dirt and grease off of the lever ball pin and rubber seal.

Do NOT install link rod assembly if there is presence of water. If there is presence of water, remove excess water and dry thoroughly prior to re-installation.

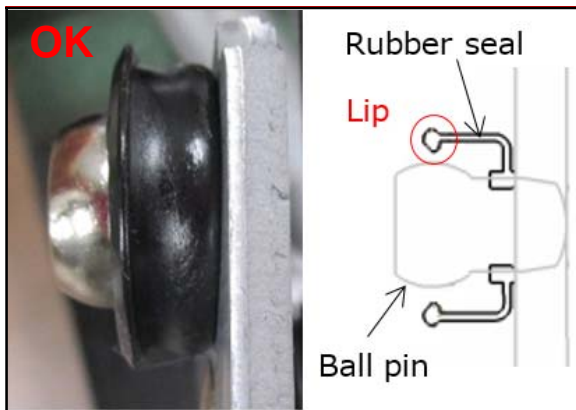
5. Verify that the rubber seal is not damaged. If rubber seal is damaged, replace it with a new rubber seal (part # 8251A098).

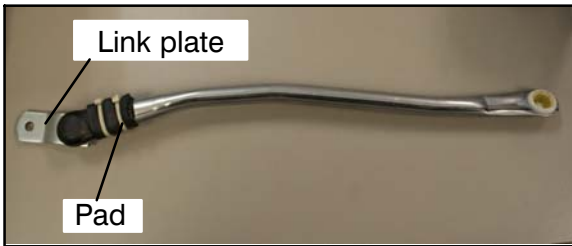
7. Obtain new wiper link rod (part # 8251A100).
8. Verify that the new wiper link rod appears as illustrated, complete with pad and link plate attached.

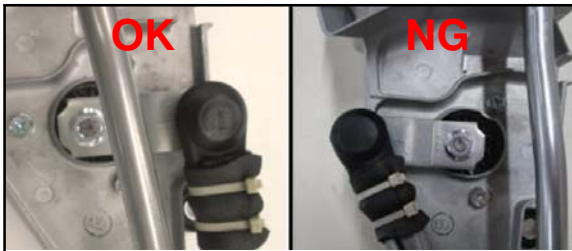
9. Install the wiper link plate to the wiper motor shaft. Make sure that the link plate and wiper link rod is in the correct orientation.

⚠ CAUTION Do NOT install link plate in a slanted position.

⚠ CAUTION Do NOT damage the pad.

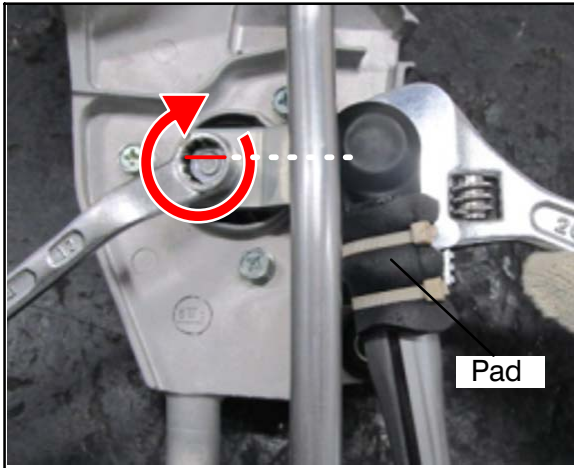
10. Make sure that the wiper motor shaft mark and the link plate center line are lined up. Use an adjustable wrench to hold the link plate in position, to prevent link plate rotation.

Tighten the nut to 12.5 ft–lb \pm 1 ft–lb (17.2 \pm 1.0 Nm).

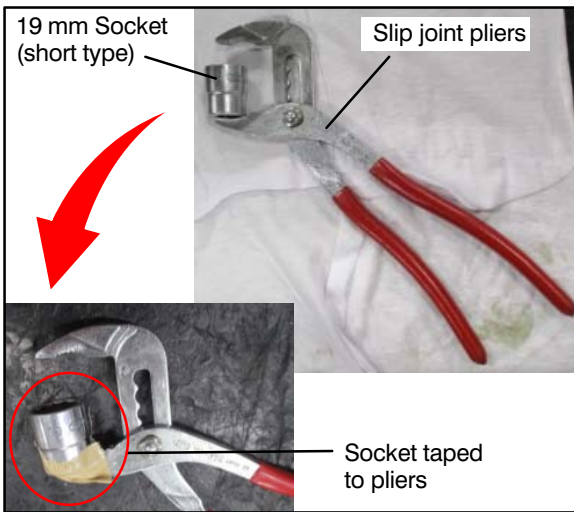
11. Install wiper link rod to the lever end that is opposing the wiper motor.

12. To prevent damage to the plastic case, improvise a tool using a 19 mm socket taped to slip joint pliers as shown.

CAUTION Turn the link plate slowly to avoid internal damage to the wiper motor.

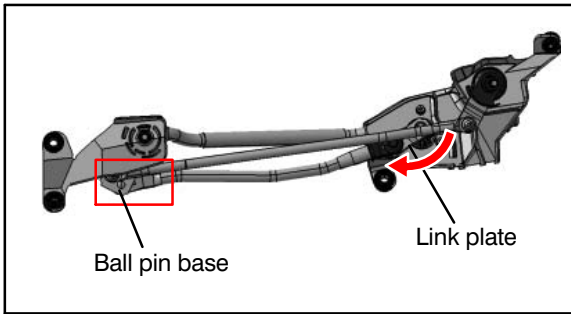
13. Turn the link plate slowly in the direction shown by the red arrow, so that the ball pin's base is visible (for easier installation).

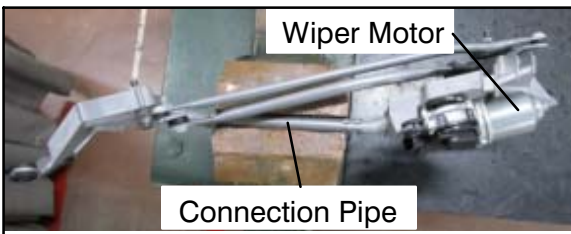
14. Rotate the wiper link assembly 90 degrees upward so that the wiper motor is directly visible from the top.
CAUTION: Clamp ONLY the connection pipe section.

15. Install wiper link rod to lever using the improvised tool.

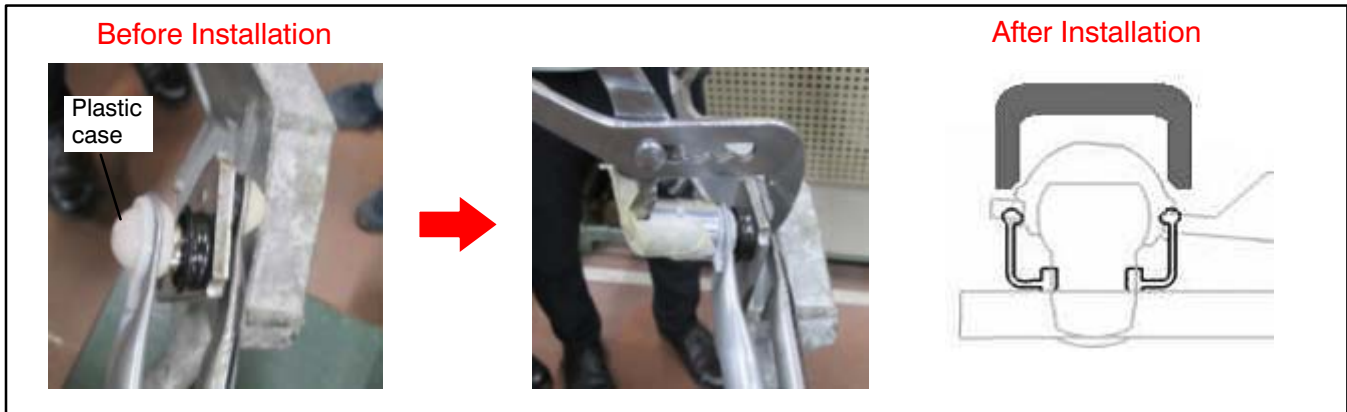
CAUTION The rubber seal must be properly seated. Confirm good condition of the rubber seal.

16. Verify that the rubber seal is properly seated.

⚠ CAUTION Confirm that the plastic case is not damaged or cracked.
