J077NAS2 TECHNICAL BULLETIN 01 MAY 2017

310-01D: Fuel Tank and Lines

SAFETY RECALL: GTDi Underfloor Fuel Line Installation

AFFECTED VEHICLE RANGE:						
MODEL:	MODEL YEAR:	VIN:	ASSEMBLY PLANT:	APPLICABILITY:		
XF (X250)	2013-2015	S92130- U88784	Castle Bromwich	GTDi 2.0L Petrol

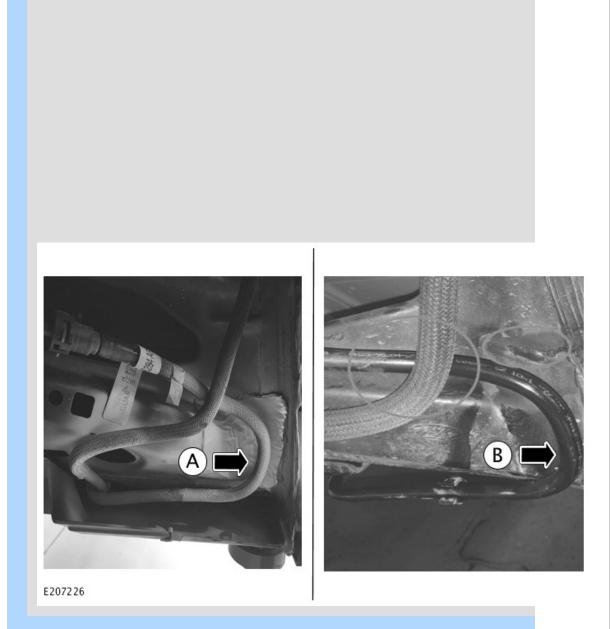
Inspect the fuel pipe to see if it has an anti-abrasive sleeve.

If the fuel pipe has an anti-abrasive sleeve (**A**), go to Step 6.

If the fuel pipe does not have an anti-abrasive sleeve (**B**), go to Step 7.

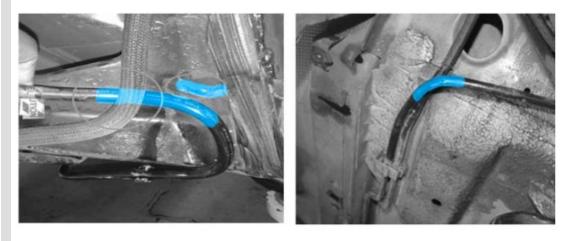
E201539

Check the fuel pipes for chafe/damage in the areas shown.

If the fuel pipe does not have chafe/damage, go to Step 9.

If the fuel pipe has chafe/damage, go to Step 7.
