J077NAS1

TECHNICAL BULLETIN

SAFETY RECALL: GTDi Underfloor Fuel Line Installation

| MODEL: | MODEL YEAR: | VIN: | ASSEMBLY PLANT: | APPLICABILITY: |
|---|---|---|---|---|
| XF (X250) | 2013-2015 | S92130- U88784 | Castle Bromwich | GTDi 2.0L Petrol |

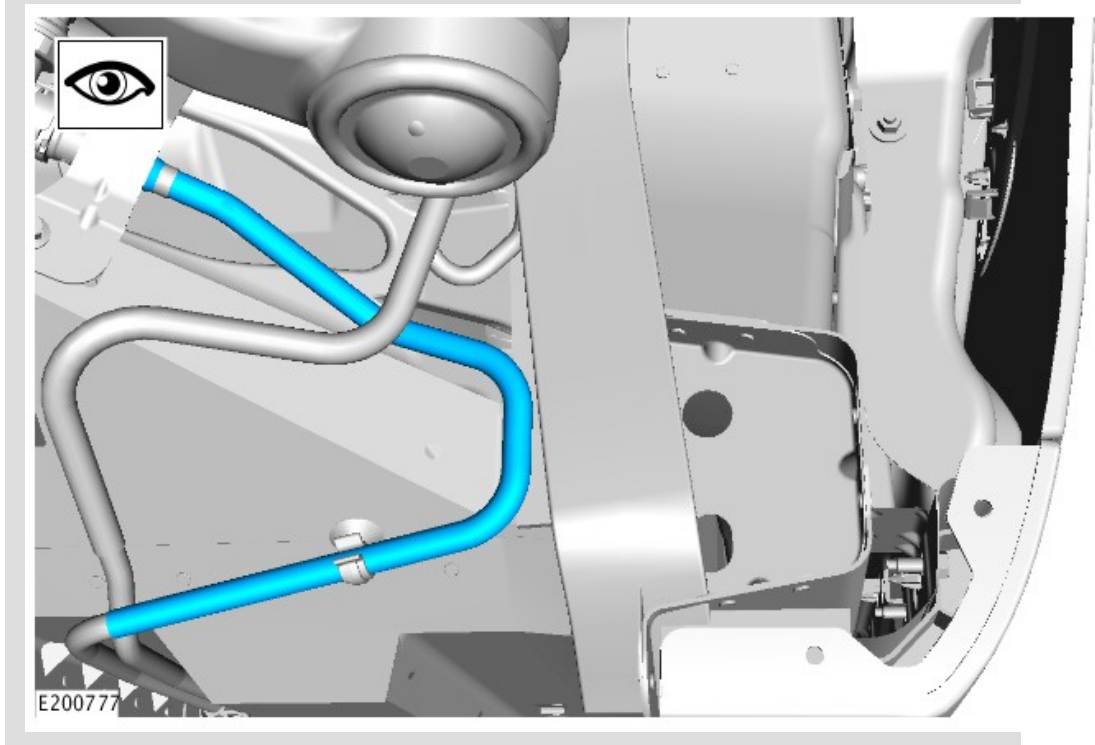
Inspect the fuel pipe to see if it has an anti-abrasive sleeve.

If the fuel pipe does not have an anti-abrasive sleeve, go to Step 7.

If the fuel pipe has an anti-abrasive sleeve, go to Step 6.

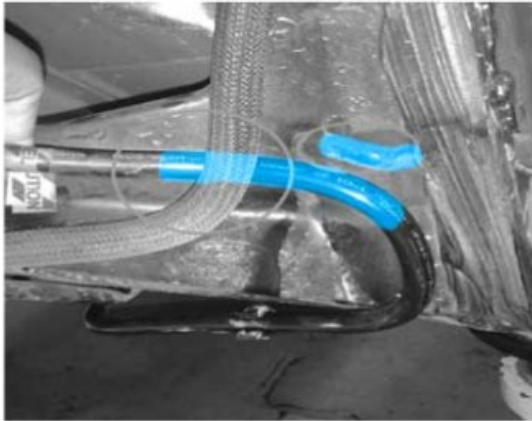
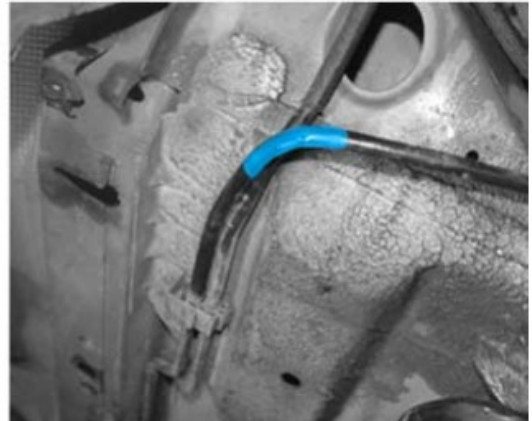
E201539

Check the fuel pipes for chafe/damage in the areas shown.

If the fuel pipe does not have chafe/damage, go to Step 9.

If the fuel pipe has chafe/damage, go to Step 7.
