Technical Journal

Recall R89708 – Front Passenger Seatbelt Buckle

| REF NO: TJ 32058.1.1 | ISSUING DEPARTMENT: Technical Service | CAR MARKET: United States and Canada | |

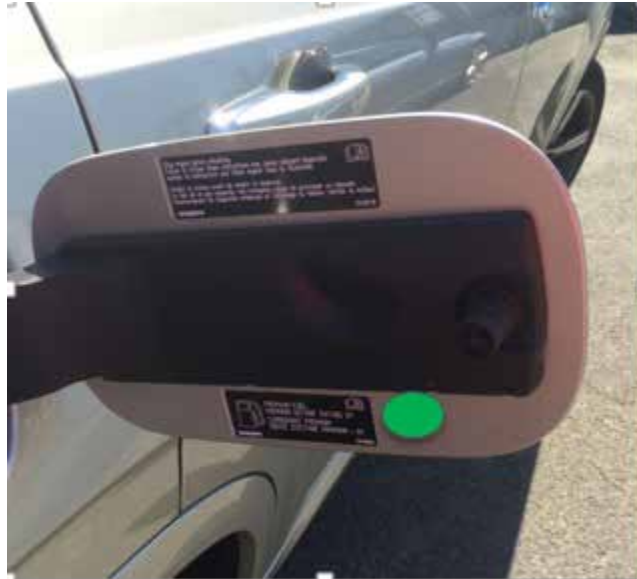
NOTE: Vehicles completed at ports will have a "Green" dot on the inside of the fuel filler door identifying the completion of this recall. Please see the attachment titled "**Port_Action_Completed.jpg**"

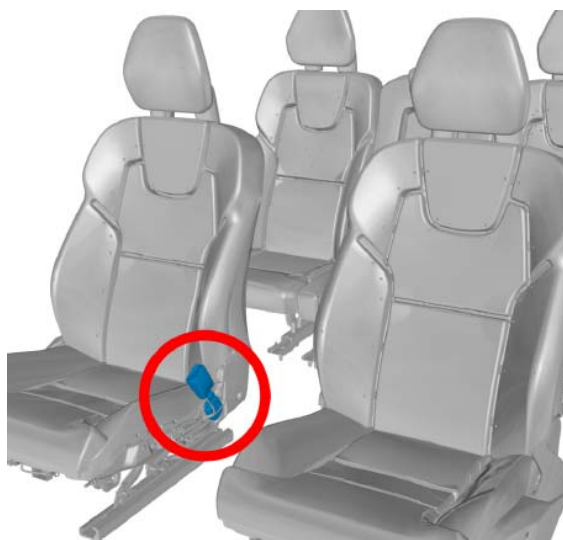
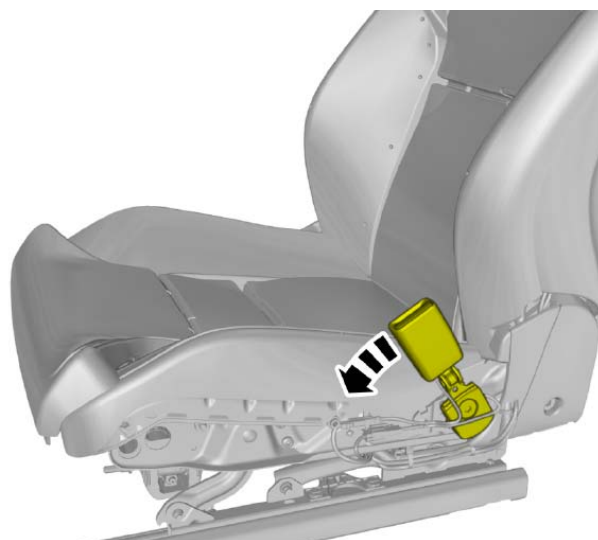
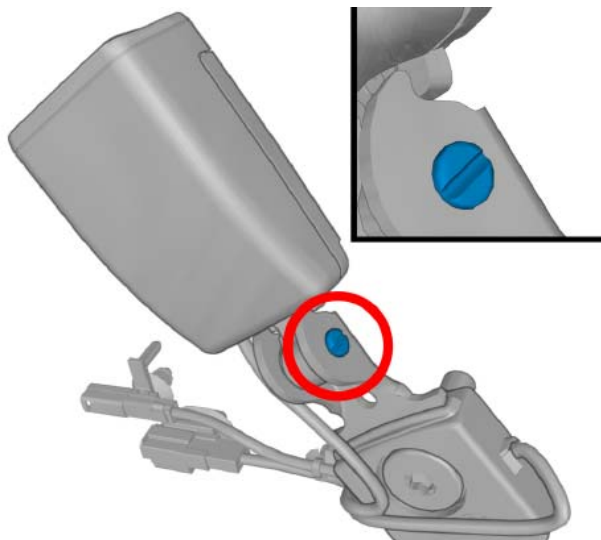
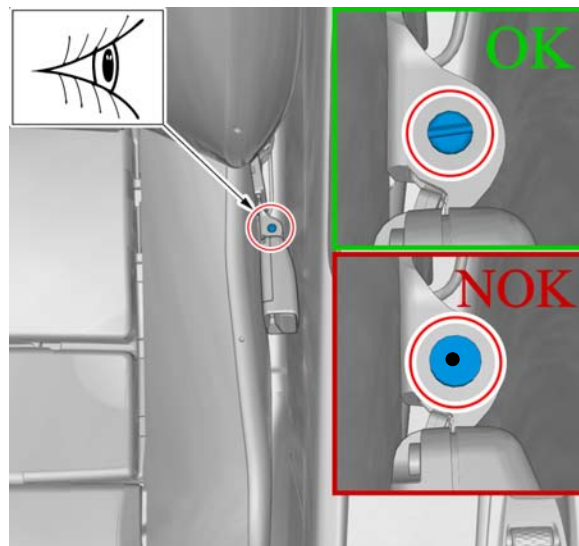
The affected vehicles may have not had the front passenger seatbelt buckle stud punched correctly. This may result in a separation between the buckle and the seat belt bracket. If this were to occur, it could increase the risk of injury to a front passenger seat occupant in a vehicle crash.

Authorized Volvo retailers will inspect the front passenger seatbelt buckle stud by pushing/rotating the passenger seatbelt buckle forward, and checking if the seatbelt buckle stud is punched according to the illustrations in the attached instruction titled "**TJ Instruction_32058_Seat Belt Inspection.pdf**"

If the inspection procedure indicates an incorrectly manufactured seatbelt buckle, Volvo retailers must replace the seatbelt buckle.
