GROUP  
Safety Recall Campaign

MODEL  
2008-2009MY  
Sportage (KM)

NUMBER  
SC138 (Rev 1, 4/19/2017)

SUBJECT: HECU ASSEMBLY AND CONNECTOR COVER  
INSPECTION AND REPLACEMENT (SC138)

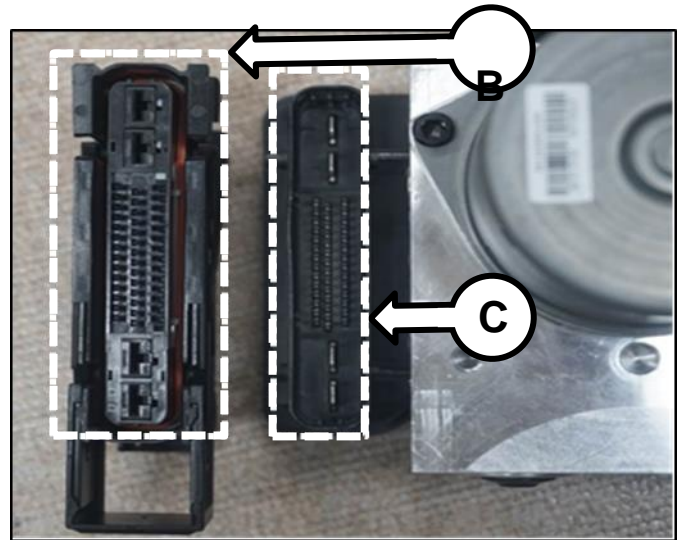
6. Confirm proper lever/lock operation.
7. Blow off any foreign substances from the wiring harness connector and the HECU connector receptacle with an air gun.
  - (B) Wiring harness side
  - (C) HECU side

Using a mirror and flashlight, carefully check for any corrosion and/or contamination of the connector pins/terminals in the HECU connector receptacle.

8. In case there is contamination on the connector, replace the HECU assembly by proceeding to the “HECU Assembly and Replacement Procedure” on the next page.
9. If there is no corrosion and/or contamination, re-install the connector onto the HECU.
10. Reinstall the washer fluid filler neck and secure with bolt.
11. Start the vehicle, confirm proper operation and confirm no MIL ON after HECU self-check.
