GROUP Safety Recall Campaign	MODEL 2008-2009MY Sportage (KM)
	NUMBER SC138	DATE November 2016
SAFETY RECALL CAMPAIGN		
SUBJECT: HECU ASSEMBLY AND CONNECTOR COVER INSPECTION AND REPLACEMENT (SC138)

This bulletin provides information relating to the inspection and replacement of the Hydraulic Electronic Control Unit (HECU) connector cover or HECU assembly and connector cover in 2008-2009MY Sportage (KM) vehicles produced from August 9, 2007 through May 13, 2009. Corrosion of the wire harness connector pins in the HECU assembly can occur due to improper sealing of the HECU's wire harness connector. If moisture contaminated with road salt reaches the HECU's circuit board, electrical short circuits may occur to the circuit board and can lead to a thermal event, including the possibility of an engine compartment fire. In some cases, the ESC warning light may also illuminate. Before conducting the procedure, verify the vehicle is included in the list of affected VINs. If so, follow the procedure outlined in this bulletin.

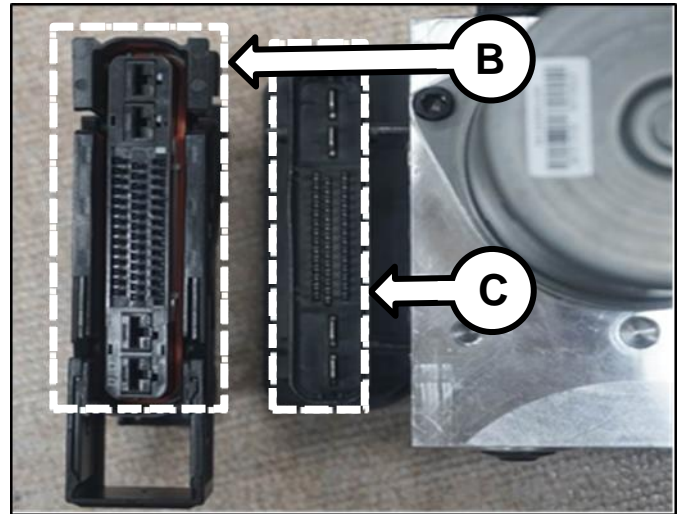
Using a mirror and flashlight, carefully check for any corrosion and/or contamination of the connector pins/terminals in the HECU connector receptacle.

6. Confirm proper lever/lock operation.
7. Blow off any foreign substances from the wiring harness connector and the HECU connector receptacle with an air gun.
 - (B) Wiring harness side
 - (C) HECU side

8. In case there is contamination on the connector, replace the HECU assembly by proceeding to the "HECU Assembly and Replacement Procedure" on the next page.
9. If there is no corrosion and/or contamination, re-install the connector onto the HECU.
10. Reinstall the washer fluid filler neck and secure with bolt.
11. Start the vehicle, confirm proper operation and confirm no MIL ON after HECU self-check.
